DRAFT Final Hangar 1 Engineering Evaluation/Cost Analysis

**Former Naval Air Station Moffett Field,
California**

**13 August 2019
EKI B20019.19**

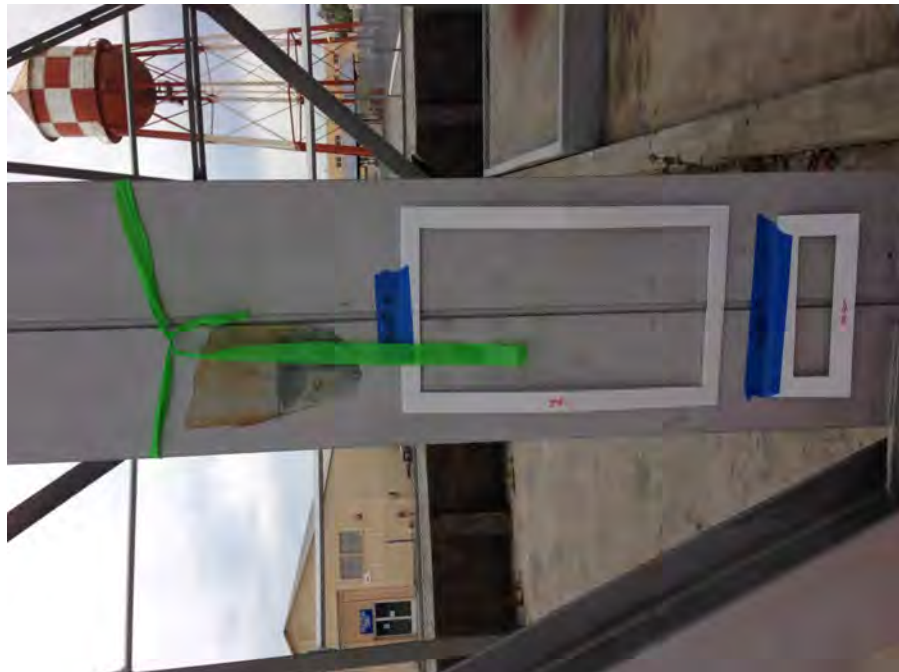
Sample Location: Ground Floor, Column Line 14, West Side
Sample Number: 14WDP
Sample System / Condition: Structural Steel below Deteriorated Encapsulant/Paint

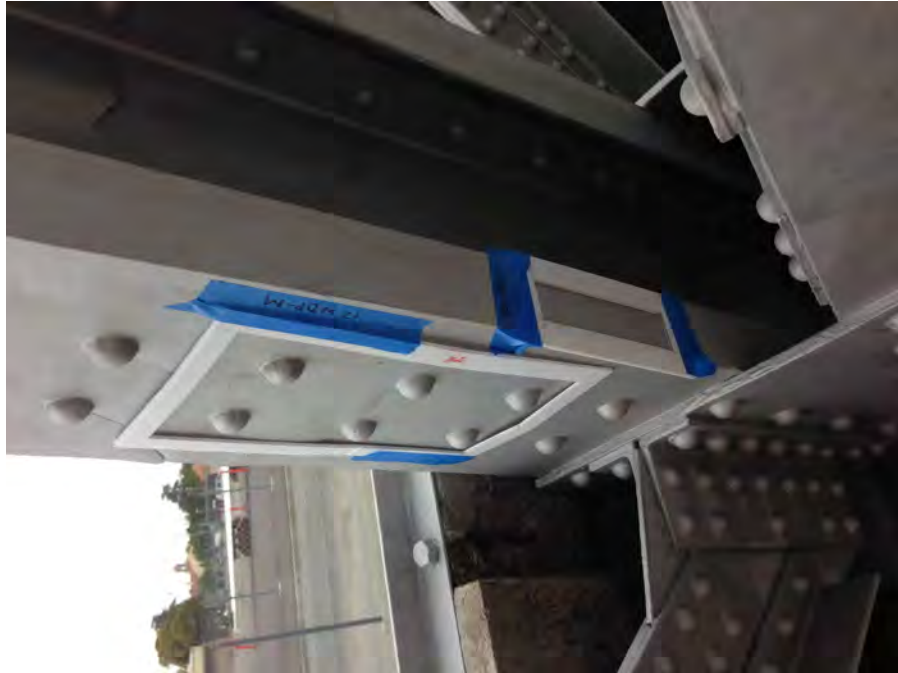
Sample Location: Ground Floor, Column Line 12, West Side
Sample Number: 12WDP
Sample System / Condition: Structural Steel below Deteriorated Encapsulant/Paint

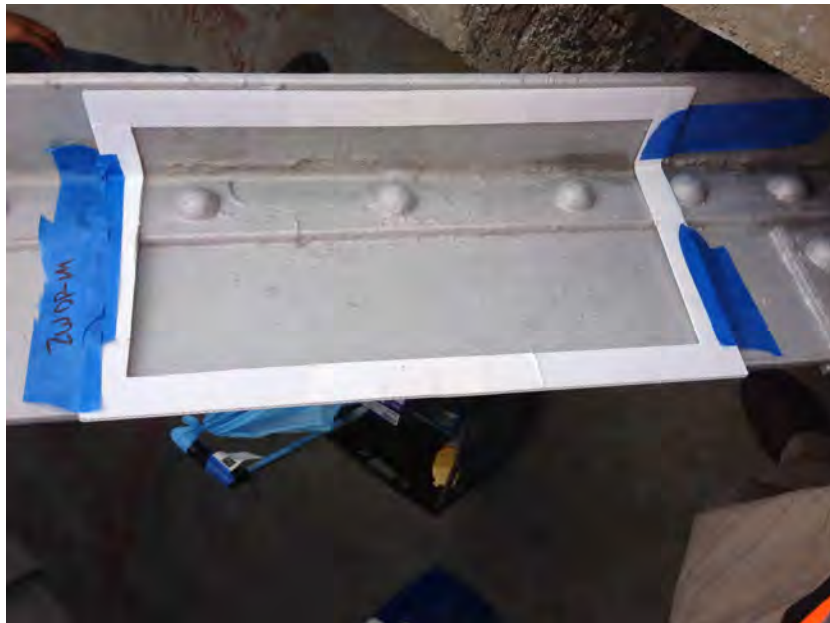
Sample Location: Ground Floor, Column Line 2, West Side
Sample Number: 2WDP
Sample System / Condition: Structural Steel below Deteriorated Encapsulant/Paint

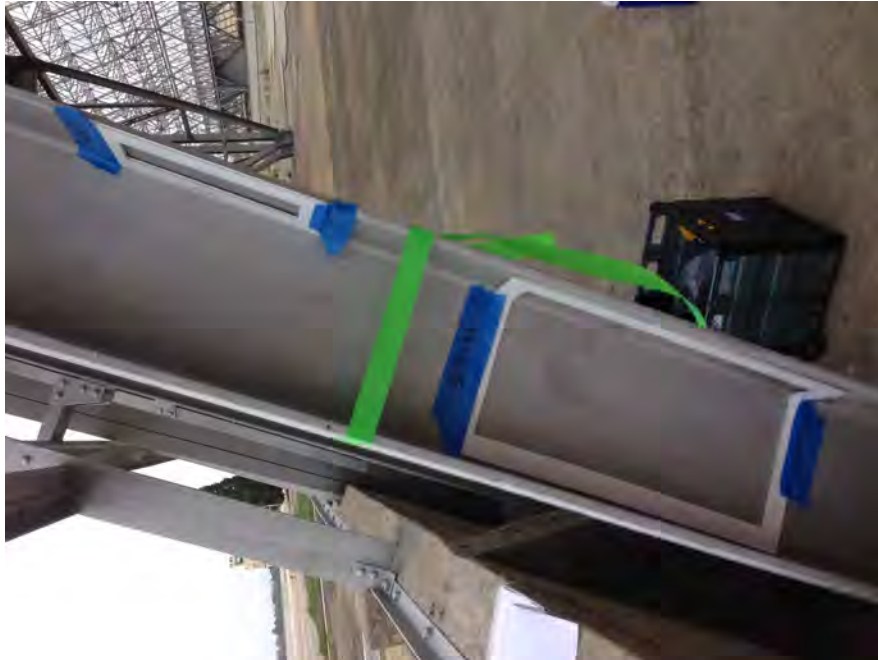
Sample Location: Ground Floor, Column Line 3, East Side
Sample Number: 3EDP
Sample System / Condition: Structural Steel below Deteriorated Encapsulant/Paint

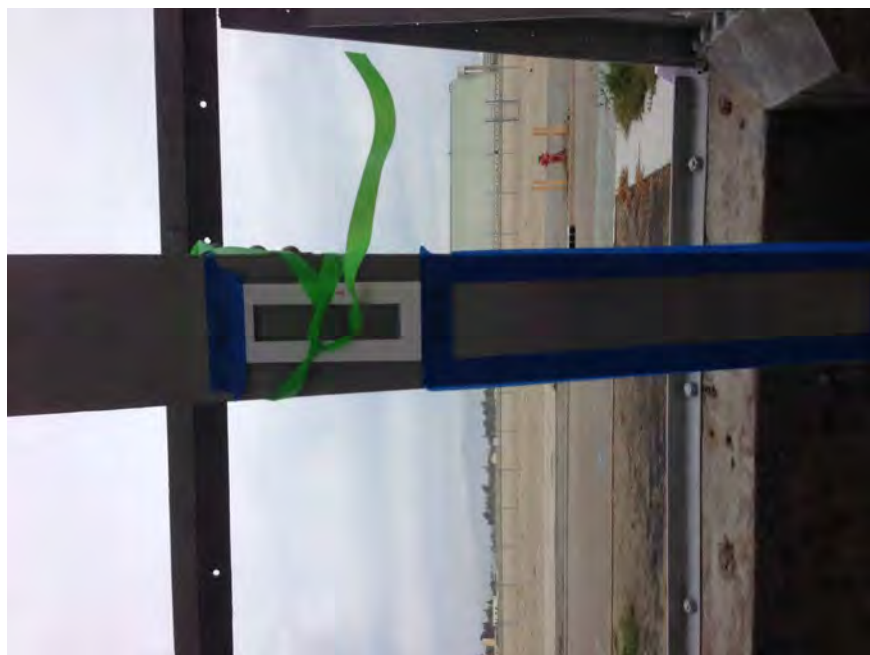
Sample Location: Ground Floor, Column Line 6, East Side
Sample Number: 6EDP
Sample System / Condition: Structural Steel below Deteriorated Encapsulant/Paint

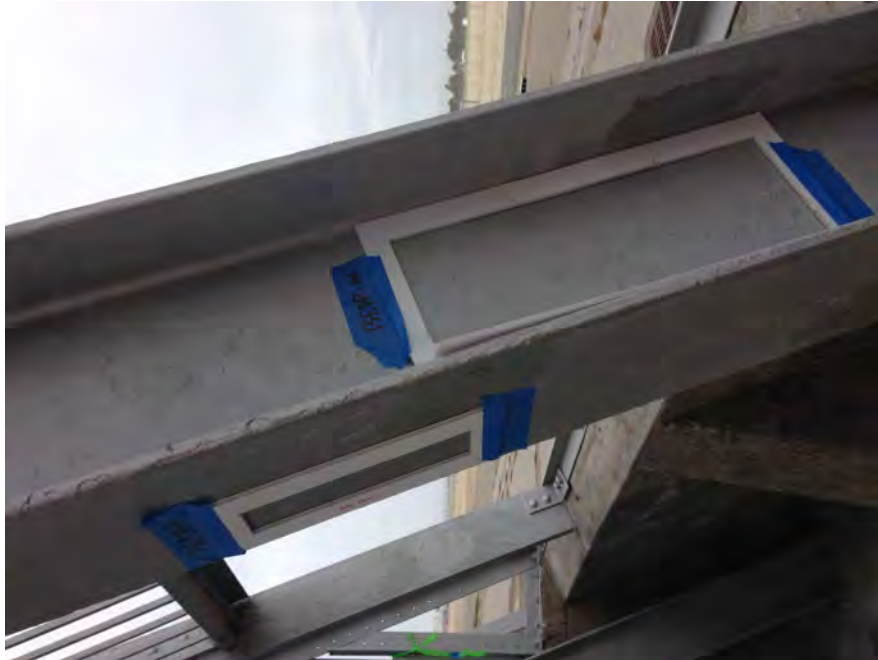
Sample Location: Ground Floor, Column Line 13, East Side
Sample Number: 13EDP
Sample System / Condition: Structural Steel below Deteriorated Encapsulant/Paint

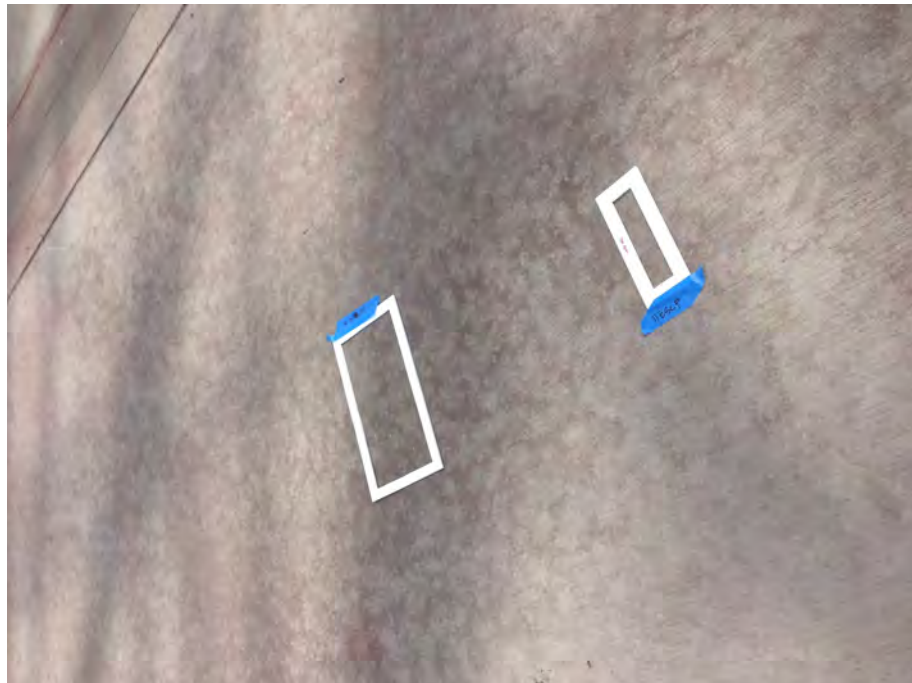
Sample Location: Ground Floor, Column Line 11, East Side
Sample Number: 11ESC
Sample System / Condition: Concrete Floor - Evidence of Pooling/Sediment

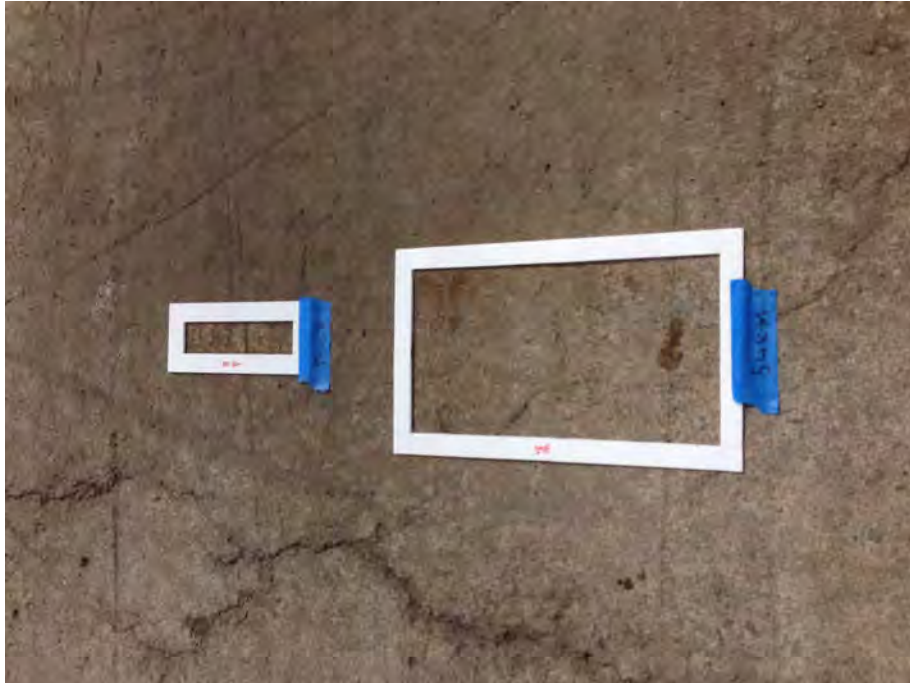
Sample Location: Ground Floor, Column Line 5, West Side
Sample Number: 5WSC
Sample System / Condition: Concrete Floor - Evidence of Pooling/Sediment

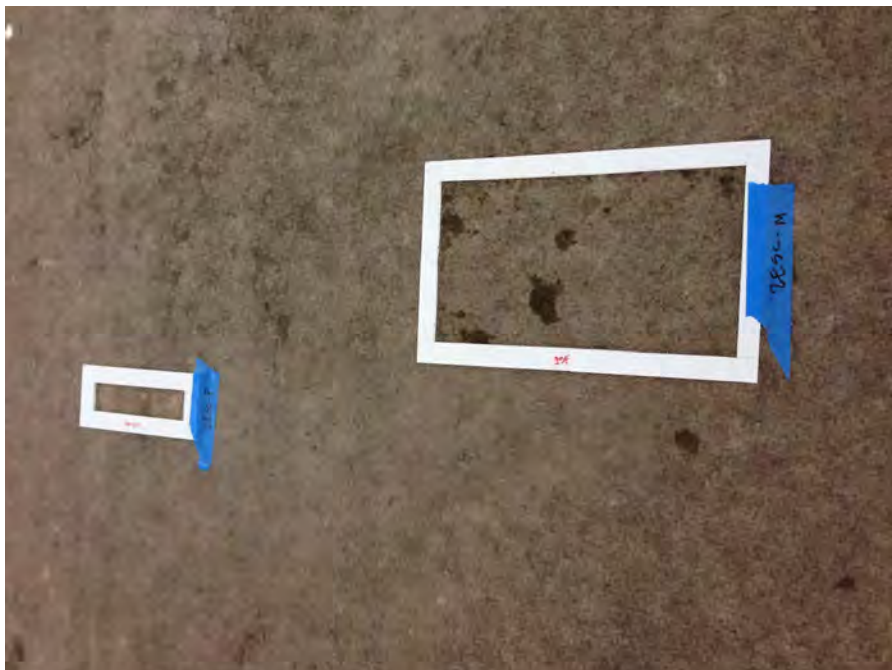
Sample Location: Ground Floor, Column Line 2, East Side
Sample Number: 2ESC
Sample System / Condition: Concrete Floor - Evidence of Pooling/Sediment

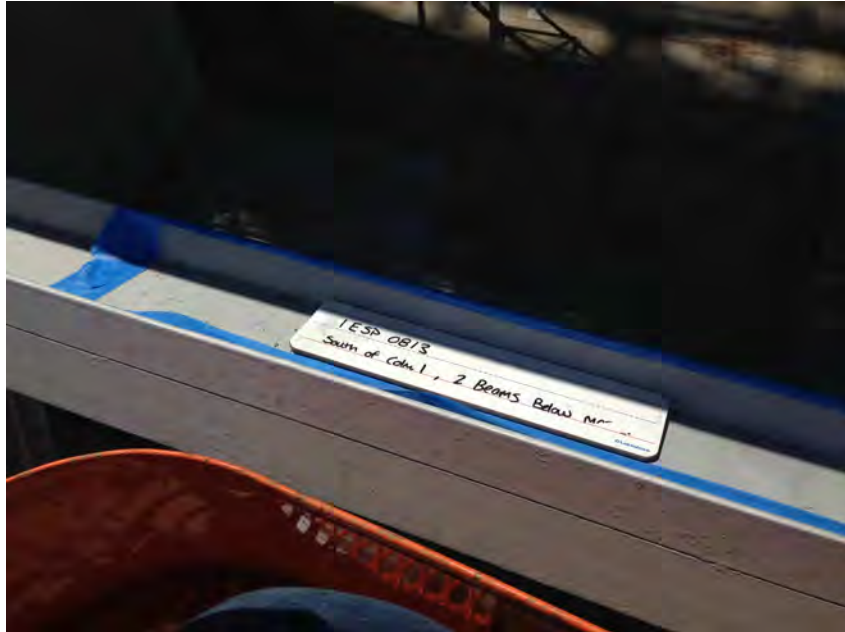
Sample Location: Ground Floor, Column Line 1, East Side
Sample Number: 1ESP0813
Sample System / Condition: Ponding Water Areas - Horizontal Structural Steel

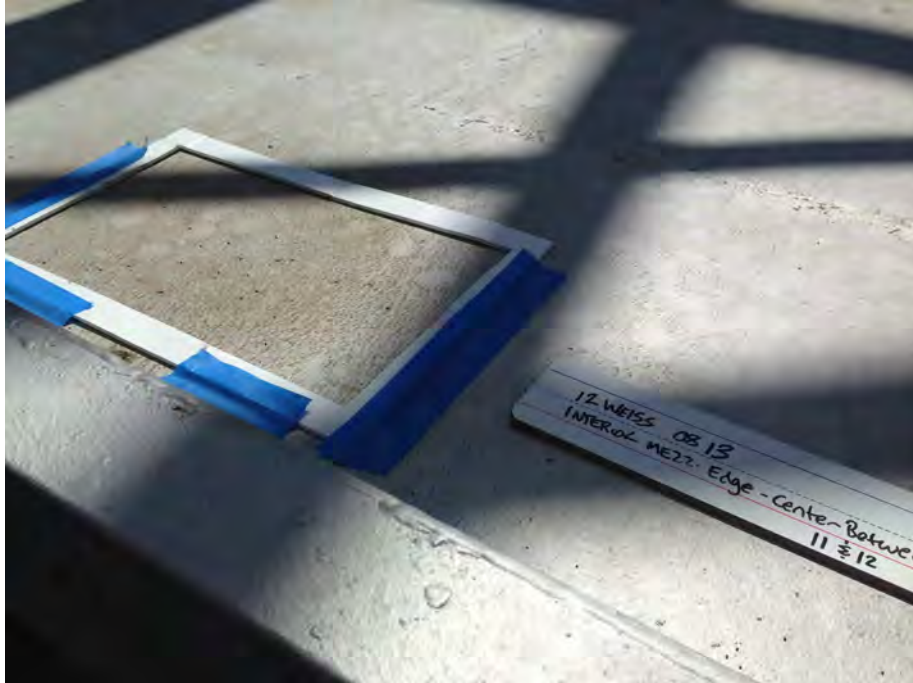
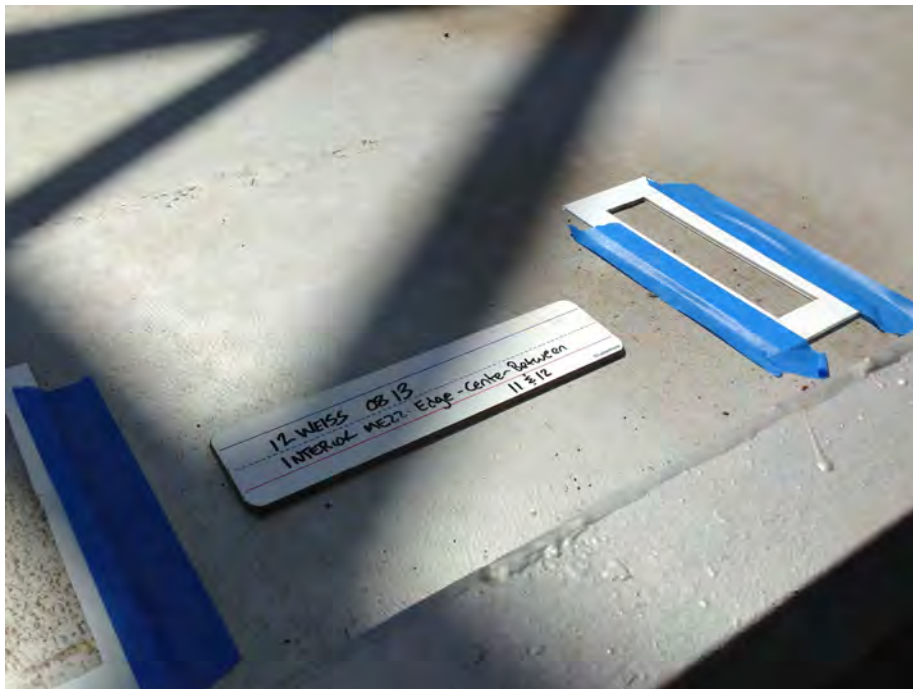
Sample Location: Ground Floor, Column Line 12, West Side
Sample Number: 12WISS0813
Sample System / Condition: Ponding Water Areas - Horizontal Structural Steel

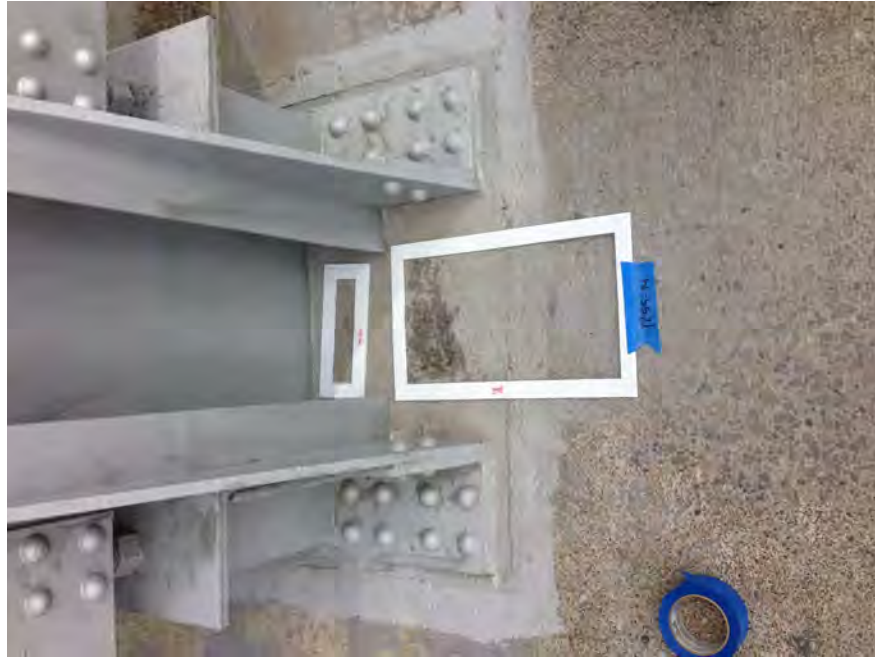
Sample Location: Ground Floor, Column Line 12, East Side
Sample Number: 12ESS
Sample System / Condition: Base of Steel Column at evidence of Pooling/Sediment

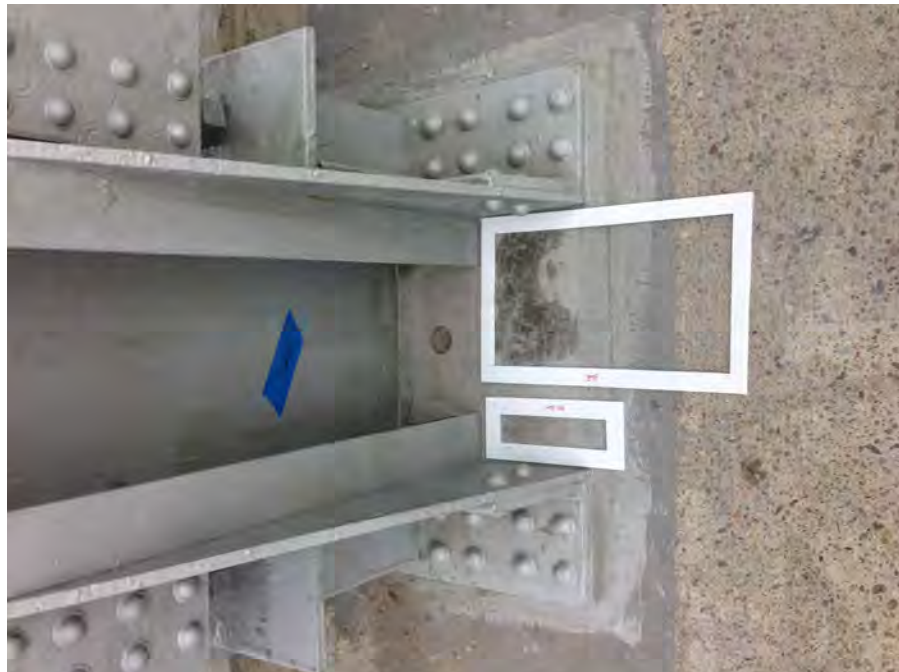
Sample Location: Ground Floor, Column Line 9, West Side
Sample Number: 9WSS
Sample System / Condition: Base of Steel Column at evidence of Pooling/Sediment

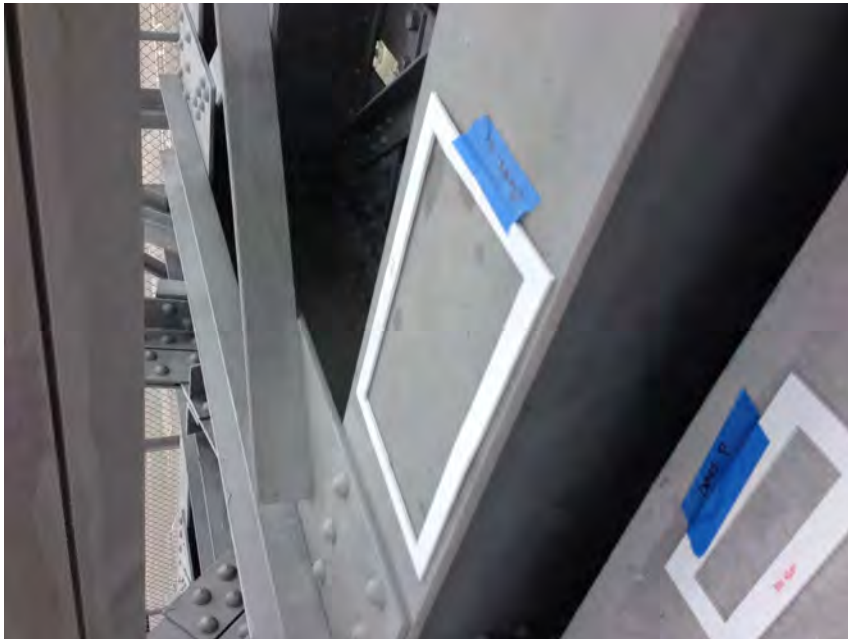
Sample Location: Ground Floor, Column Line 0, West Side
Sample Number: 0WSS
Sample System / Condition: Base of Steel Column at evidence of Pooling/Sediment

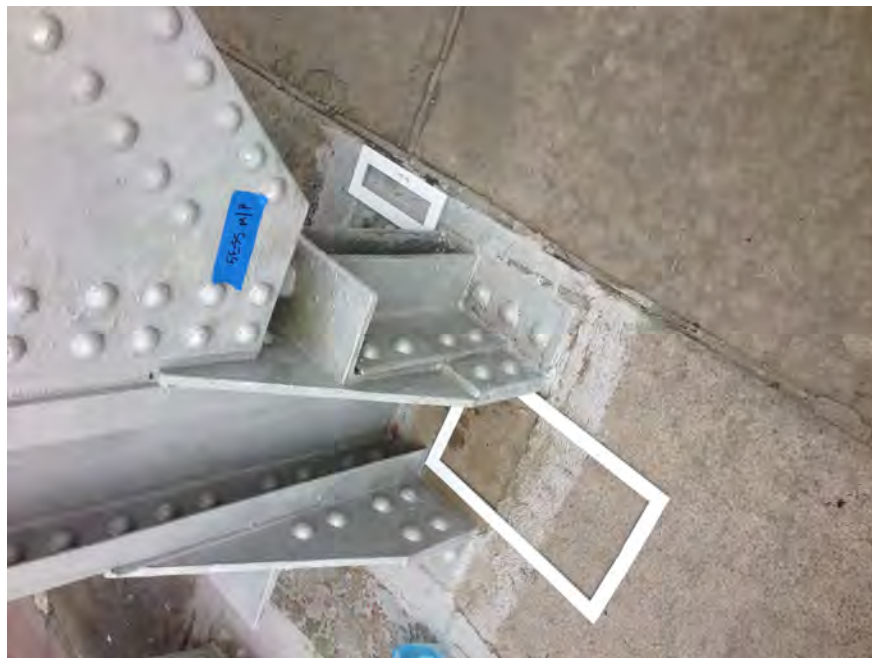
Sample Location: Ground Floor, Column Line 5, East Side
Sample Number: 5ESS
Sample System / Condition: Base of Steel Column at evidence of Pooling/Sediment

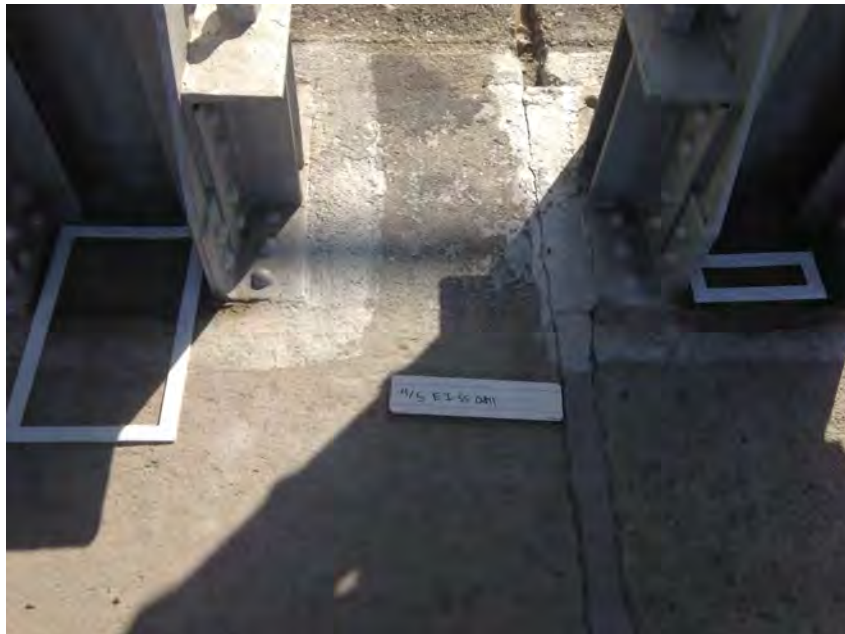
Sample Location: Ground Floor, Column Line 4/5, Outer Column, East Side
Sample Number: 4/5EOSS0811
Sample System / Condition: Base of Steel Column at evidence of Pooling/Sediment

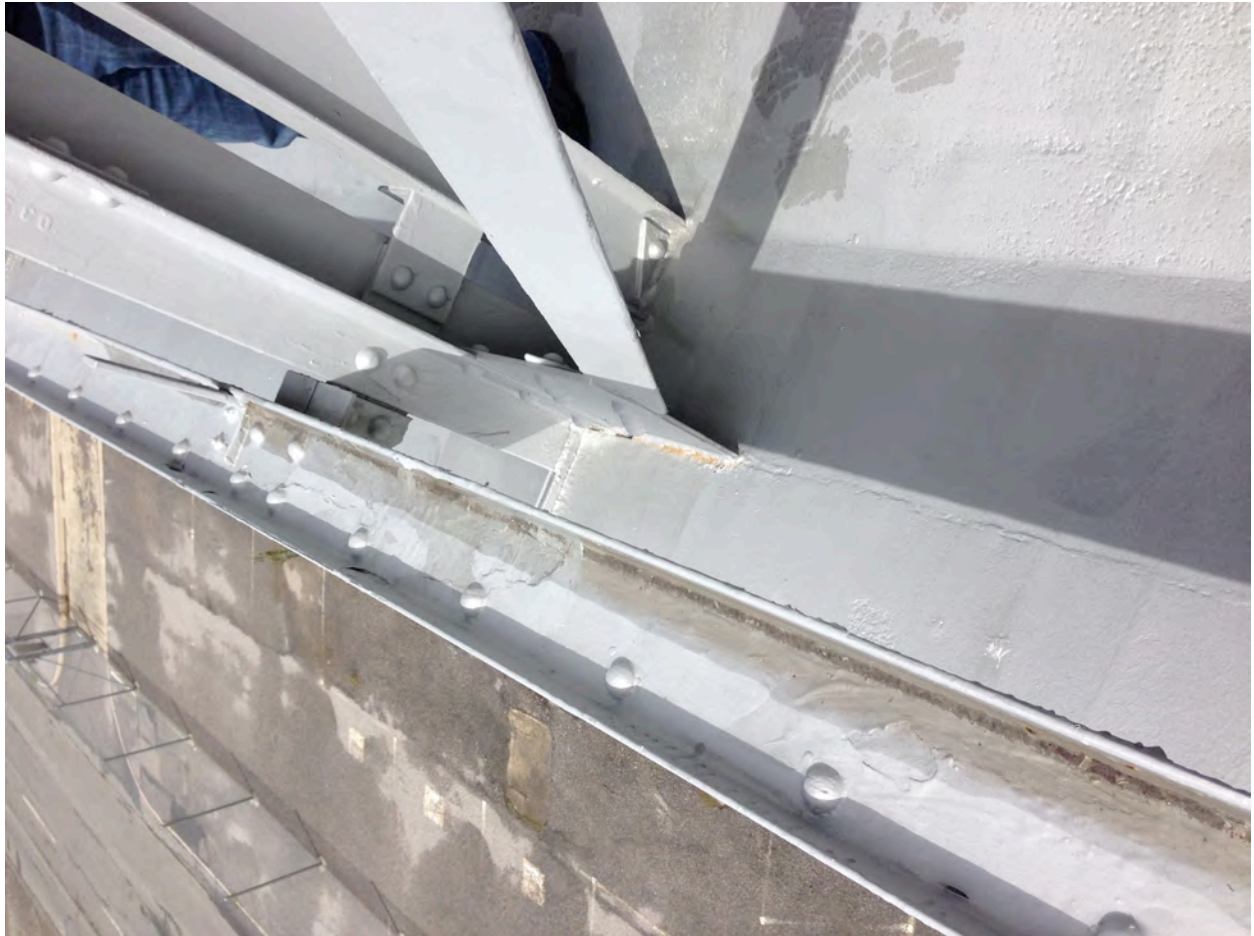
Pooled Water & Deteriorating Paint Edges (Horizontal Steel Framing)

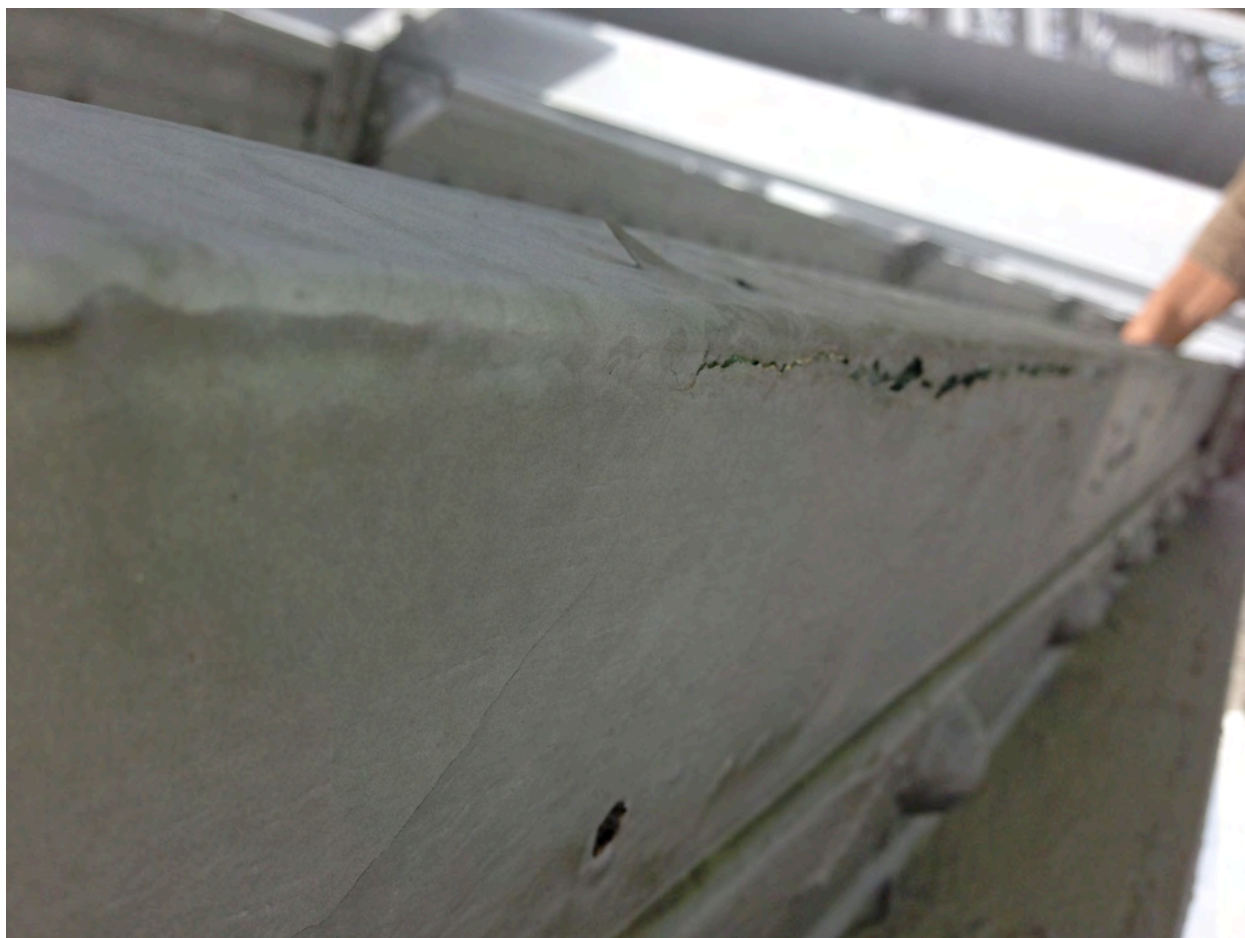
Deteriorated paint, underside of horizontal steel

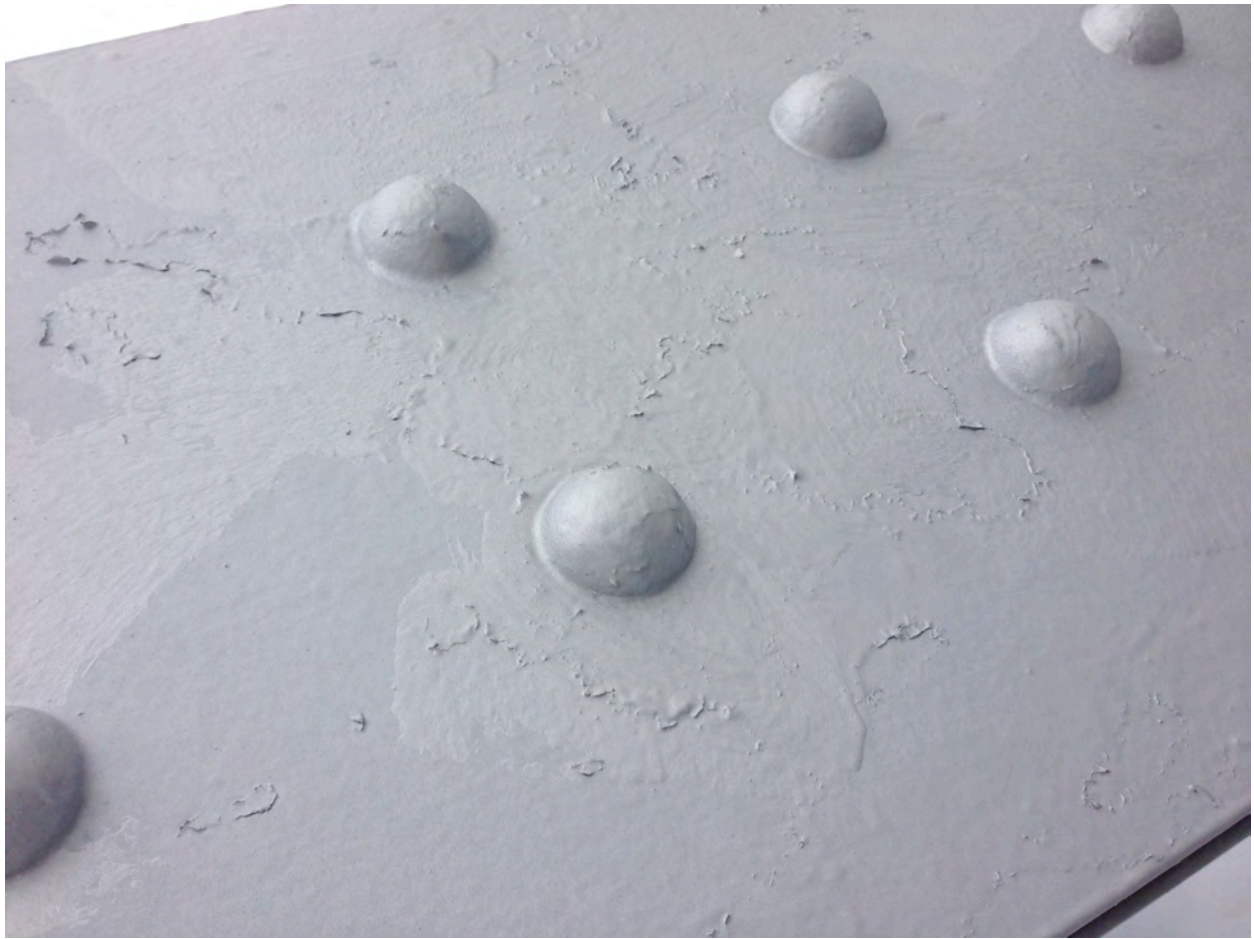
Peeling Edges of Original Coating, vertical steel

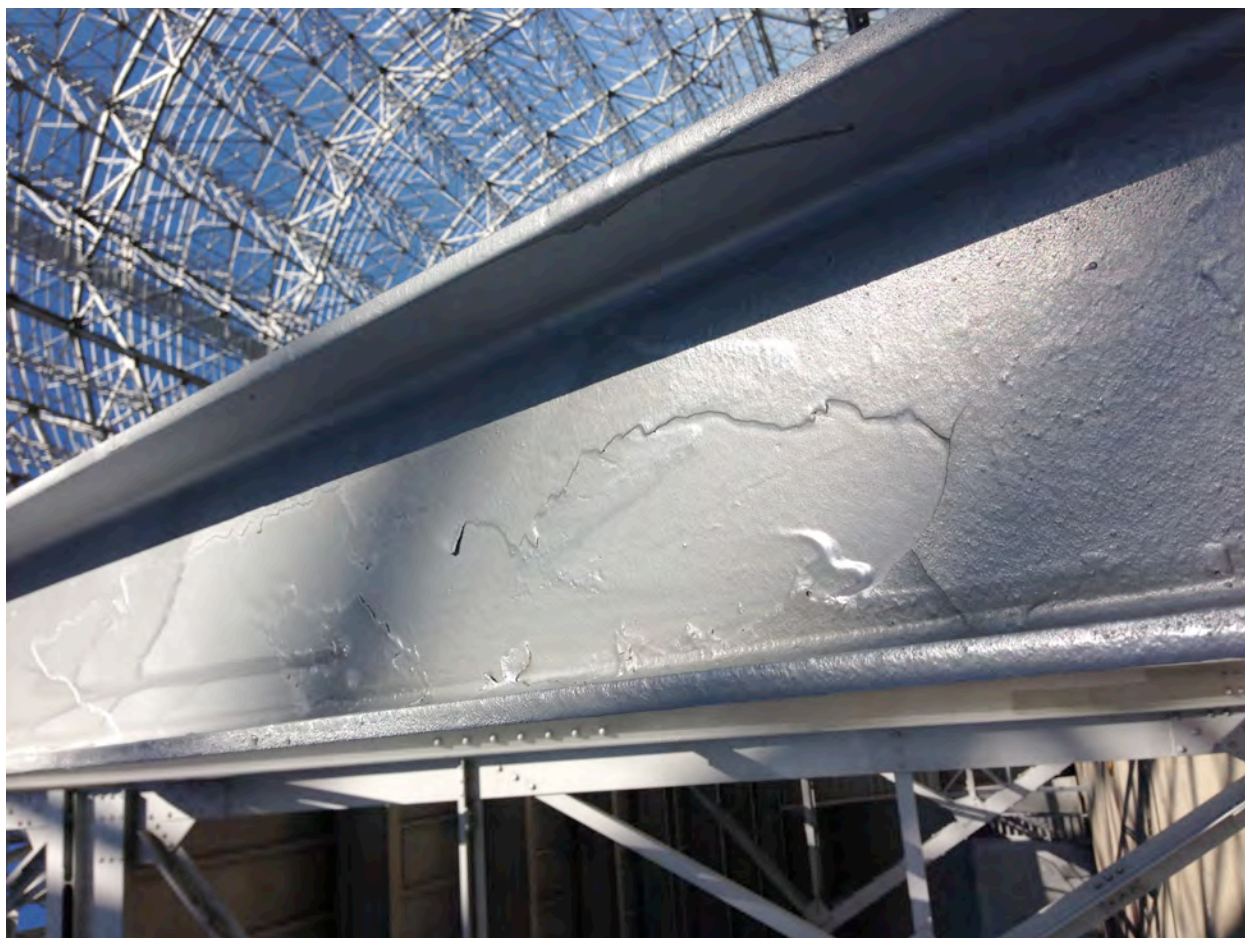
Poor stabilization of original coatings, horizontal steel

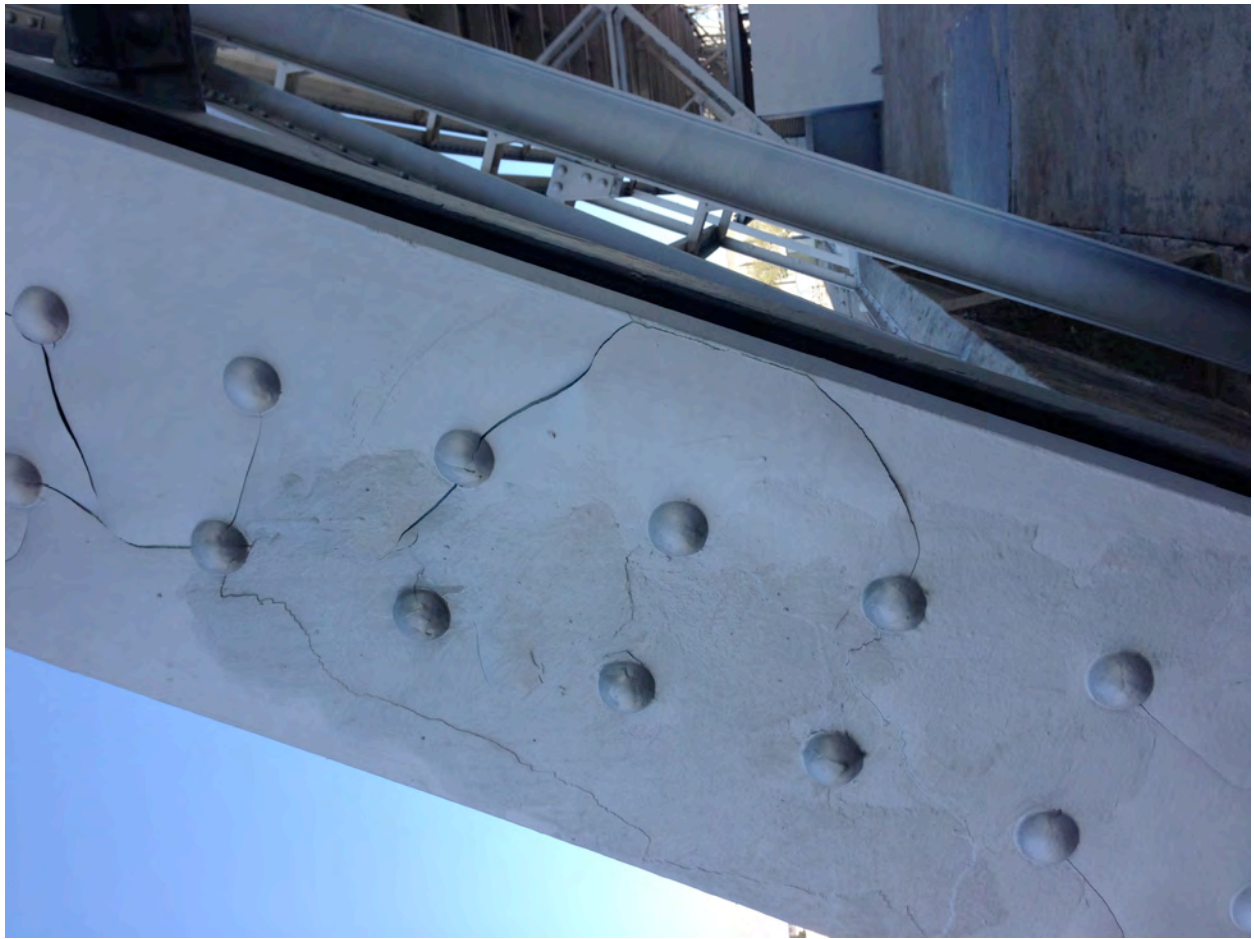
Delaminating encapsulant and original paint, vertical steel

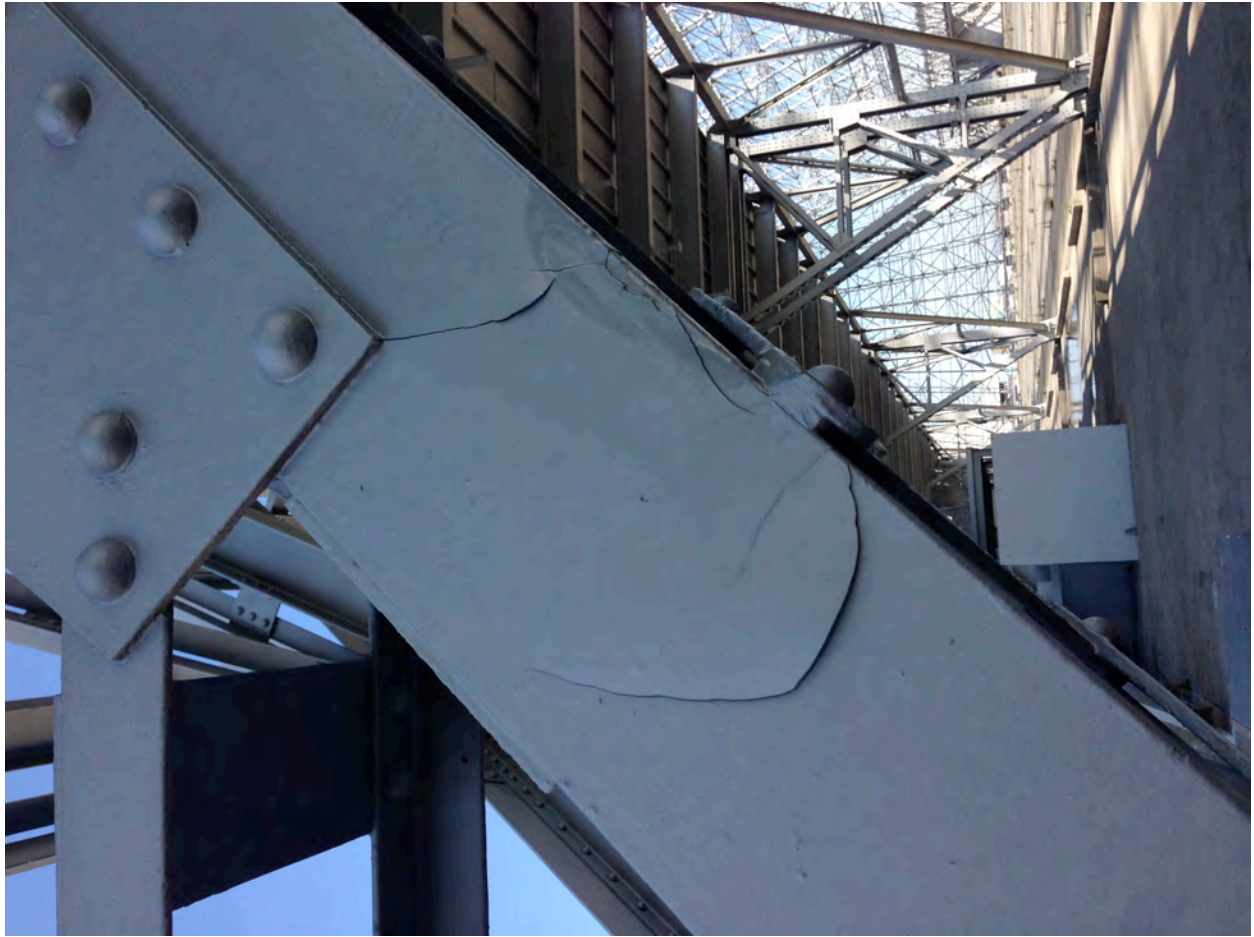
Delaminating encapsulant and original paint, vertical steel

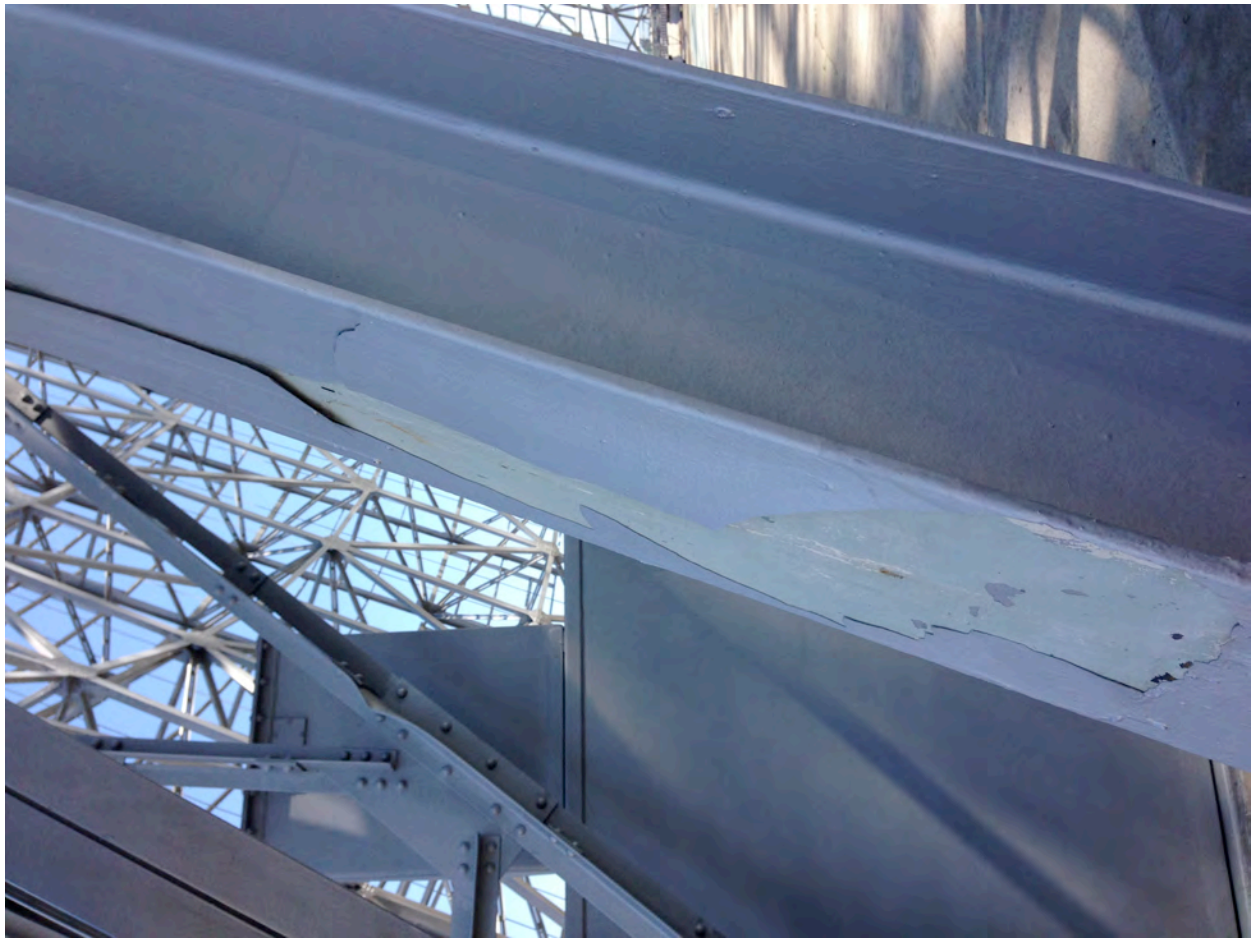
Delaminated encapsulant and original paint, vertical steel

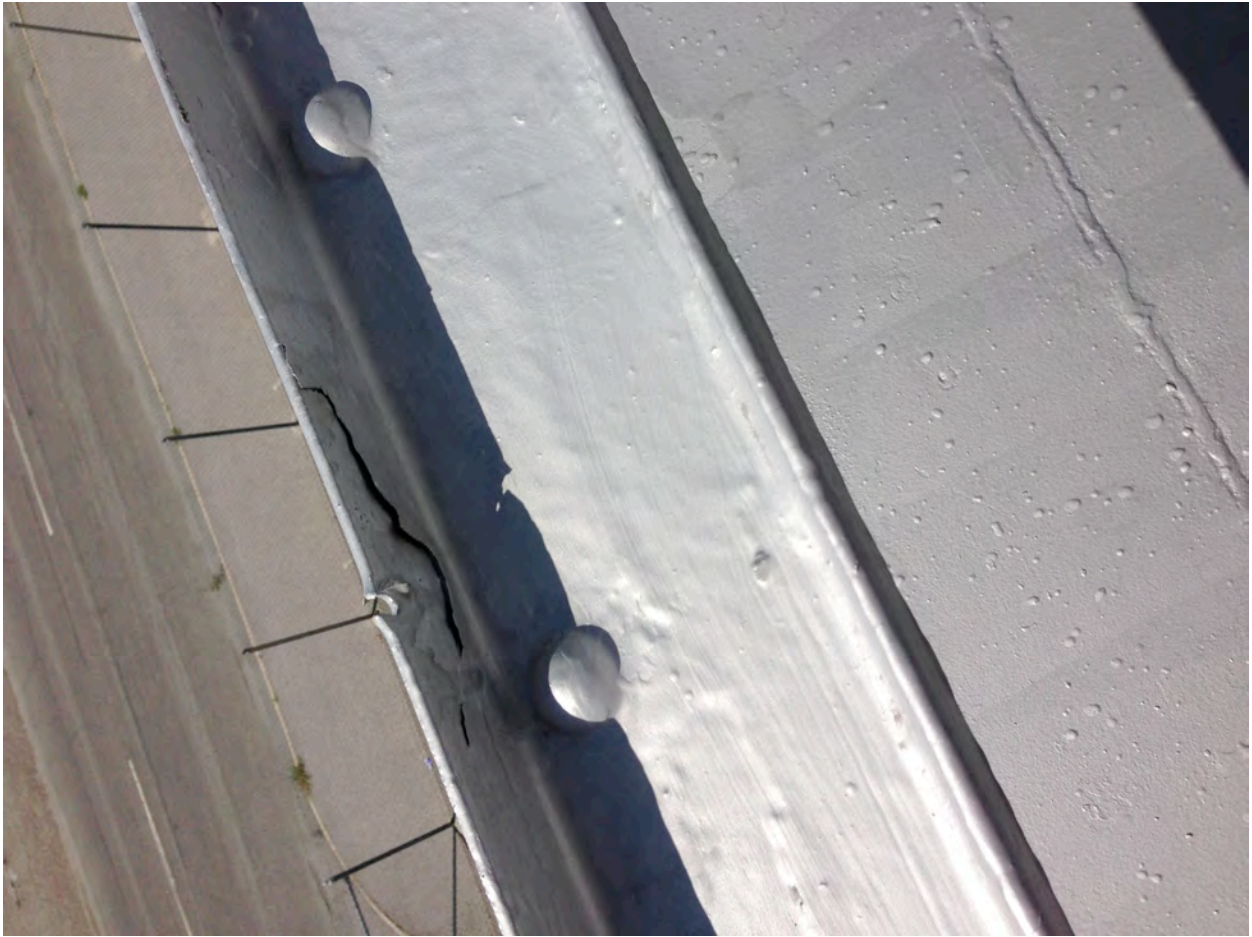
Delaminating encapsulant, horizontal steel

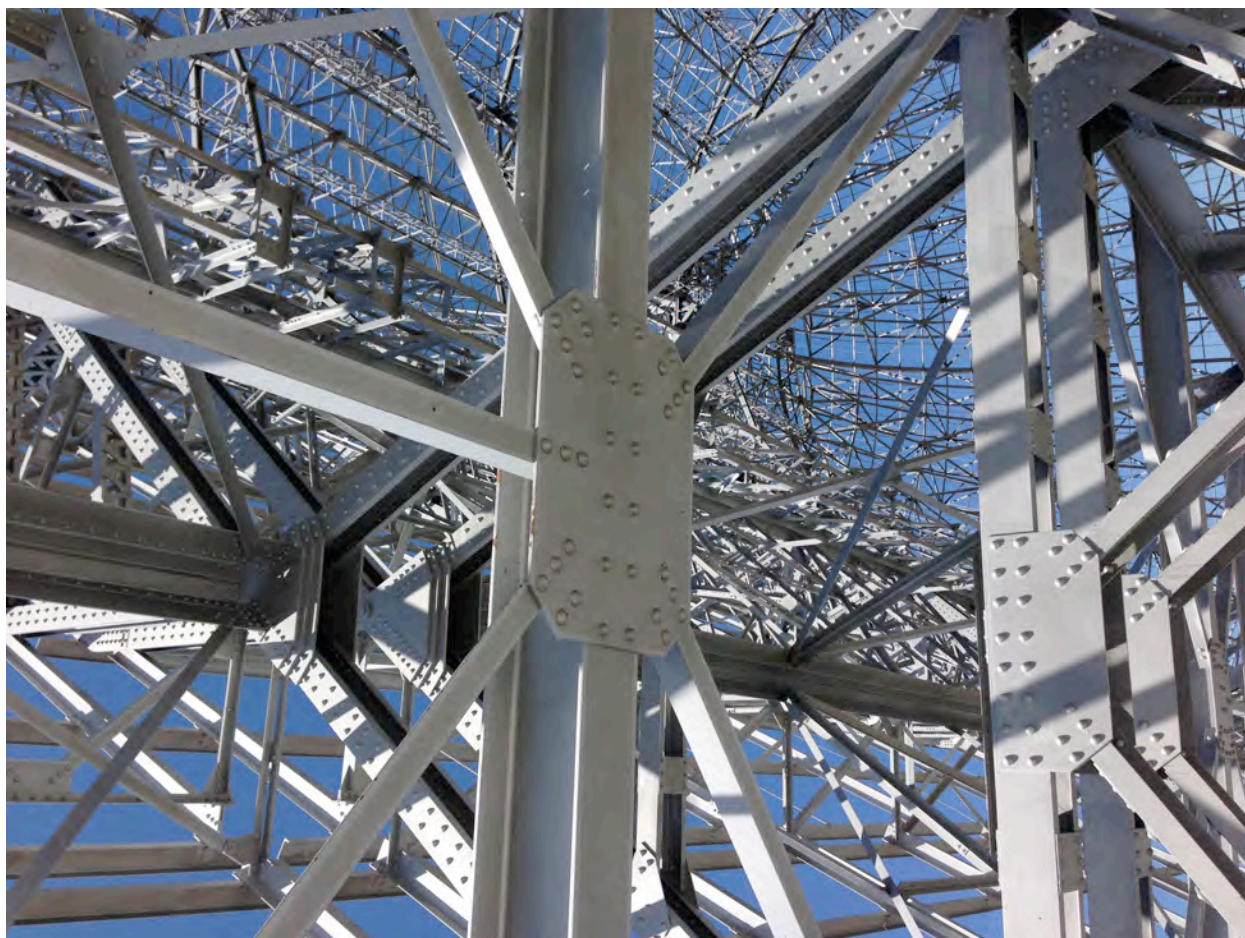
Small rust spots on horizontal steel beam and plate

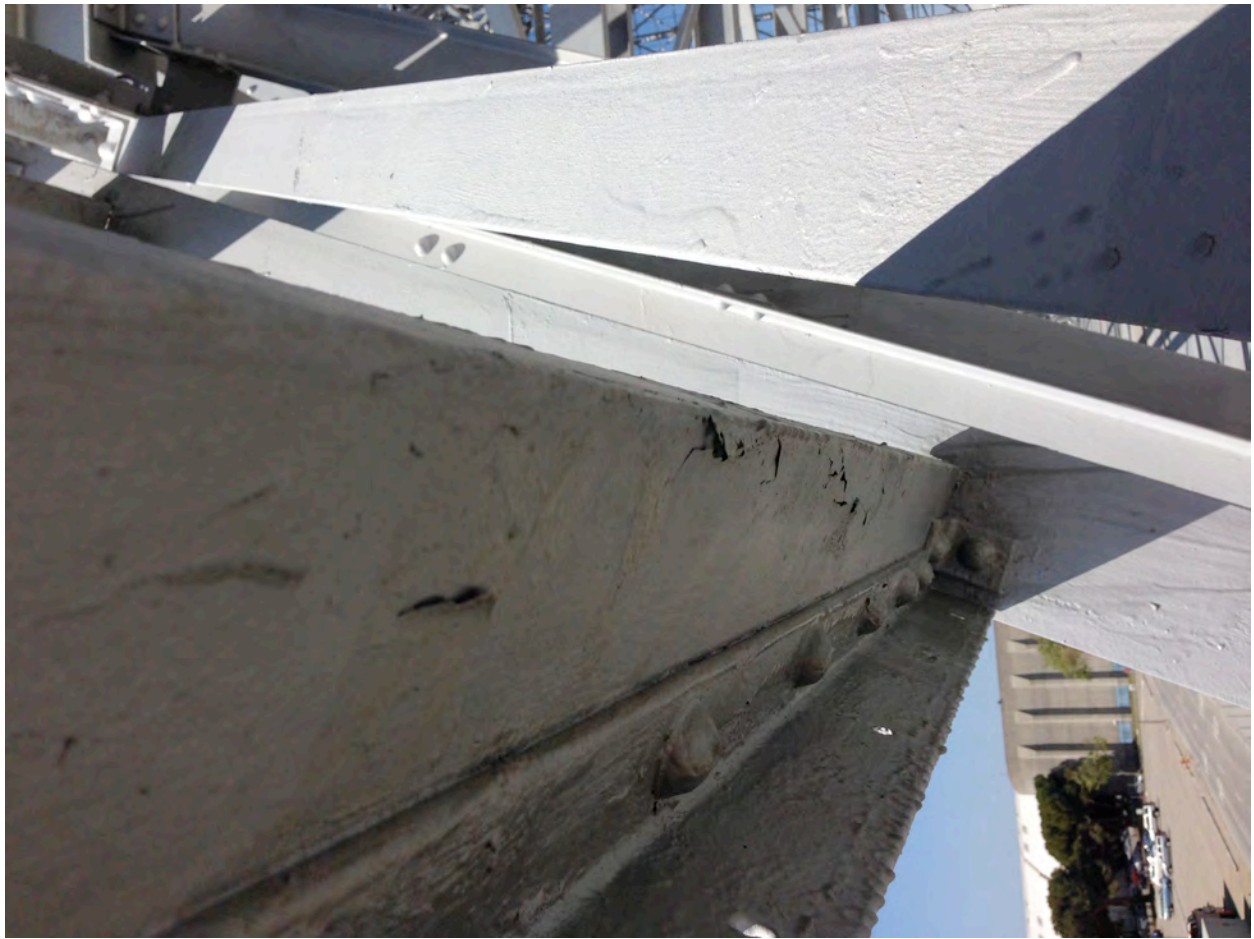
Loose & peeling original coatings, horizontal steel
