DRAFT Final Hangar 1 Engineering Evaluation/Cost Analysis

**Former Naval Air Station Moffett Field,
California**

**13 August 2019
EKI B20019.19**

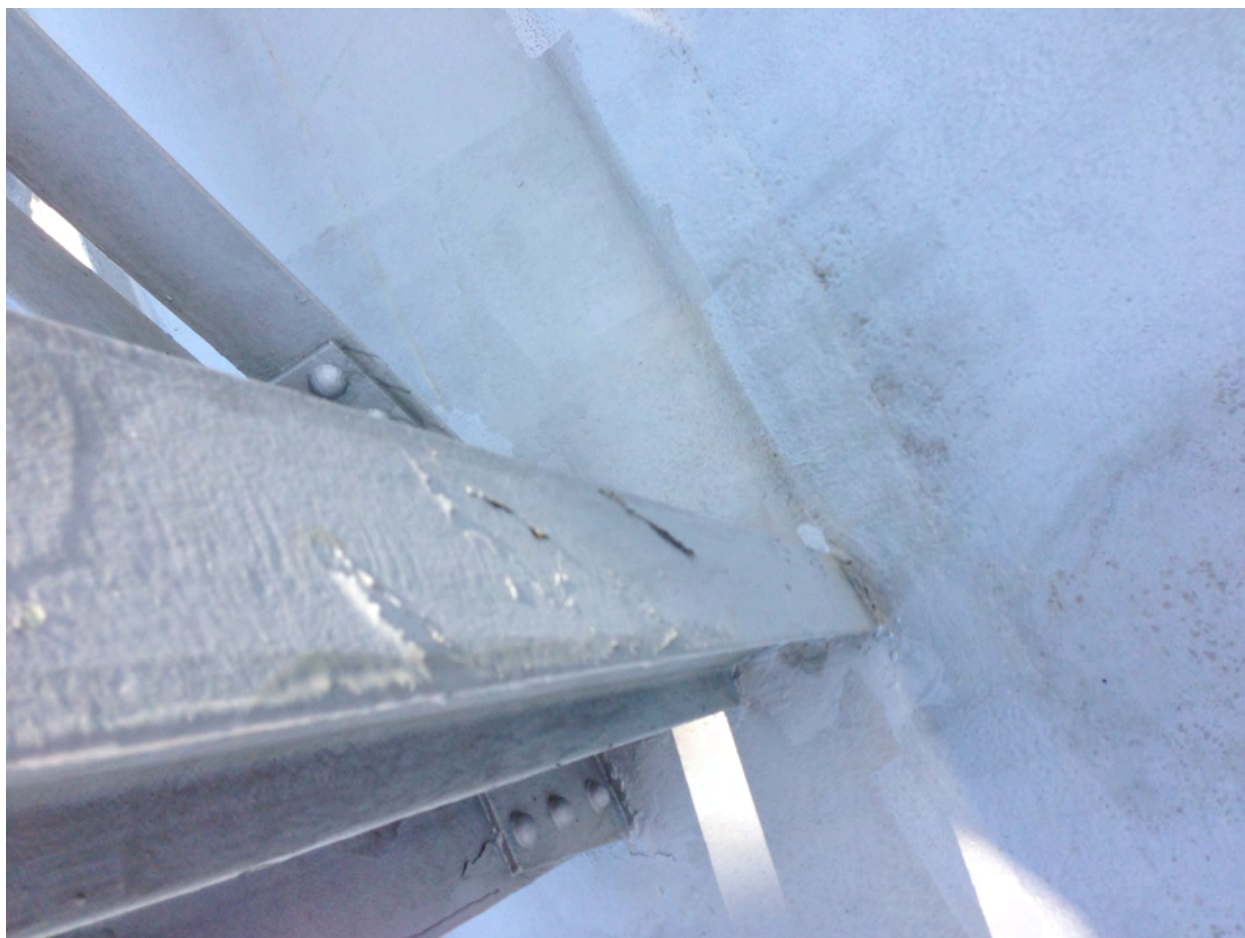
Peeling Edges of Original Coating, vertical steel

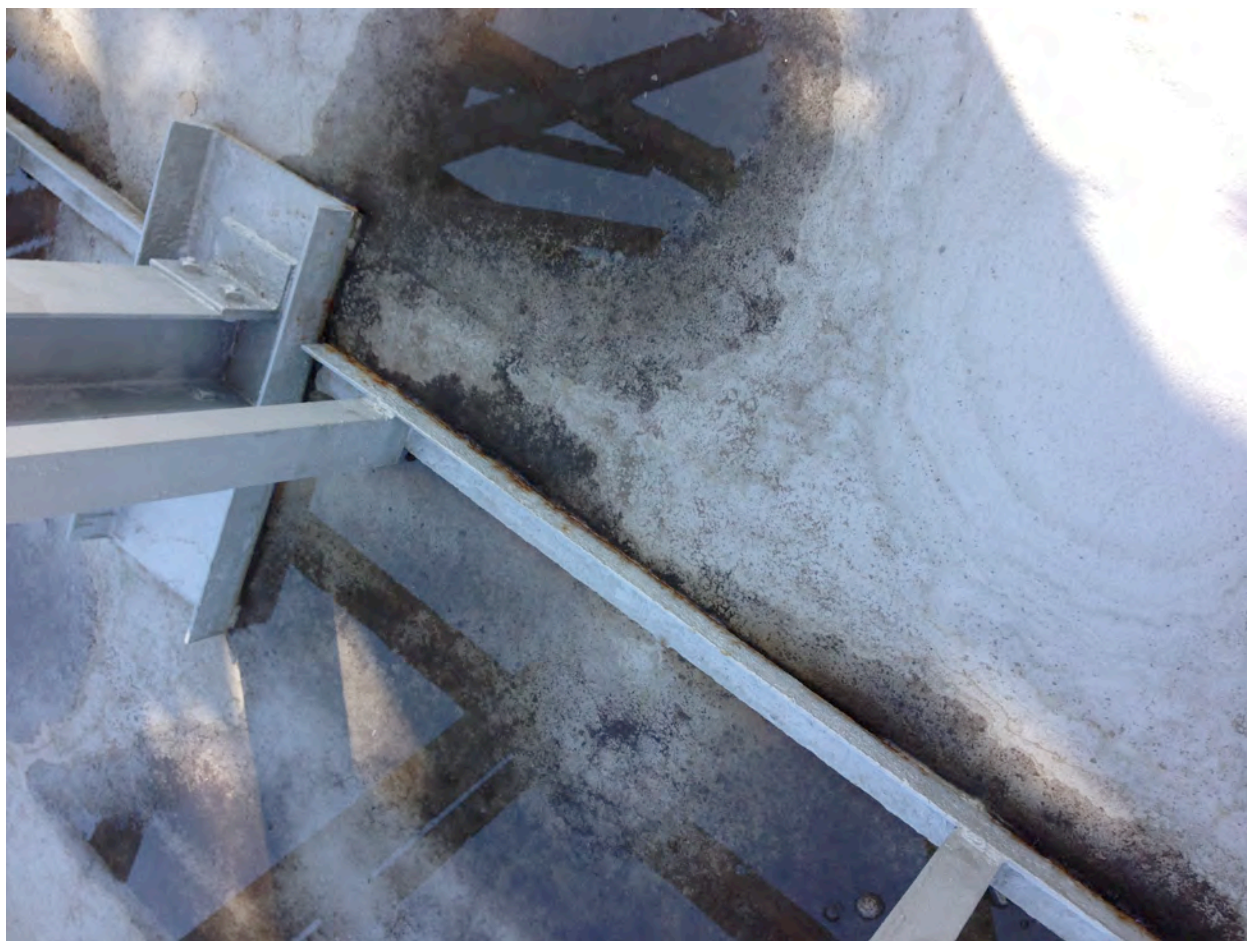
Mezzanine Pooling Water & Sediment

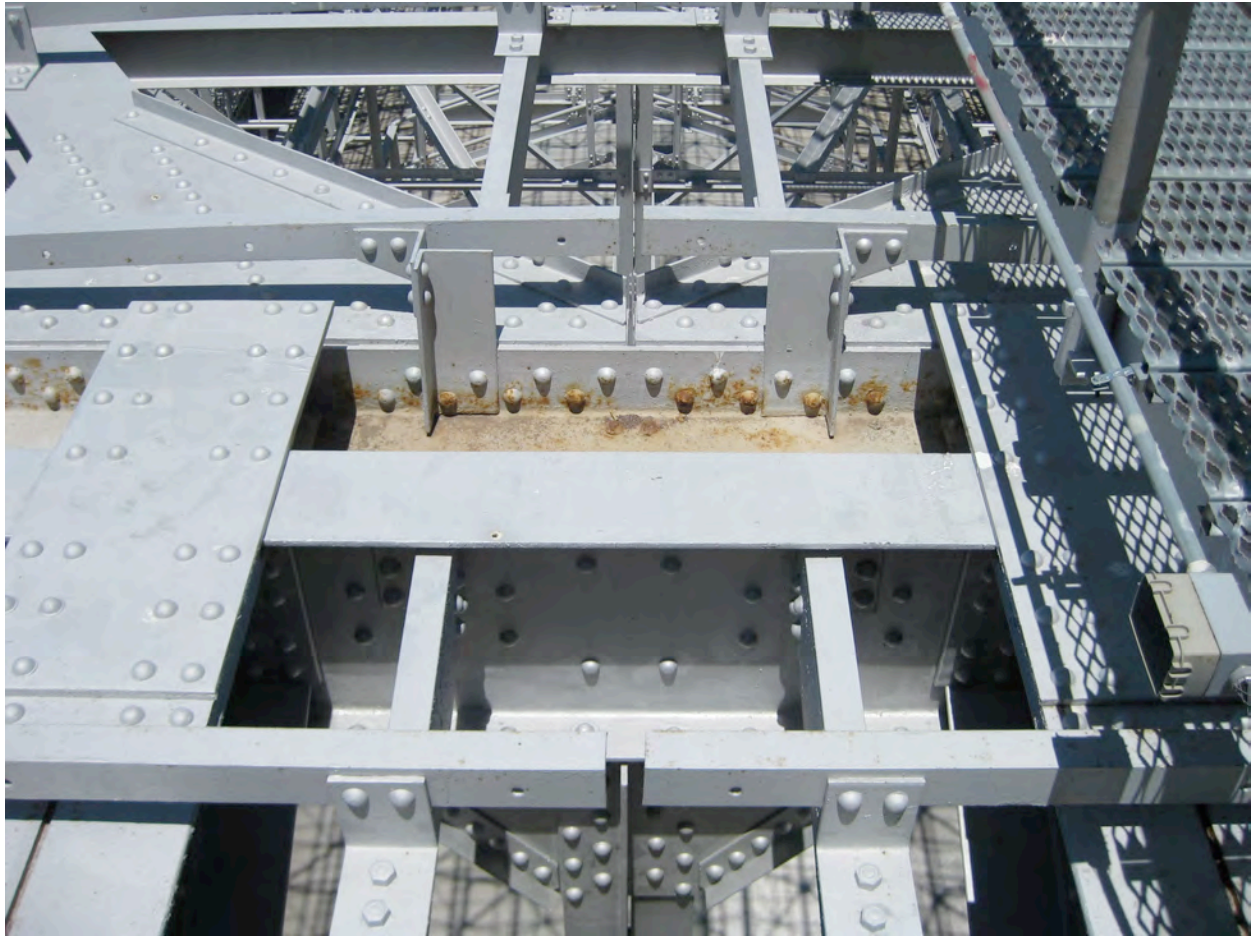
Roof-top rusting of NTCRA Coating, area where water pools

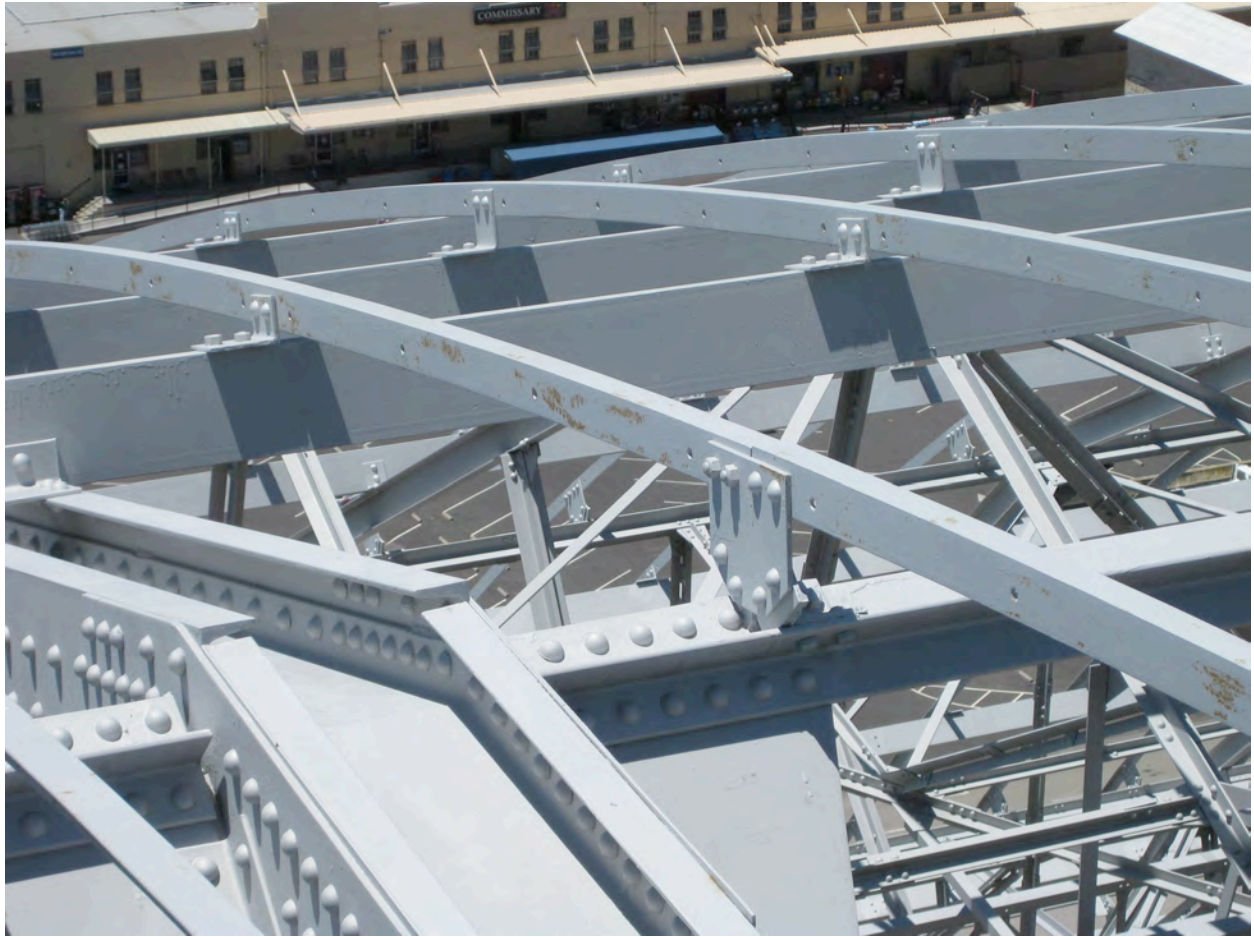
Roof-top rusting of NTCRA Coating

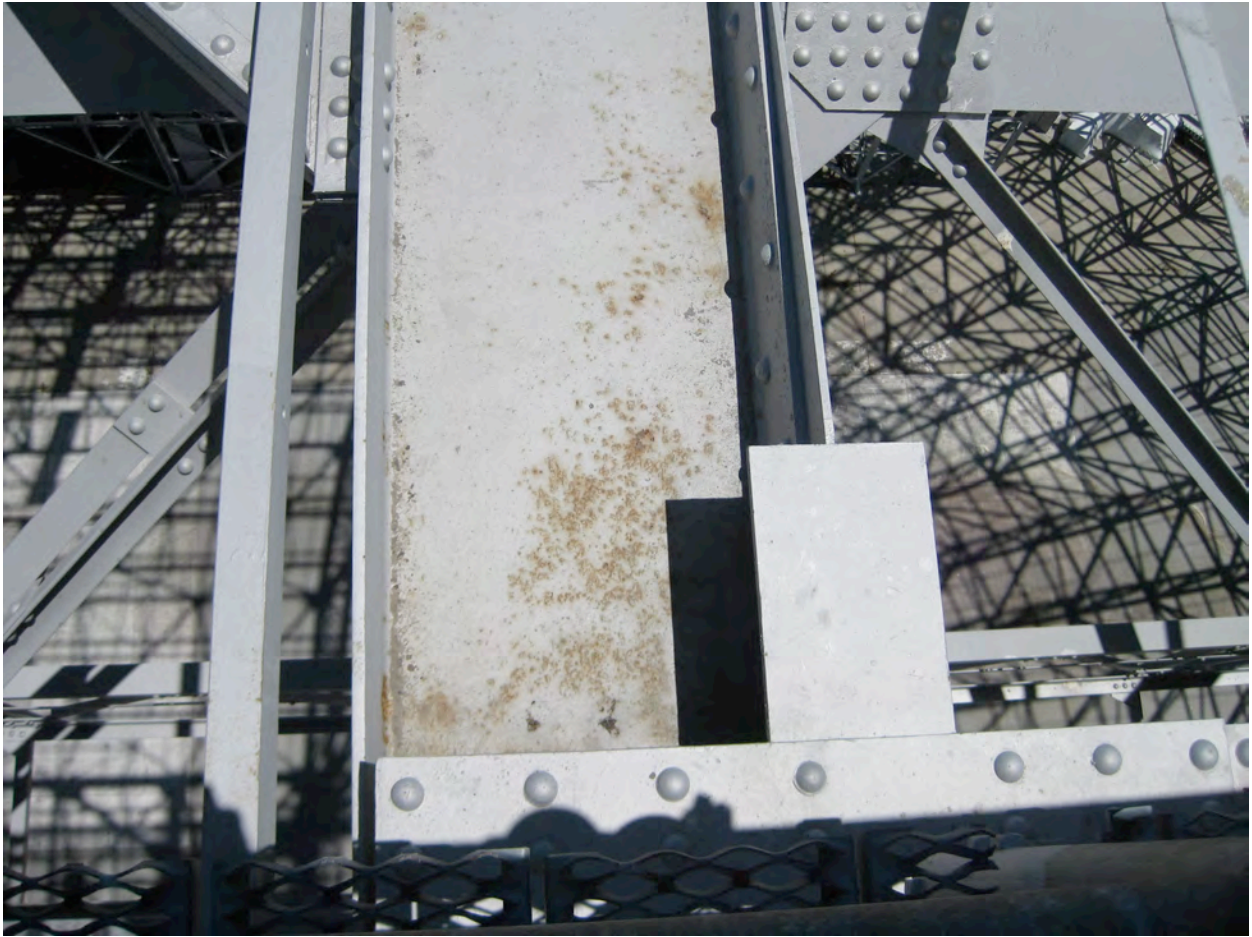
Roof-top rusting of NTCRA Coating

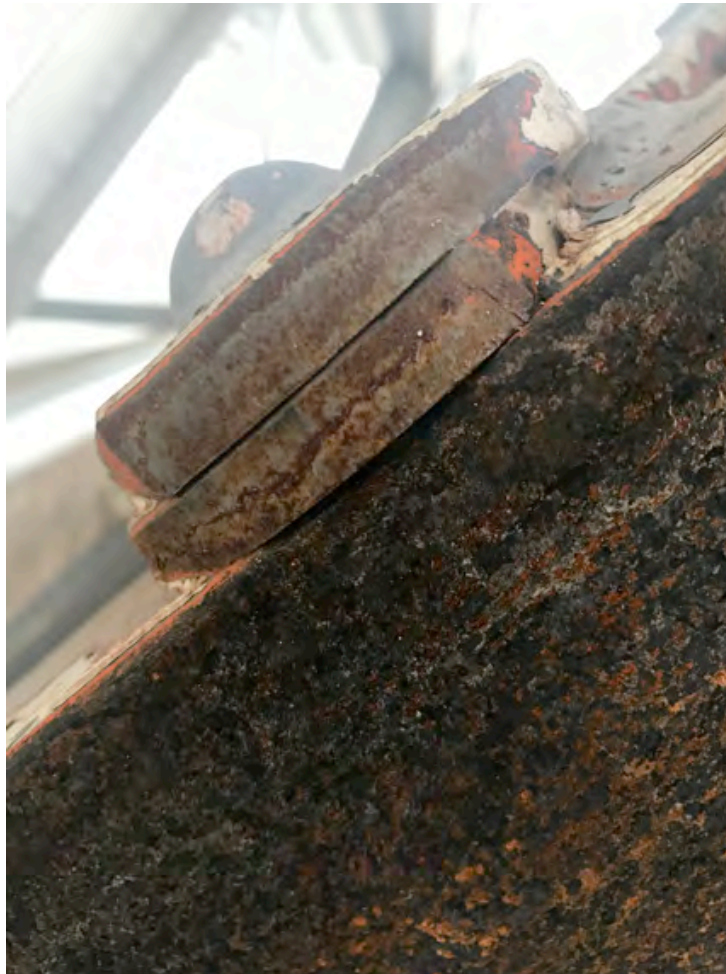
Photograph 1 – Structural Steel after abatement with UHPW. Note the presence of black mill scale, paint/coatings in tight-tolerance mated surfaces and rough surfaces.

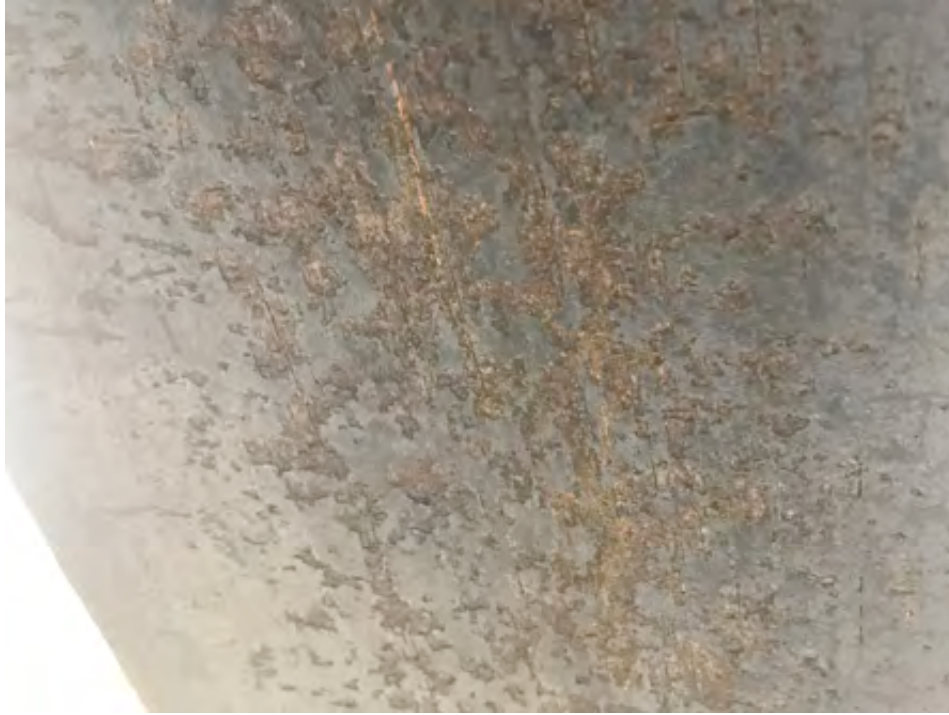
Photograph 2 – Mill scale present on structural steel after paint/coating removal with UHPW system.

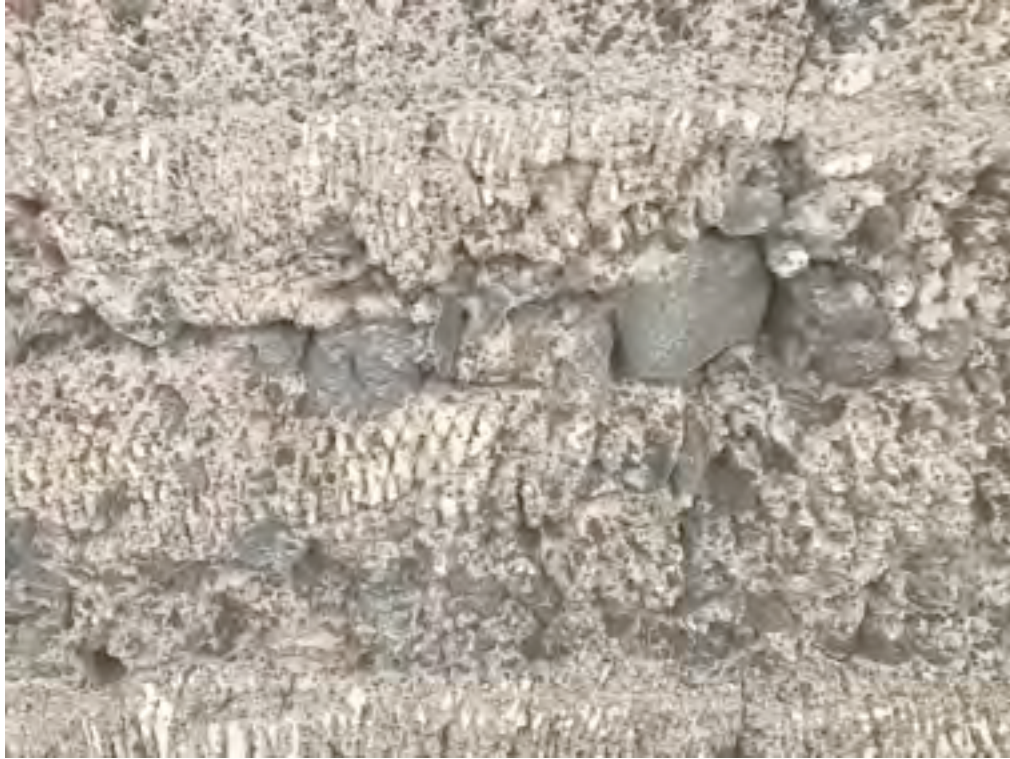
Photograph 7 – Damage to concrete and paint/coatings remaining on surface of CMU wall.

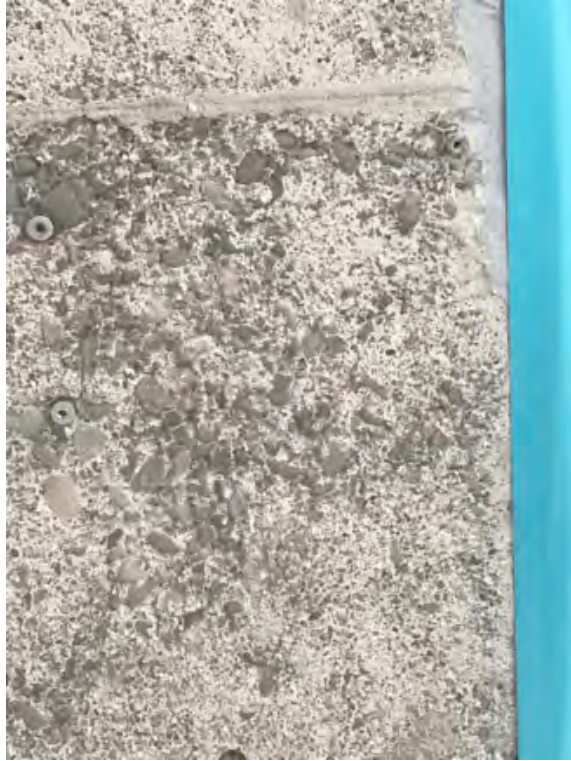
Photograph 13 – CMU wall after removal of paint/coatings by plastic bead media blasting. Removal method exposes aggregate and caused minor damage to “board form” markings on the CMU wall.

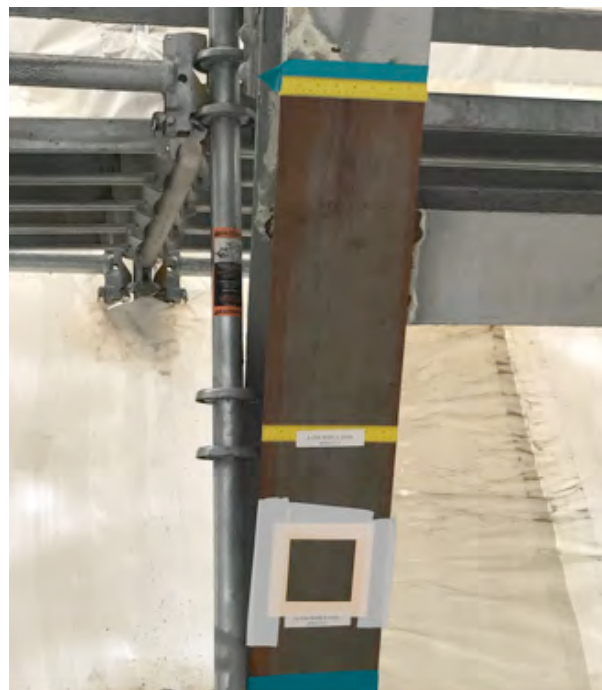
Photograph 16 – Structural steel after removal of paint/coatings with vapor media system at time of verification sampling. Note the formation of surface rust.

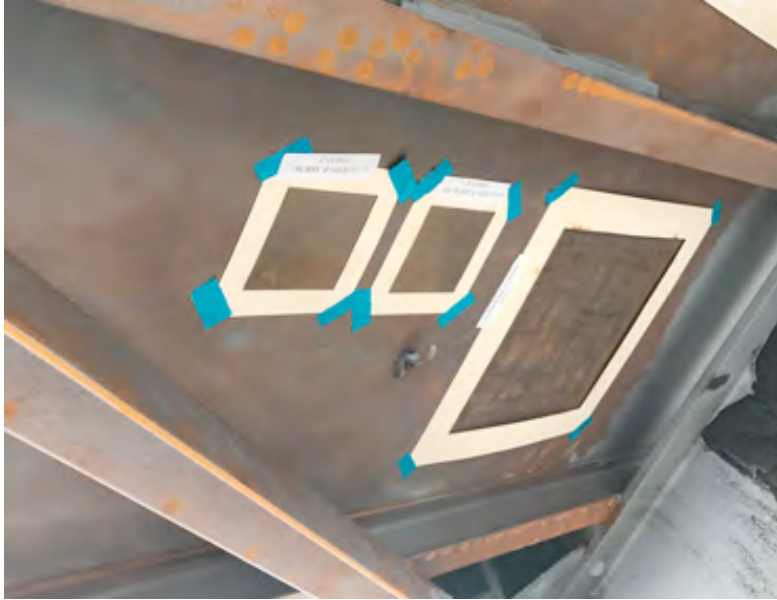
Photograph 17 – Under side of mezzanine after removal of paint/coatings at time of verification sampling. Note the formation of surface rust.
