Building 46 (Hangar 2) and Building 47 (Hangar 3)

Due Diligence Phase 1 Report

**A.22 - Hangar 3
Emergency Truss Repairs**

Hangar 3 Emergency Truss Repairs Narrative

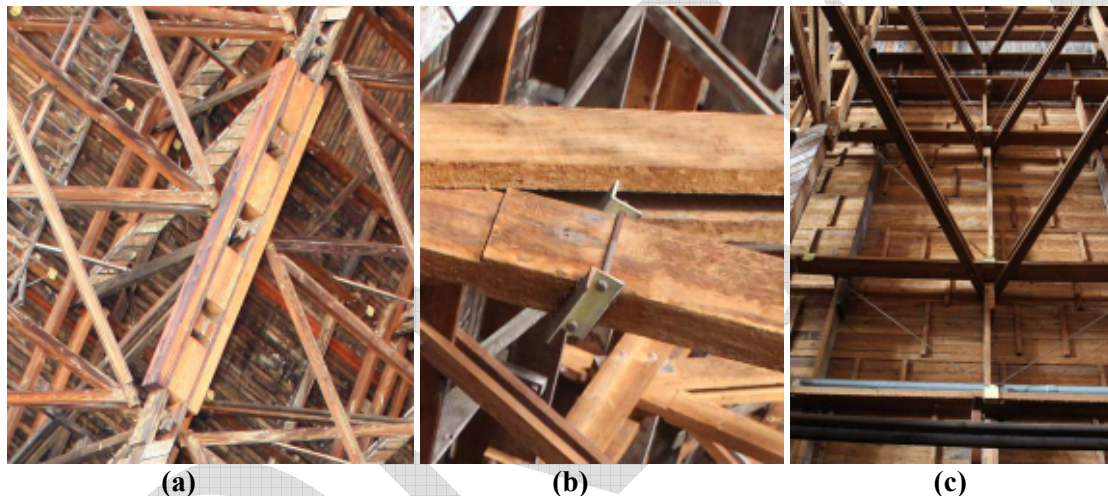
Figure 3. Retrofit techniques observed throughout Hangars 2 and 3 (a) Strengthening of arch chords by addition of glulam bypass members (b) Clamps and stitch bolts to close small cracks (c) Replacement of wood sag braces with steel cables and bolts.

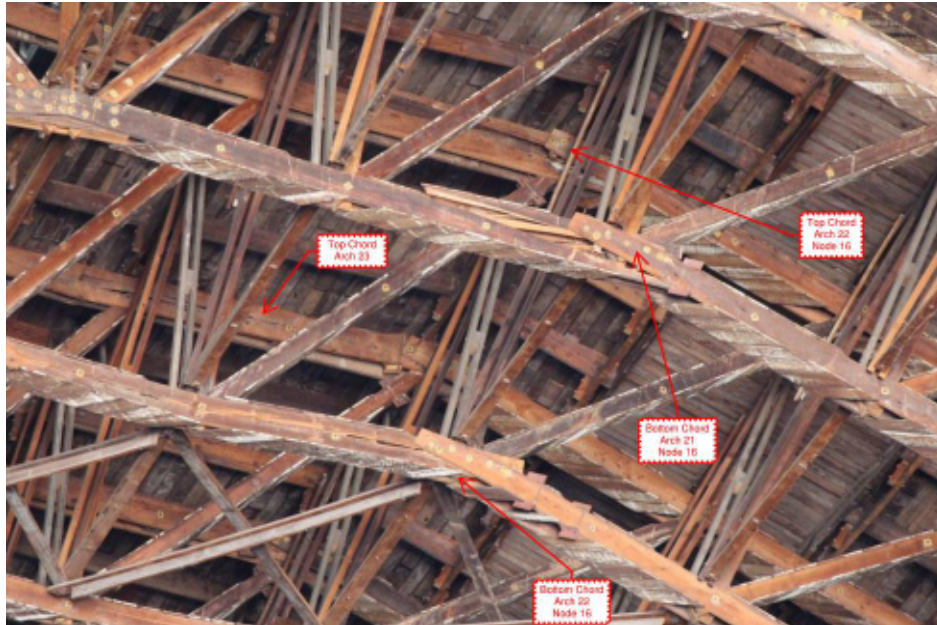
As seen in Figure 4, a significant amount of cracking and out-of-plane distortion is observed on the bottom and top chords of the timber arches. The most prominent cracks are located in the bottom chord of arch 21 at node 16 and in the top chord of arch 22 at node 16. Both cracks widths are approximately 8” and contribute to the appearance of torsionally warped members. The latter could be a direct result of the out-of-plane relative distortion, as seen between nodes 16 and 17 within the bottom chord of arch 22.

Figure 4. Observed cracks and distortion of the timber arch bottom and top chords in Hangar 3.

2. KPFF recommends immediate correction for the alignment and bracing of the previously mentioned arches for in and out-of-plane movement. Methods of adding glulam bypass members as well as clamps and stitch bolts to the connections provide good potential for restoring the arches back to their original strength. However, it is recommended to monitor adjacent connections and members during restoration as load redistribution could be a potential hazard.

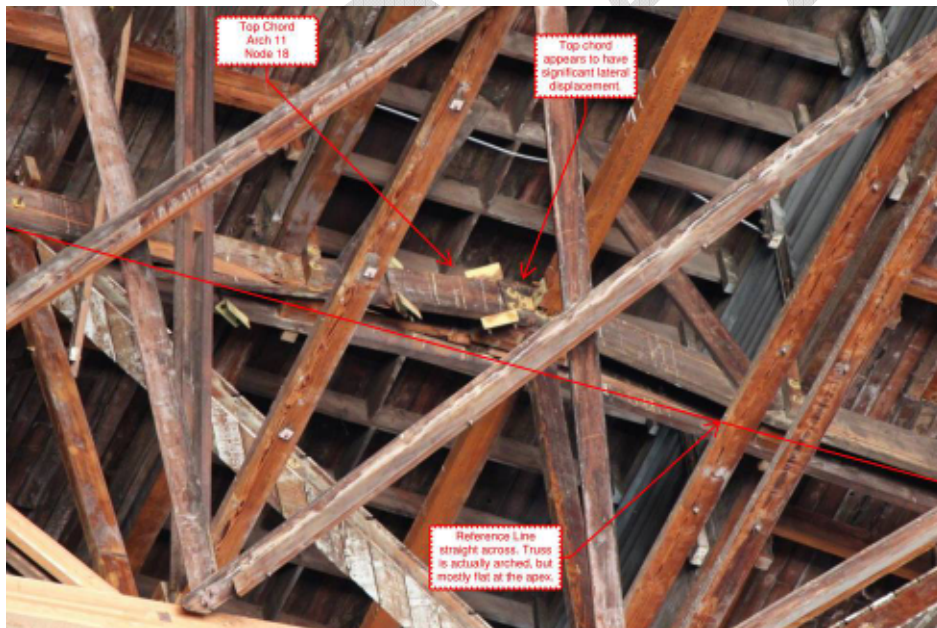
This general observation is emphasized in Figure 5 with the relative lateral displacement between the apex of the arch and a theoretical reference line connecting adjacent arch nodes. Similar results are also displayed in Figure 6 for the top chord of arch 18.

Figure 5. Relative lateral displacement between arch apex and reference line for Hangar 3 single arch.

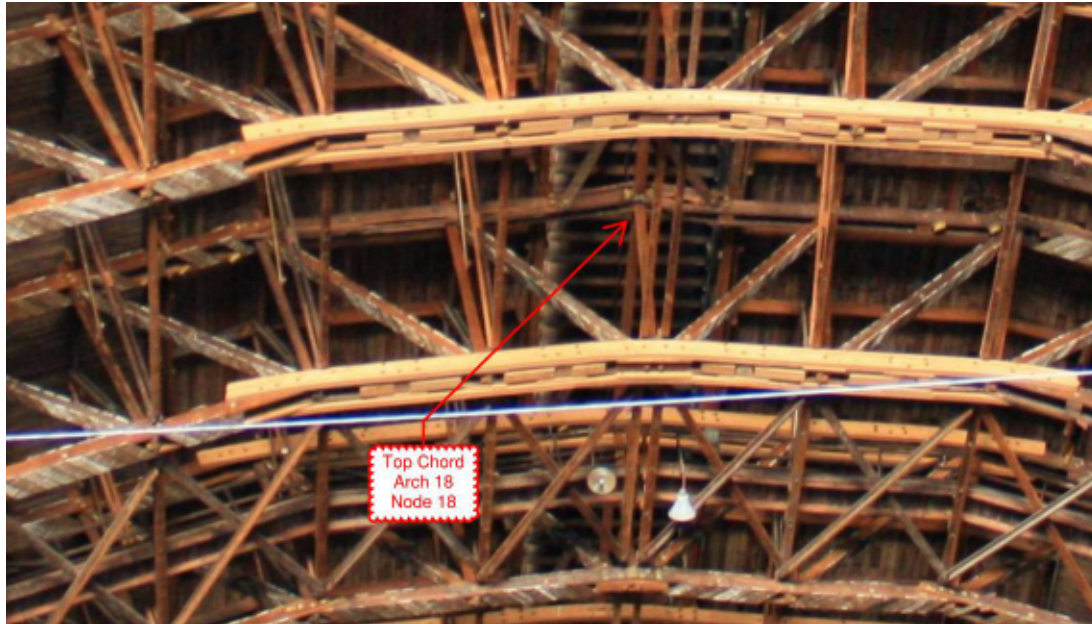
Figure 6. Observed cracks and lateral displacement of arch top chord in Hangar 3.

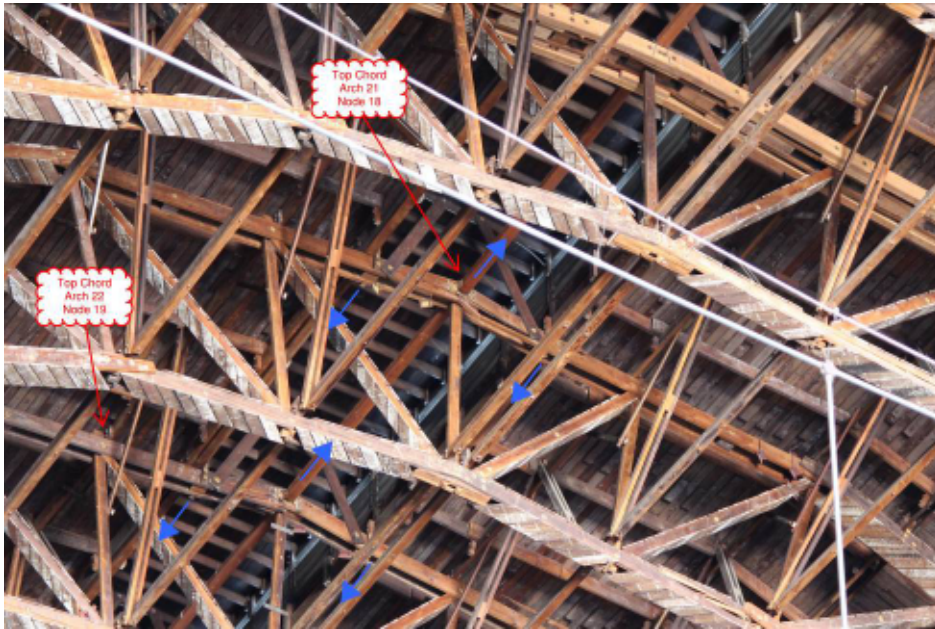
In addition, it was observed that the apex of numerous arches contain a consistent trend of node 18 displacing relative to the adjacent nodes supporting the monitor (exterior protrusion of the hangar at the apex outer chord). This is displayed in Figure 5 for arch 11, Figure 6 for arch 18, and Figure 7 for arches 21 and 22. The latter contains blue sketch-up arrows displaying the relative lateral displacement of the nodes, where node 18 appears to display south. It is unknown whether or not if all of the observed cracks and distortions propagated from the 1995 retrofits or if their origin emanated within the past couple of months.

Figure 7. General trend of relative lateral displacement at the arch apex top chord in Hangar 3.

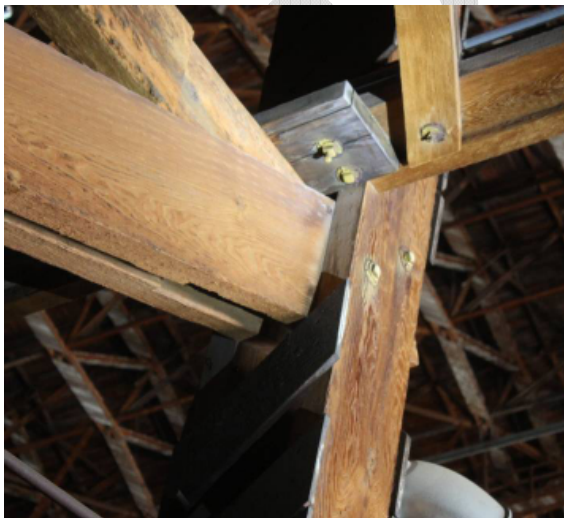
Hangar 2 did not have the extent of distress as seen in Hangar 3. There was only one location where the main arches were strengthened by glulam bypass members. This location was on arch line 14 and between nodes 28 and 30. The only visual signs of distress were observed through end splits of cross braces, as shown in Figure 8. This distress was common at locations where the fasteners were too close to the end grains.

Figure 8. Example location of end split in cross brace member within Hangar 2.

3. KPFF recommends full documentation of all member split end locations. The retrofit techniques will involve clamps, stitch bolts, and some form of epoxy injection.

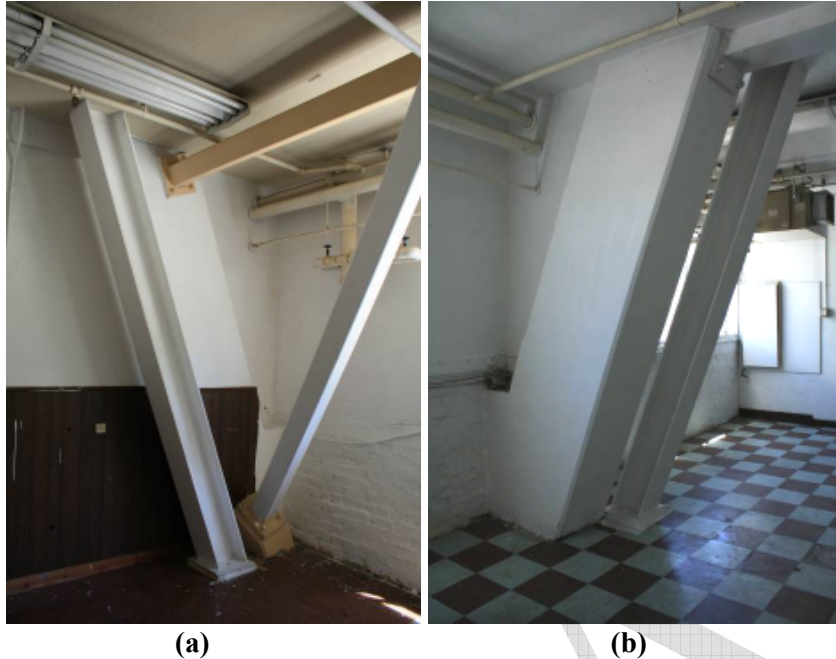
Turnbull (2006). However, wide flange steel shapes were also observed for additional reinforcement of the concrete bents in the strong axis, as shown in Figure 9.

Figure 9. Hangar 2 office space retrofits (a) Longitudinal HSS and Lateral I-Shape bracing (b) Lateral I-Shape and HSS bracing.

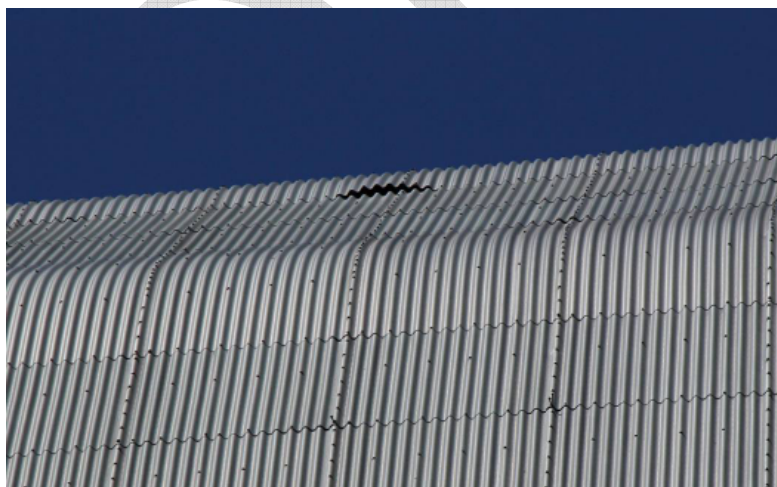
While on the recent site visit, it was also observed that the doors on the southwest corner of Hangar 3 were open while all other doors between both hangars were closed. Therefore, future observations must verify if the doors are operable. In addition, the existing corrugated aluminum sheathing was detached at various locations along the roof of Hangars 2 and 3, as shown by example in Figure 10.

Figure 10. Example location of detached corrugated aluminum sheathing on roof exterior of Hangar 2.

4. KPFF recommends a survey of the condition of the existing roofing, followed by proposed methods of repair or replacement.
5. KPFF recommends that the project team researches whether the hangar doors are currently operable, and for the team to assess the usable life and anticipated maintenance required for the continued operation of the hangar doors.

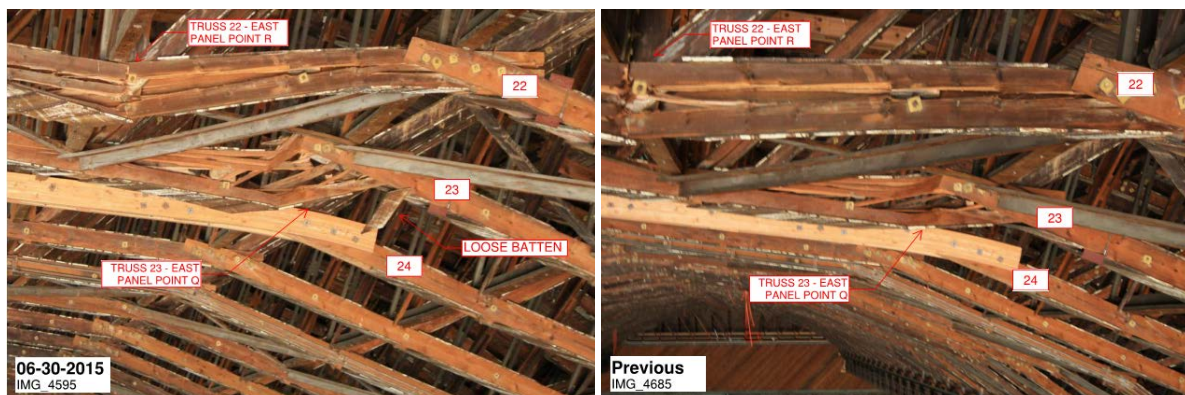
On June 24, 2015, KPFF performed a routine site visit to observe field conditions of the shed framing in Hangar 2. During that site visit, KPFF also observed Hangar 3 trusses from the deck slab and upon observation, suspected damage progression in the Hangar 3 arched trusses. On June 30, 2015, KPFF performed a follow-up site visit to Hangar 3 with aerial boom lift access and observed severe damage progression and increased excessive truss deflections. Turner Construction provided photographs of the ridge line indicating substantial increased deflection at the roof monitor. KPFF issued findings in engineer's field report EFR-03 along with recommendations for a zone of immediate emergency shoring due to damage progression. Selected photos from EFR-03 are provided below in Figure 1, Figure 2, and Figure 3. A reference truss elevation with panel points labeled is provided in Figure 4.

Figure 1. Truss damage progression at Trusses 22 and 23 East near Panel Points R and O.

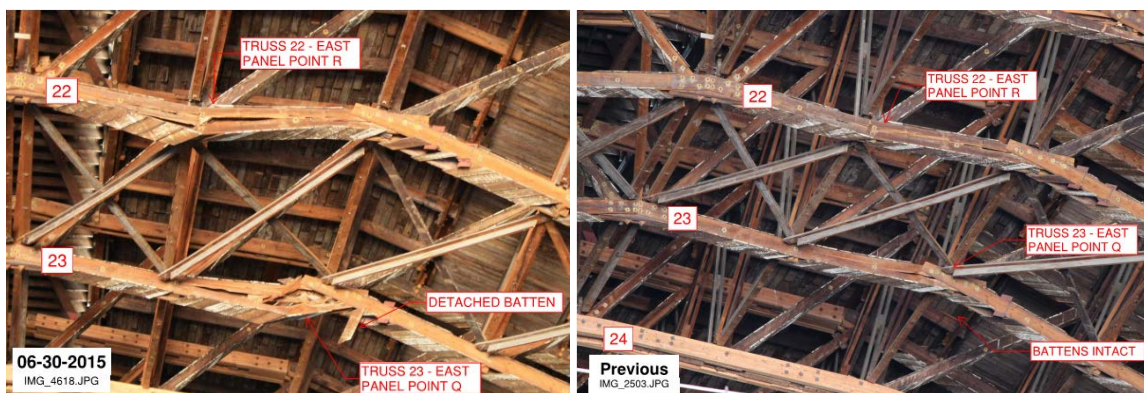
Figure 2. Truss damage progress at Trusses 22 and 23 East near Panel Points R and Q.

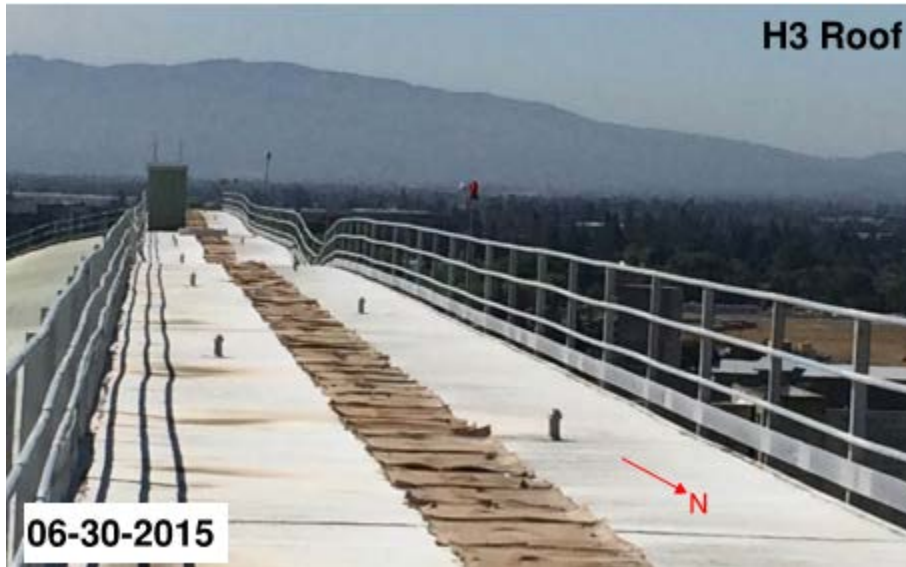
Figure 3. Damage observable at ridge line from building exterior.

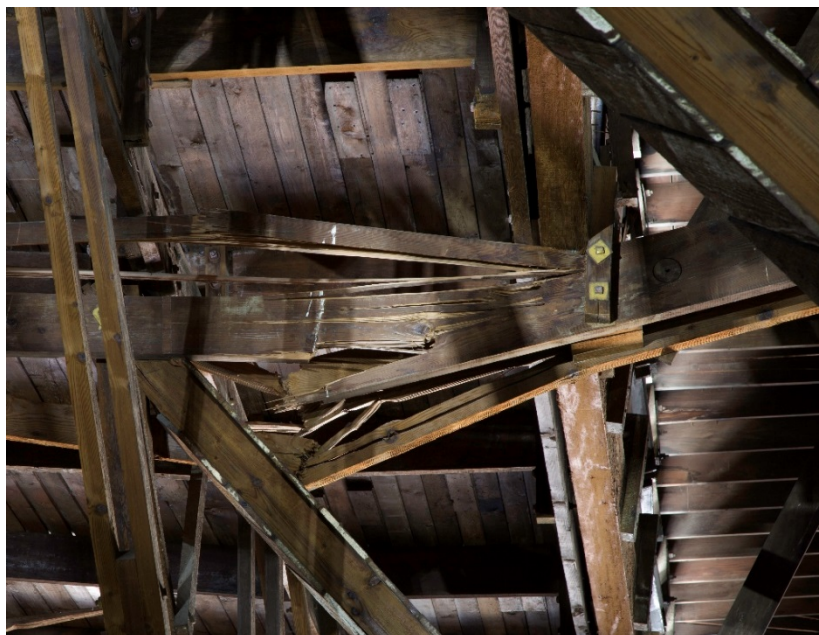
Based on the progressing downward movement of the trusses observed in Hangar 3, there is a threat of partial collapse of the upper portions of the roof which may lead to progressive collapse of other portions of the truss. For this reason, temporary shoring has been installed within the most severely damaged zones to prevent any progressive collapse from occurring within the Hangar. The temporary shoring does not provide shoring to the upper most portion of the truss, since that zone needs to remain clear for accessibility by the movable access tower for the installation of truss repairs.

The following photos (Figure 5, Figure 6) demonstrate the severity of existing damage and the immediate danger of partial structure collapse.

Figure 5. Broken top chord near roof monitor at top of truss

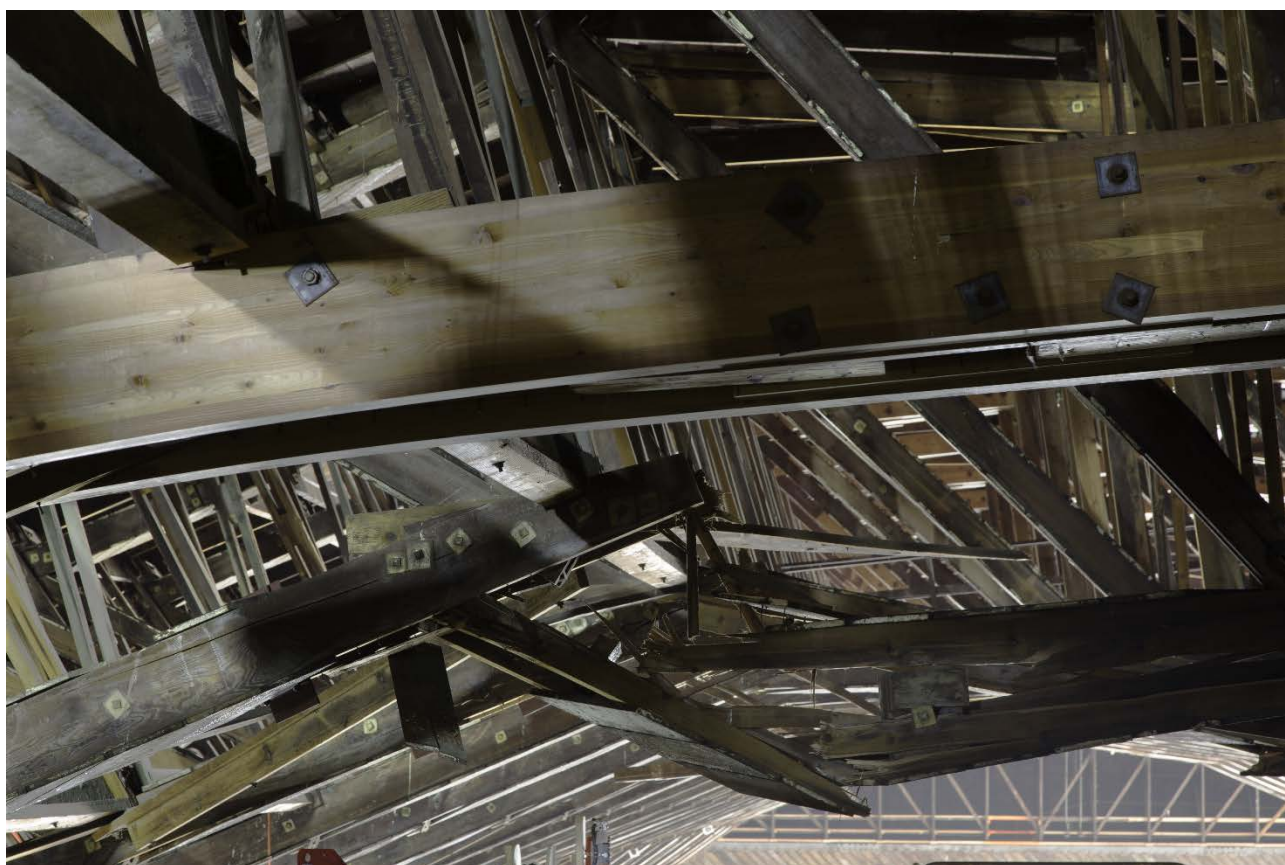
Figure 6. Broken bottom chord near top of truss.

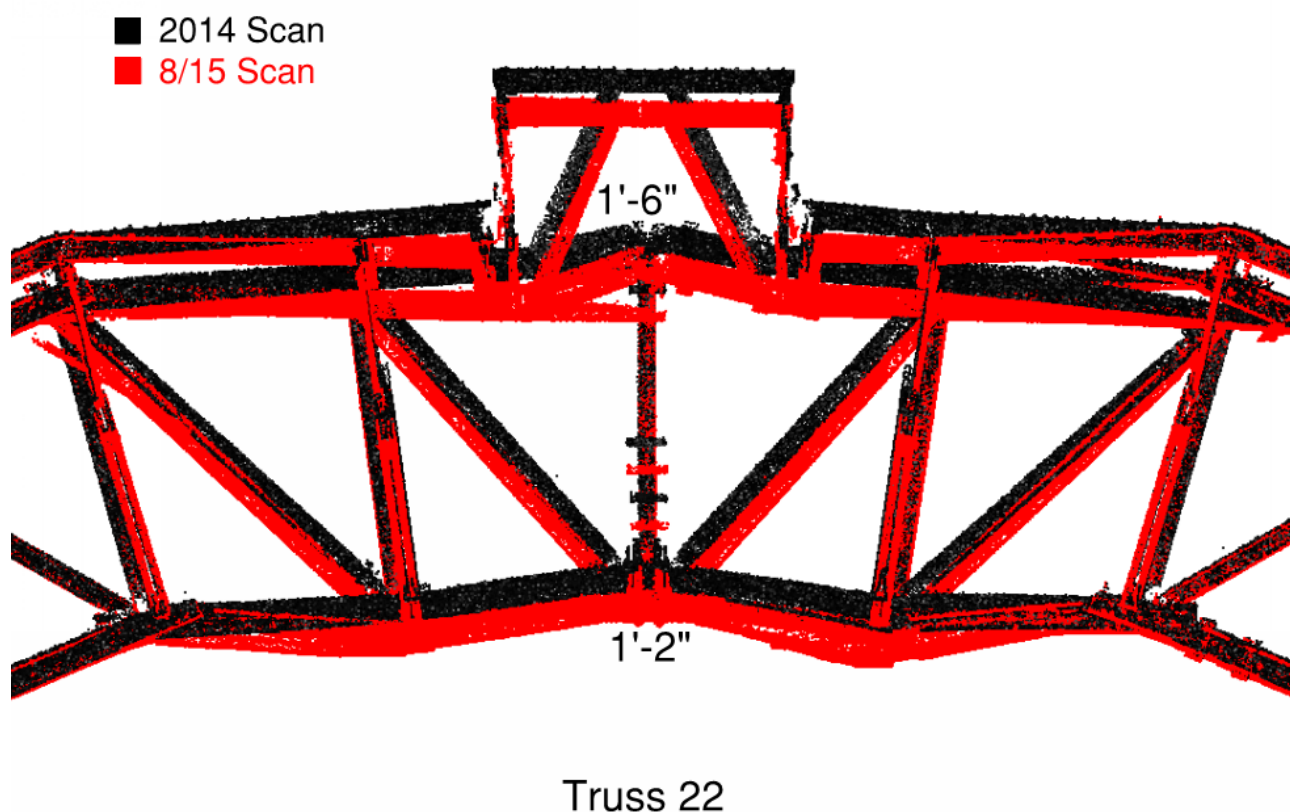
Quantitative measurements of the truss deflections were taken from successive point cloud surveying of the hangar interior. The damage progression is shown in an example processed image from the 3D point cloud scans taken in 2014 and 2015 (Figure 7). In that figure, the black portion represents the actual position of Truss 22 between Panel Points Q-West and Q-East in 2014, while the red portion shows the position in August 2015. The measurements on the image show the increase in downward deflection between the surveys. A summary of deflections at Panel Point S indicate zones of damage concentration (Figure 8).

Figure 7. Approximately 18" of additional deflection observed between 2014 and 2015 point cloud surveying scan at top of truss.

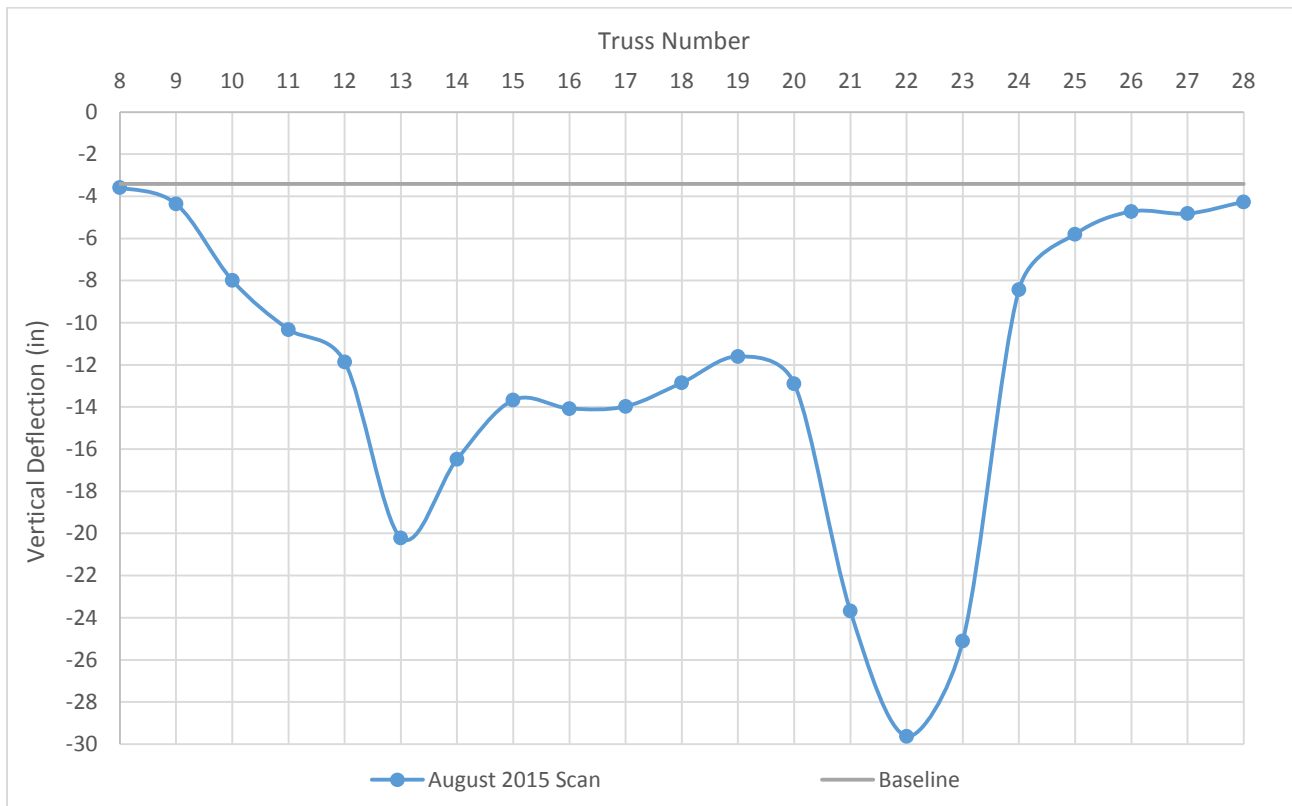
Figure 8. Deflections relative to baseline at Panel Point S.

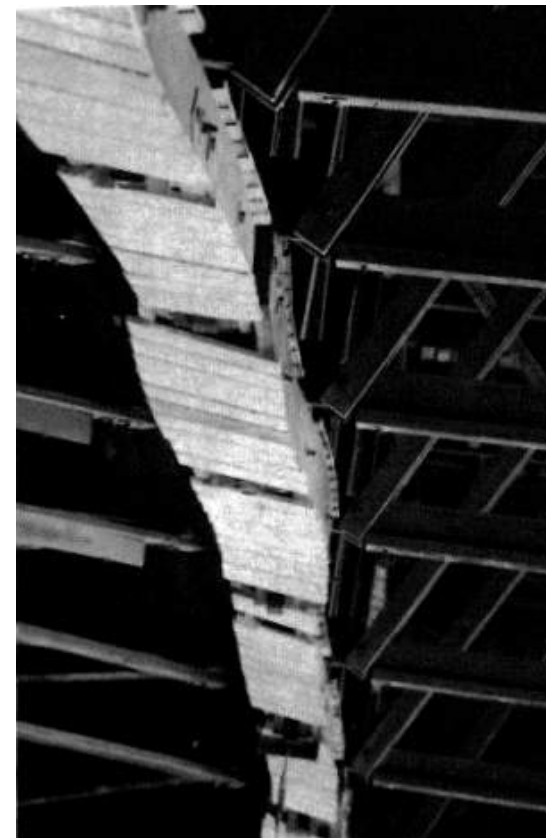
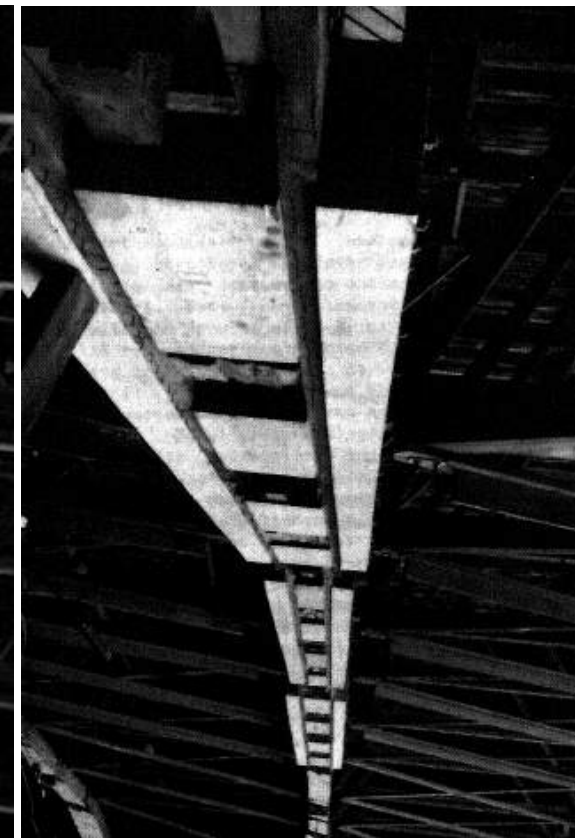
- Major glulam repairs were made in 1981 to correct buckling observed in truss chords
- Glulam strongback members were installed to re-align chords, but load path remained in the original members
- Major repairs made to **49** members
- Struts added at each arch at node 18 to brace top of truss, with rod cross-bracing added at the north and south ends of the hangar
- Minor repairs were also made with clamps and stitch bolts. Many 1x6 purlin ties were replaced with steel rod ties

Buckled chords (left) and glulam strongback repairs (right)
- "Restoration of Navy LTA (Lighter than air) Hangars", Donal Neal, 1986

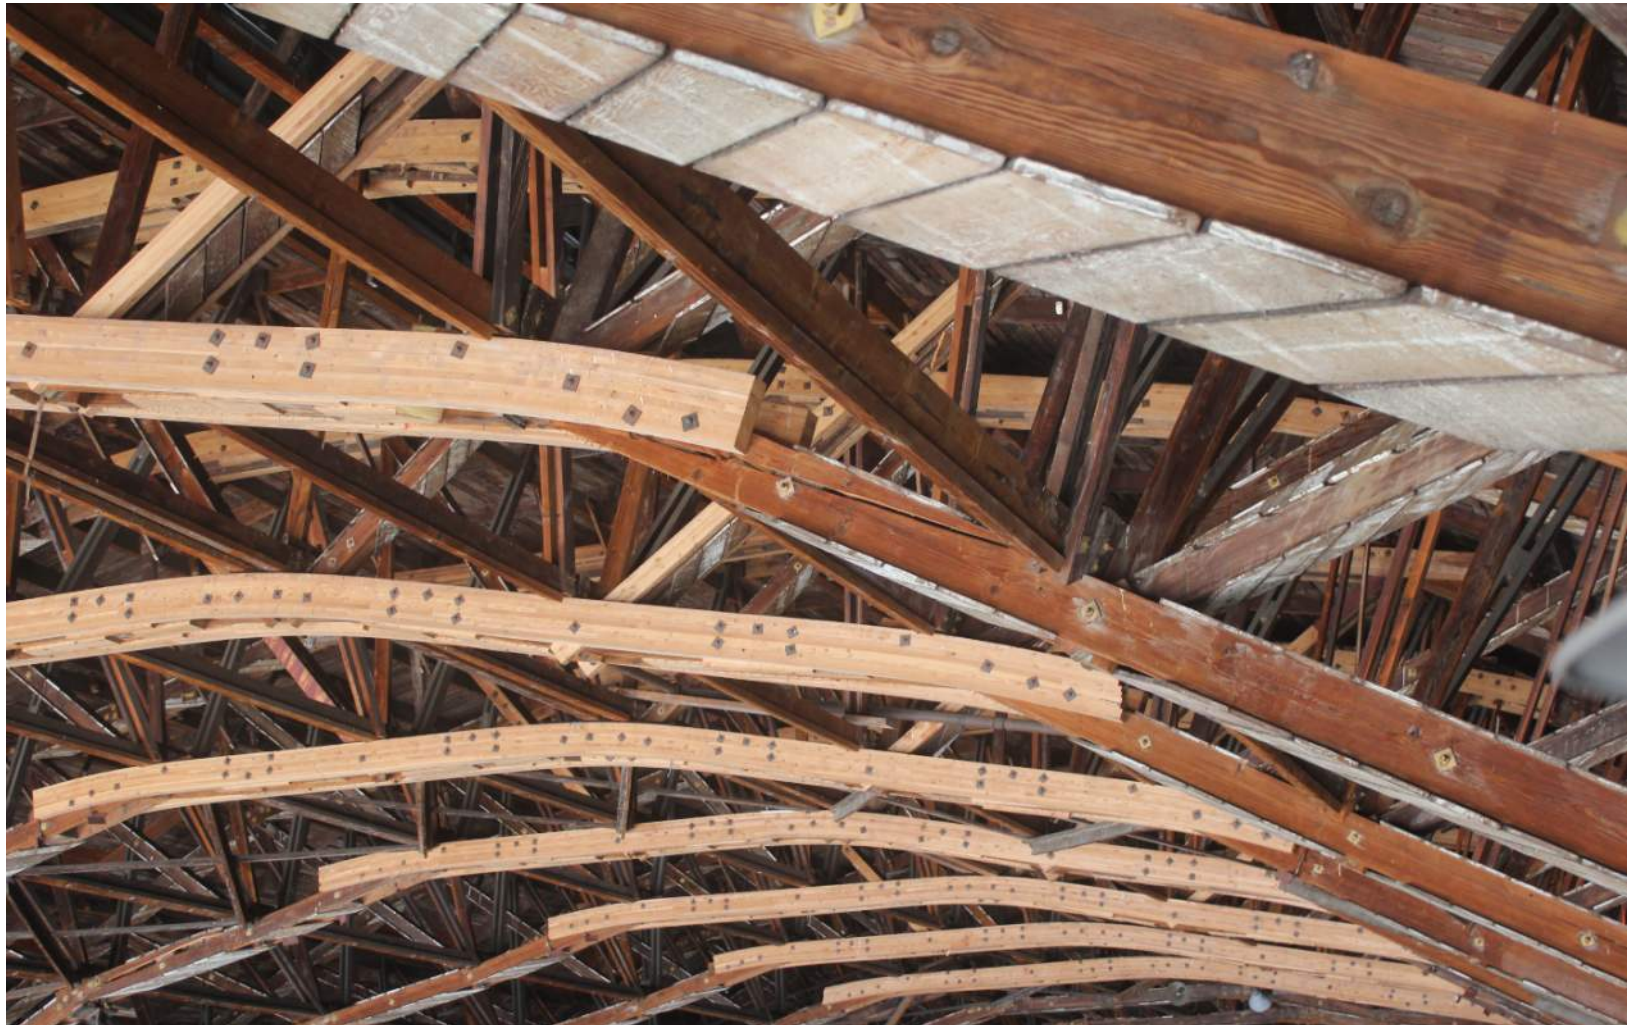
- Continued deterioration of Hangar 3 necessitated further glulam repairs in 1993
- Repairs consisted of glulam strongbacks for buckling, and multi-chord glulam sistered members
- Many of these repairs were made in the critical zone where the most severe deflections and damage were later found
- Major repairs made to **75** members
- Sistering repairs also made to roof support purlins and minor clamp repairs were again performed on arch trusses

1993 glulam sister repairs to chord members in critical zone

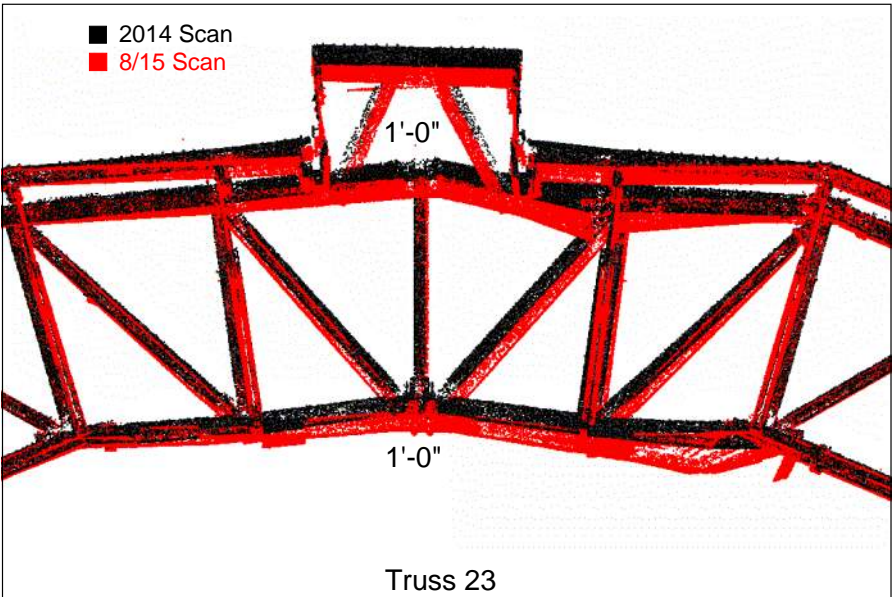
Point cloud visualization of damage progression

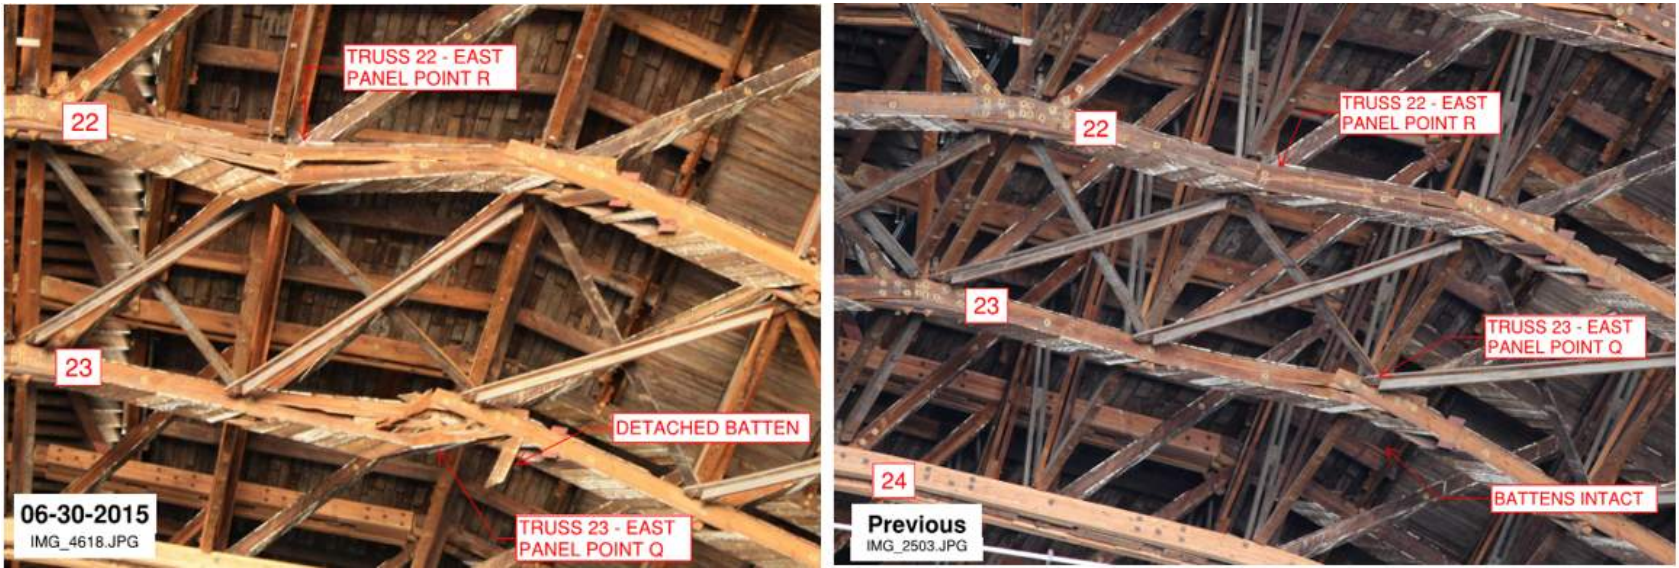
- During a site visit on June 24, 2015 KPFF observed damage progression in arch trusses
- On July 2, 2015 KPFF issued an Emergency Truss Repairs permit drawing set
- KPFF, Power Engineering Construction, Turner, and Page & Turnbull coordinated work to implement shoring and emergency truss repairs
- Permit for emergency repairs was received from NASA on August 19, 2015.

Photos of damage progression

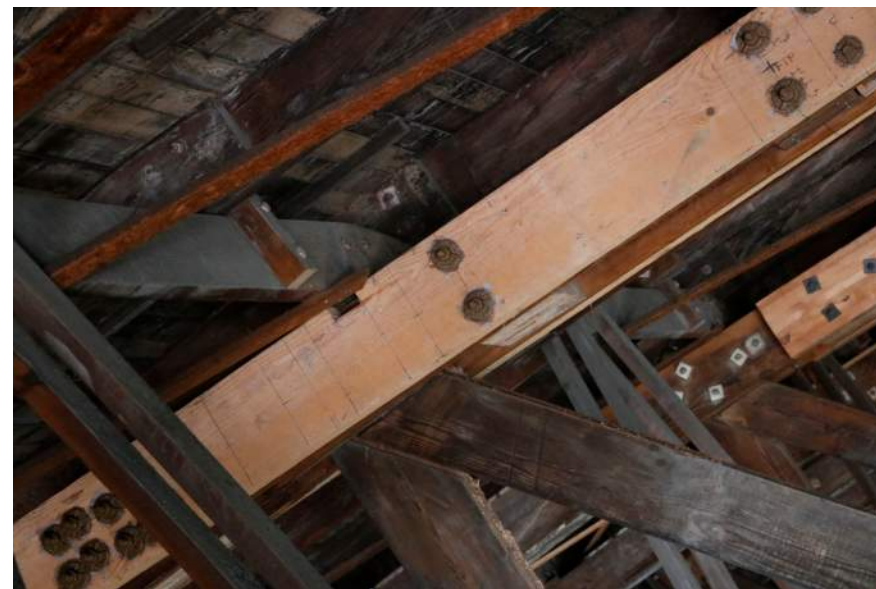
- The KPFF survey discovered chord damage which was either not observed or not present during the due diligence investigations
- The survey uncovered extensive deficiencies within the web member connections, including many plug pullout failures
- **10** additional arch members received glulam sistering repairs
- **39** chord connections received connection strengthening brackets

Chord sister repair installed prior to exoskeletons

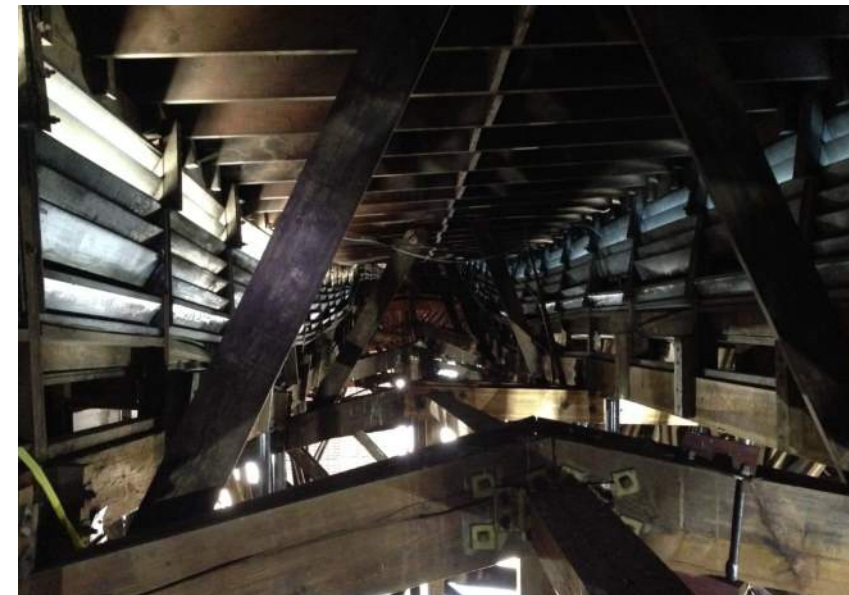
- **50** additional members were identified as severely damaged and scheduled to be removed and replaced after roof jacking
- Before jacking and repairs were made, decision was made to defer further construction activities

Roof monitor deflection in critical zone

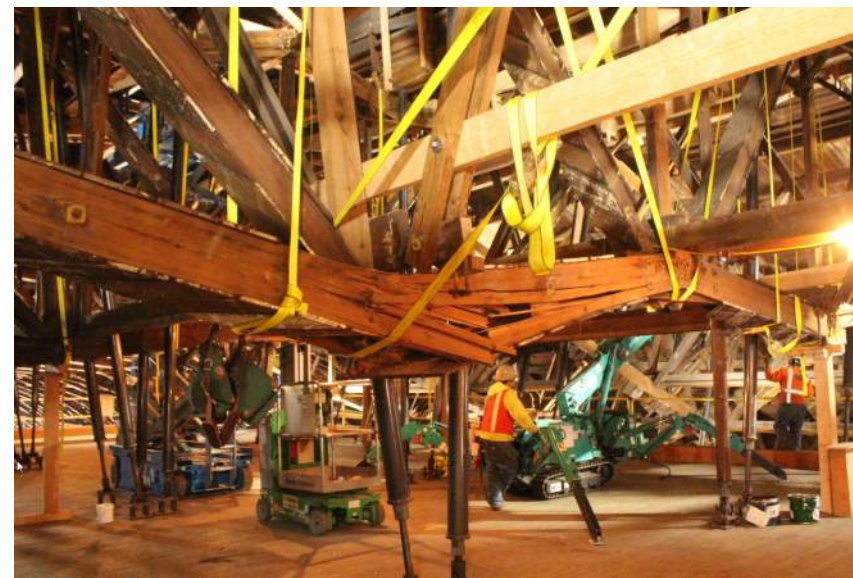
Temporary strapping on chord marked for removal and replacement

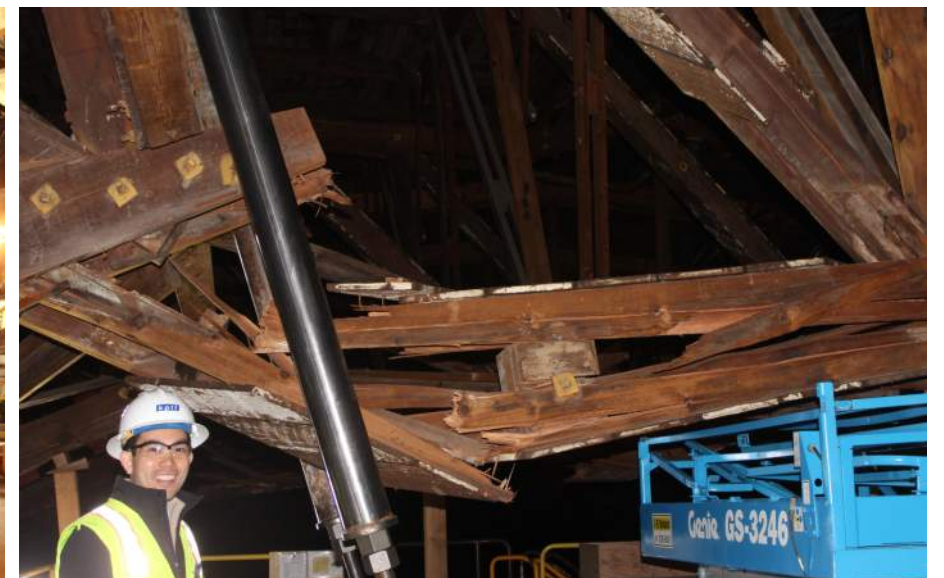
Damaged chord member viewed from access tower

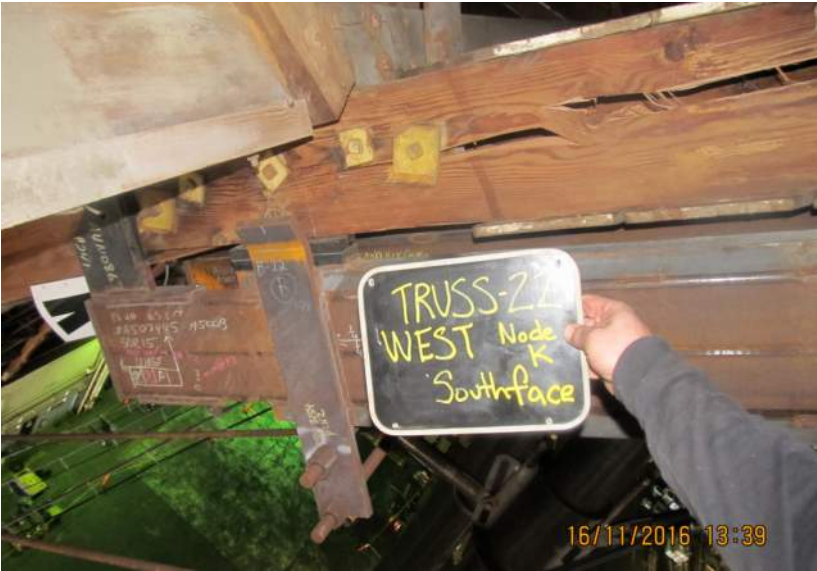
- Months after installation of exoskeletons, major splits were observed in chord members which had previously been observed and cleared.
- Major damage was observed on **19** chords, most between panel points I to M.
- Sistering repairs installed on most severe cases
- Due to the concentration of new damage at the lower chord members at panel points I to M, preemptive measures were taken to help reduce the progression of damage.
- Preemptive measures included fully-threaded screws at connections, and steel clamps.

Chord damage at node K after exoskeleton install
