Final Hangar 1 Engineering Evaluation/Cost Analysis

Former Naval Air Station Moffett Field,
California

12 December 2019
EKI B20019.19

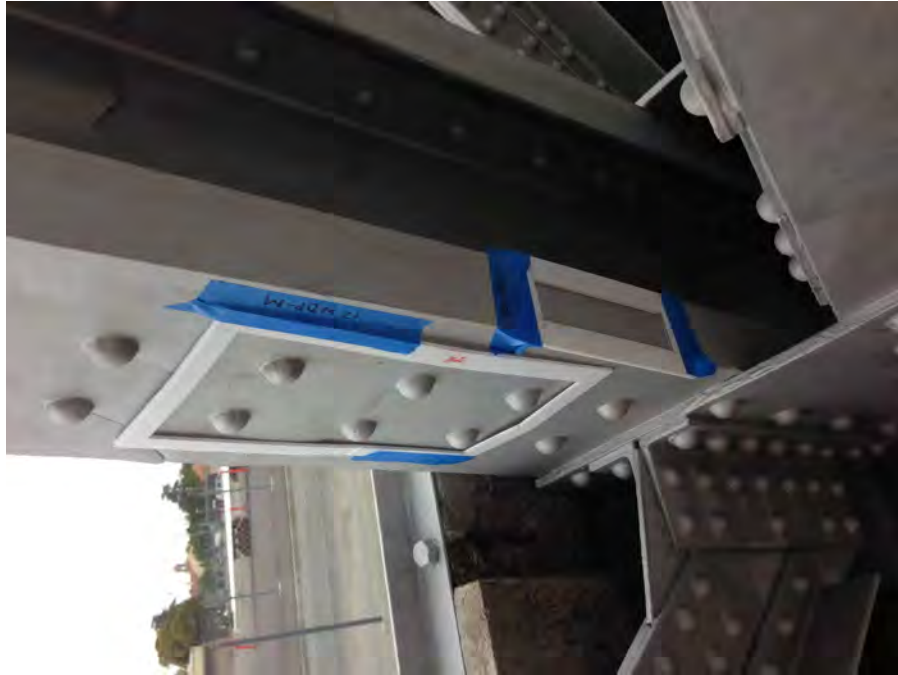
Sample Location: Ground Floor, Column Line 12, West Side
Sample Number: 12WDP
Sample System / Condition: Structural Steel below Deteriorated Encapsulant/Paint

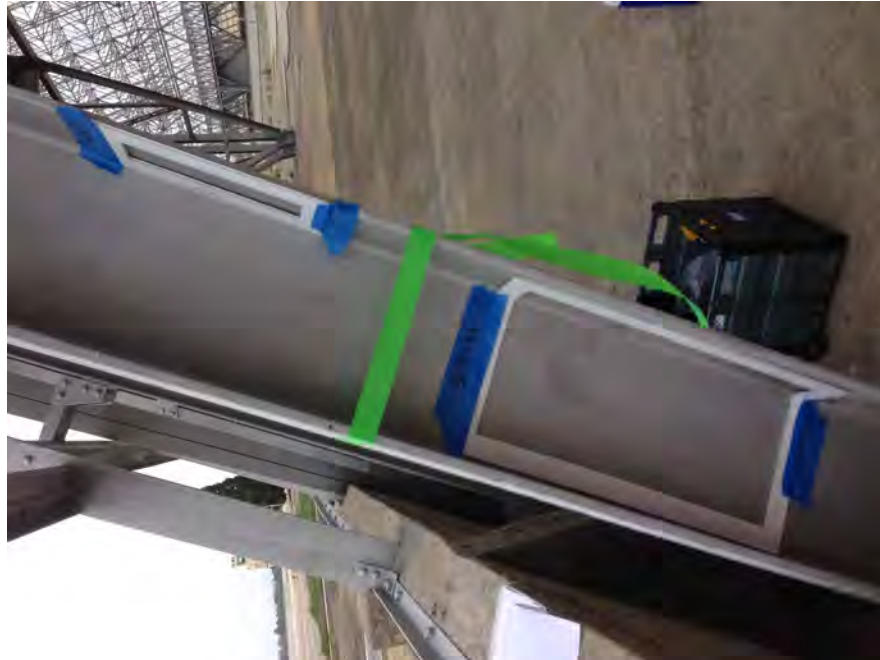
Sample Location: Ground Floor, Column Line 3, East Side
Sample Number: 3EDP
Sample System / Condition: Structural Steel below Deteriorated Encapsulant/Paint

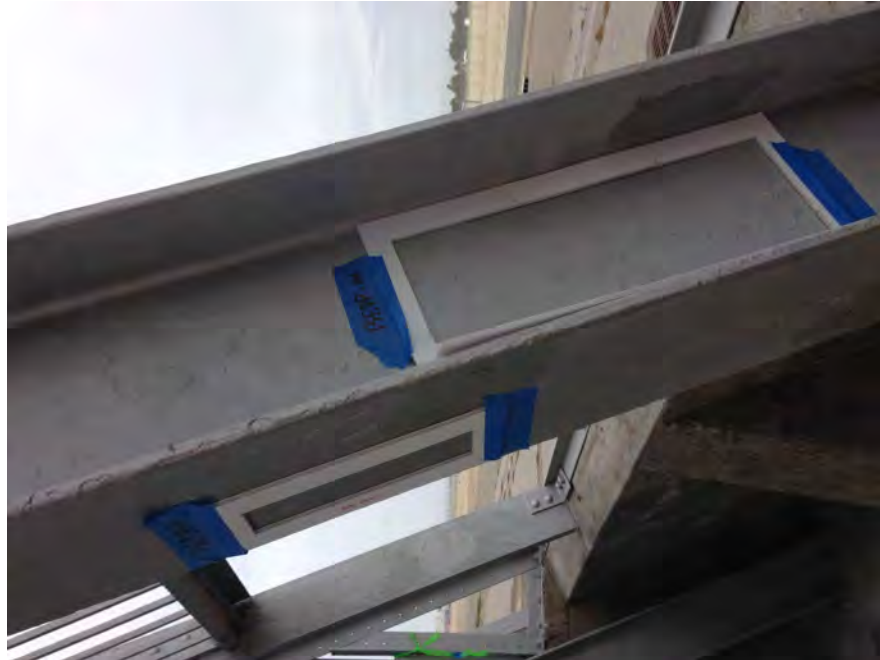
Sample Location: Ground Floor, Column Line 13, East Side
Sample Number: 13EDP
Sample System / Condition: Structural Steel below Deteriorated Encapsulant/Paint

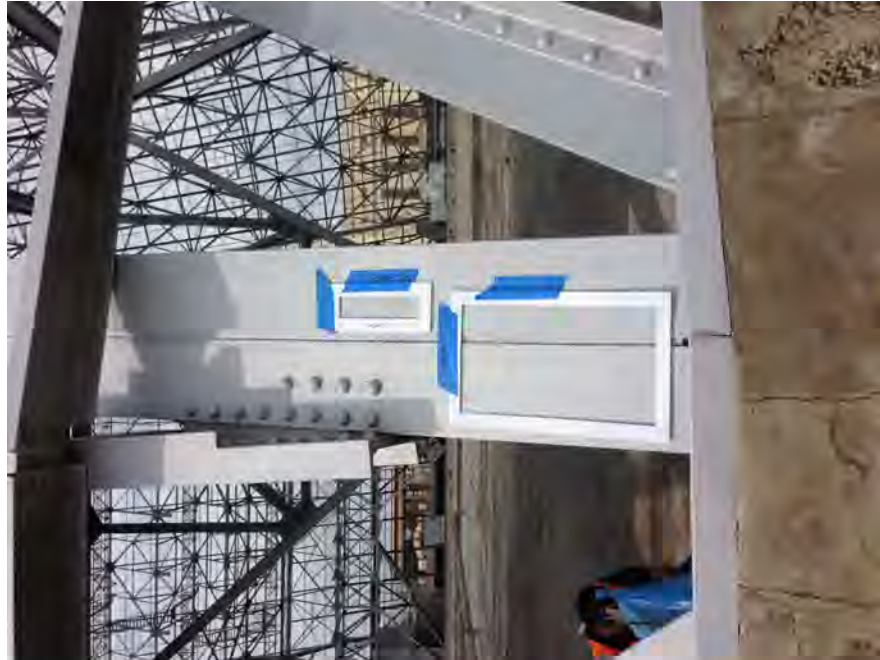
Sample Location: Ground Floor, Column Line 7, East Side
Sample Number: 7EO
Sample System / Condition: Intact Encapsulant/paint over Structural Steel

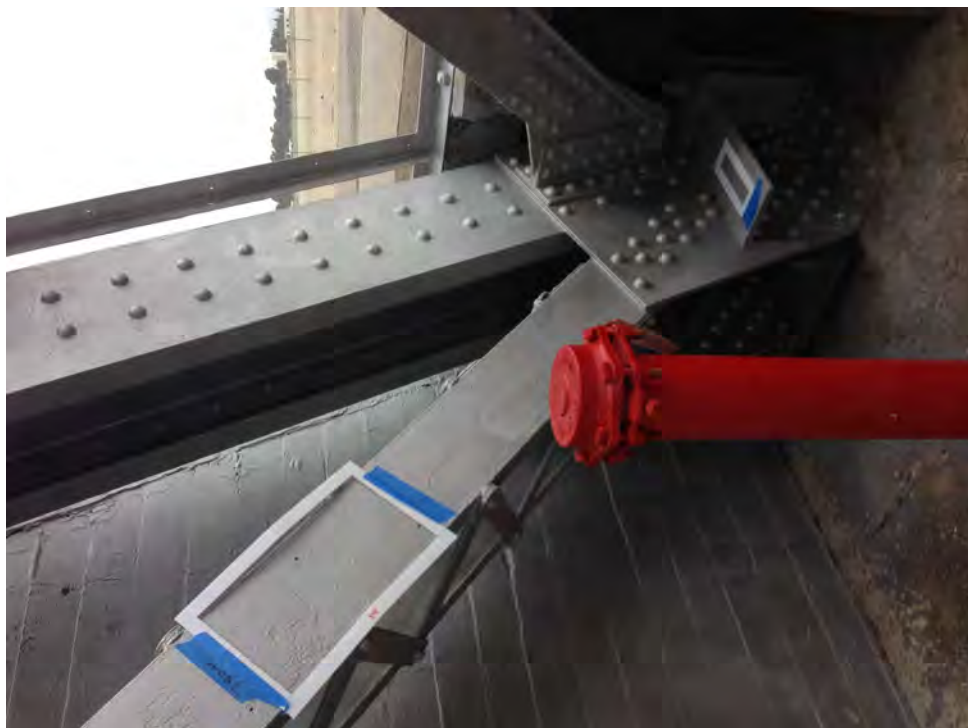
Sample Location: Ground Floor, Column Line 9, East Side
Sample Number: 9EO
Sample System / Condition: Intact Encapsulant/paint over Structural Steel

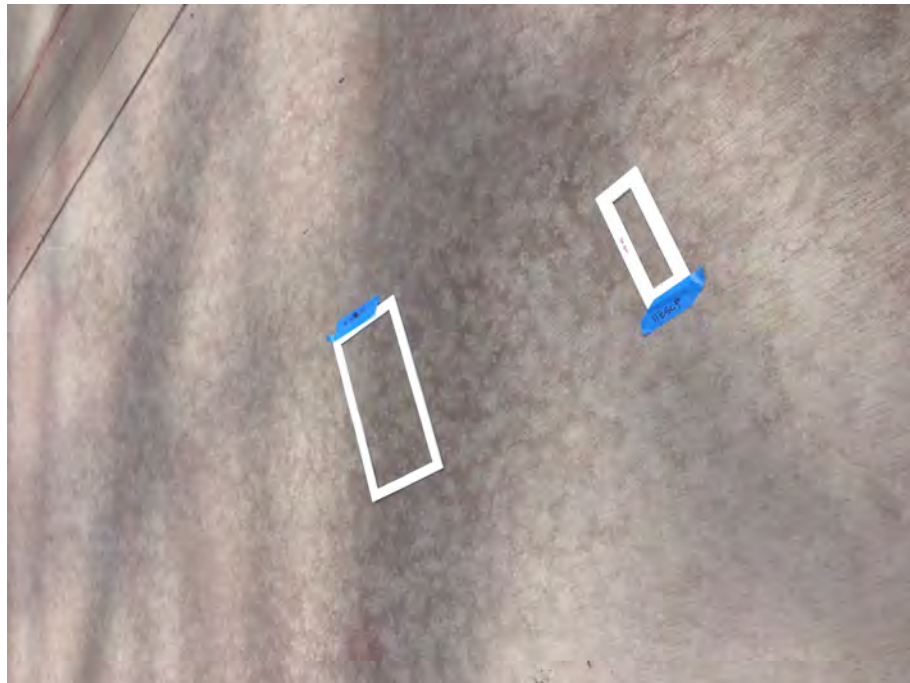
Sample Location: Ground Floor, Column Line 5, West Side
Sample Number: 5WSC
Sample System / Condition: Concrete Floor - Evidence of Pooling/Sediment

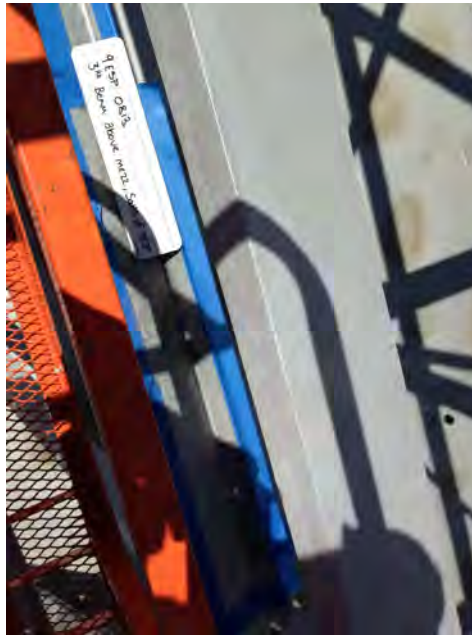
Sample Location: Ground Floor, Column Line 5, East Side
Sample Number: 5ESP0813
Sample System / Condition: Ponding Water Areas - Horizontal Structural Steel

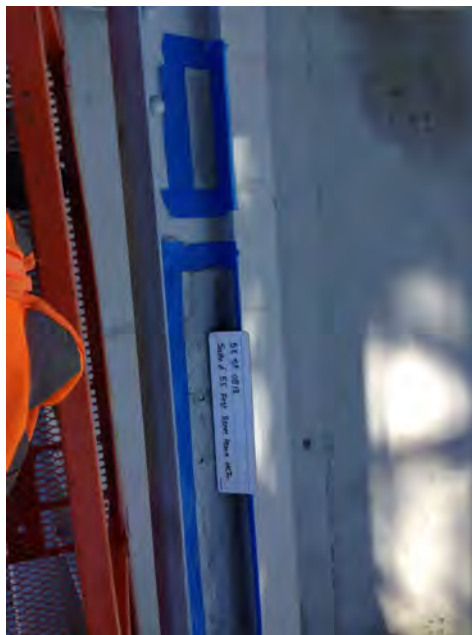
Sample Location: Ground Floor, Column Line 1, East Side
Sample Number: 1ESP0813
Sample System / Condition: Ponding Water Areas - Horizontal Structural Steel

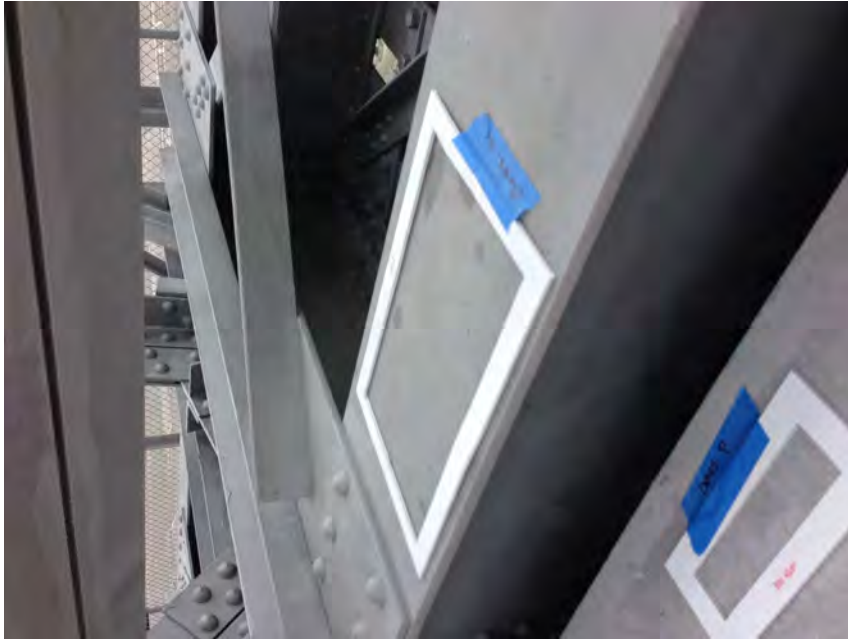
Sample Location: Ground Floor, Column Line 0, West Side
Sample Number: 0WSS
Sample System / Condition: Base of Steel Column at evidence of Pooling/Sediment

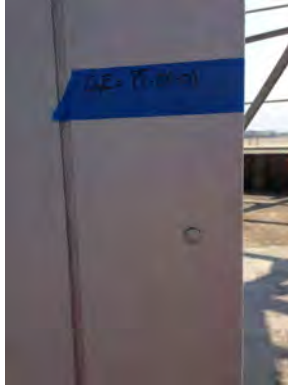
Prior to Sampling

Material Description: Multi-color paint under CM15 encapsulant over structural steel

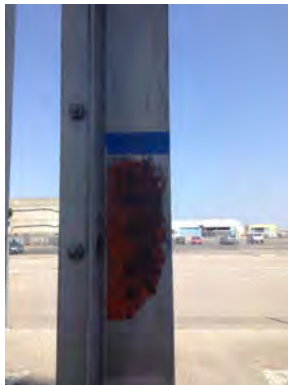
Sample Location: Ground Floor North Column

Material Description: Multi-color paint under CM15 encapsulant over structural steel

Prior to Sampling

After Sampling

After Recoating/Repairs by DPR

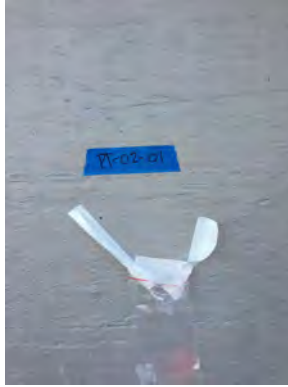
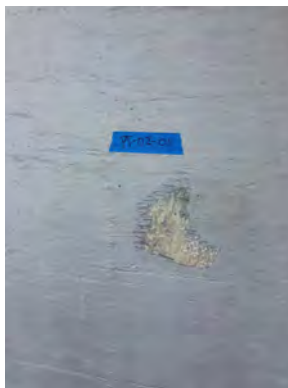
Sample Location: Ground Floor Column Line 12, East Hangar

Material Description: Multi-color paint under CM15 encapsulant over concrete

Prior to Sampling

After Sampling

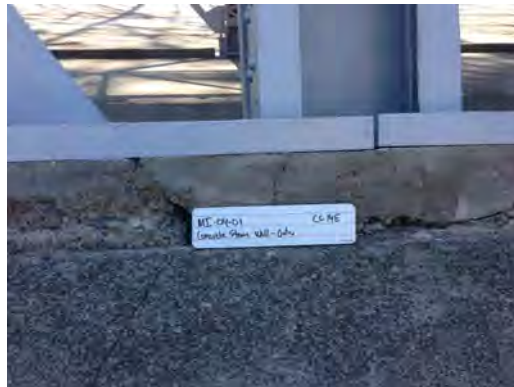
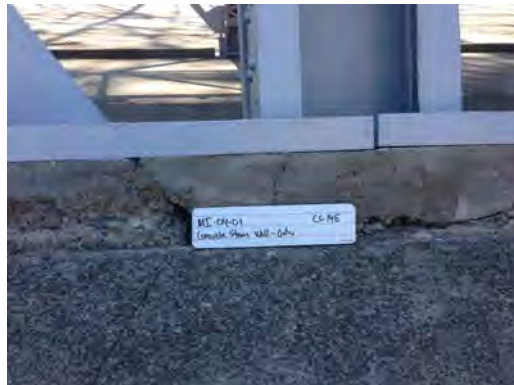
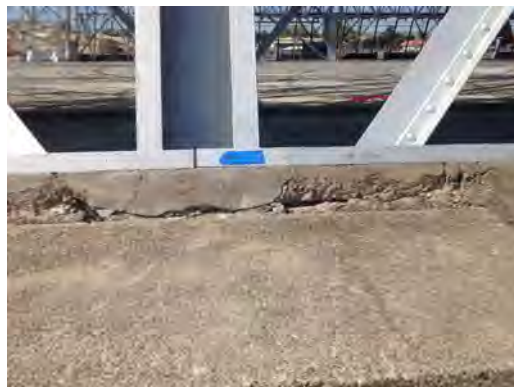
Sample Location: Ground Floor Column Line 14, East Hangar
Sample Number: MI-04-01
Material Description: Carbocrete coated concrete perimeter stem wall

Prior to Sampling

After Sampling

After Recoating/Repairs by DPR

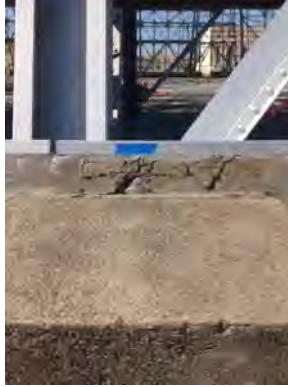
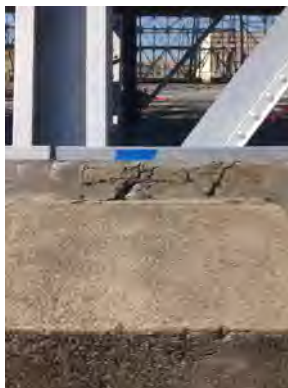
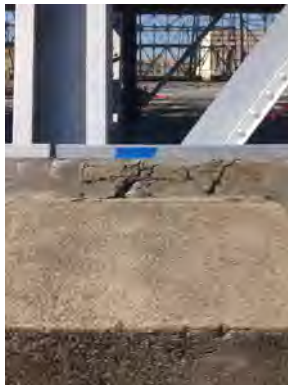
Sample Location: Ground Floor Column Line 1, East Hangar

Material Description: Carbocrete coated concrete perimeter stem wall

Prior to Sampling

After Sampling

After Recoating/Repairs by DPR

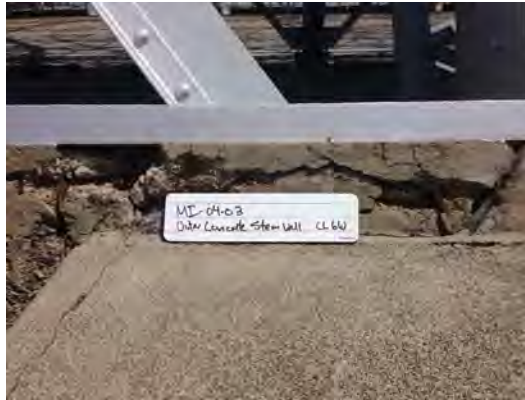
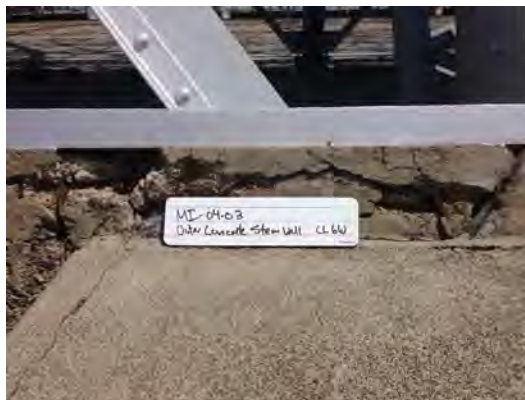
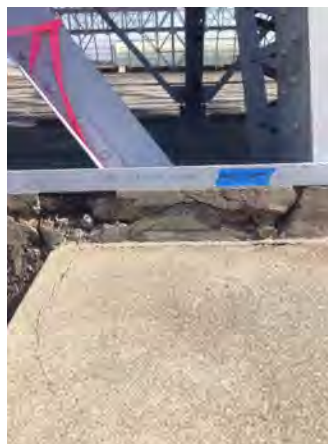
Sample Location: Ground Floor Column Line 6, West Hangar

Material Description: Carbocrete coated concrete perimeter stem wall

Prior to Sampling

After Sampling

After Recoating/Repairs by DPR

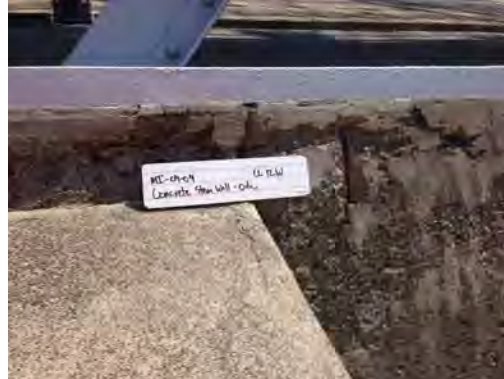
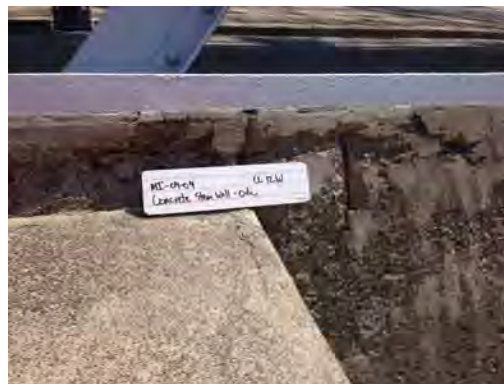
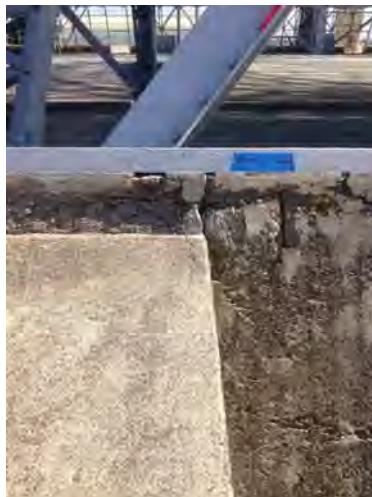
Sample Location: Ground Floor Column Line 12, West Hangar

Material Description: Carbocrete coated concrete perimeter stem wall

Prior to Sampling

After Sampling

After Recoating/Repairs by DPR

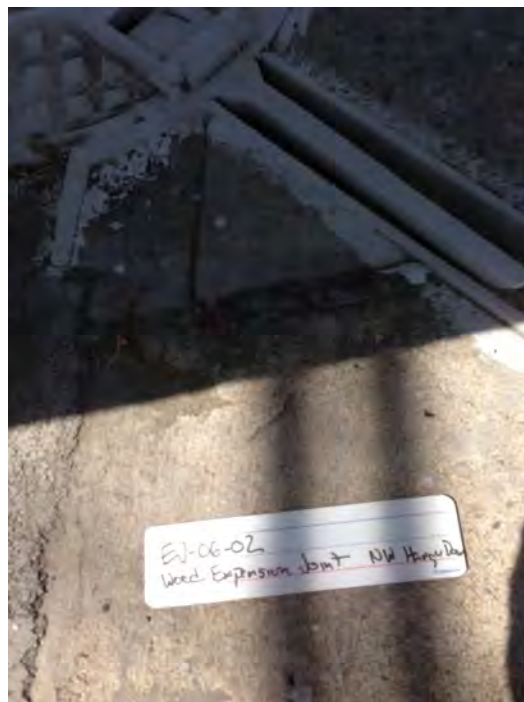
Sample Location: Ground Floor Column Line 6, West Hangar
Sample Number: EJ-06-02
Material Description: Bituminous concrete expansion joint

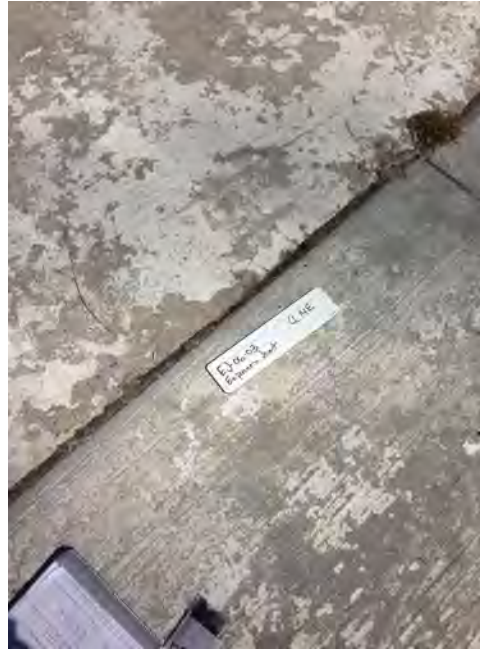
Sample Number: EJ-06-03

Sample Location: Ground Floor Column Line 6, West Hangar

Material Description: Bituminous concrete expansion joint

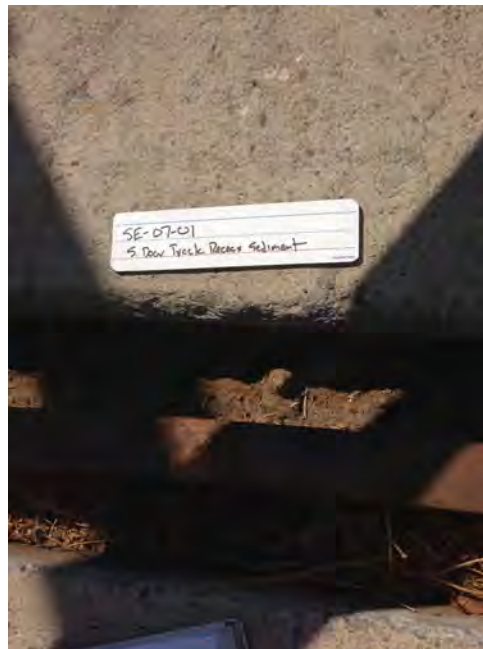
Sample Number: SE-07-01

Sample Location: Ground Floor Column Line 6, West Hangar

Material Description: Floor trench, door trench and trench drain sediment

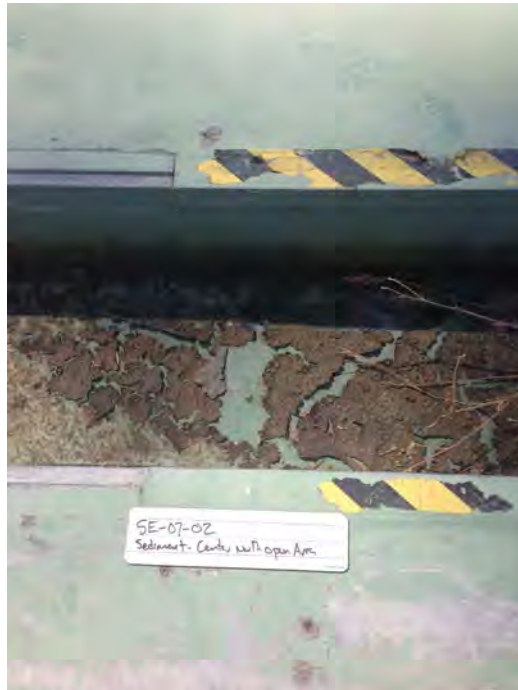
Sample Number: SE-07-02

Sample Location: Ground Floor Column Line 6, West Hangar

Material Description: Floor trench, door trench and trench drain sediment

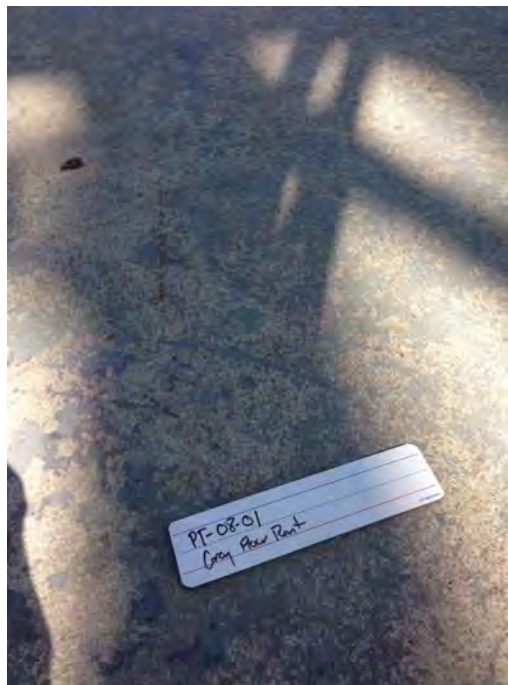
Sample Number: PT-08-01

Material Description: Sanded Floor Paint

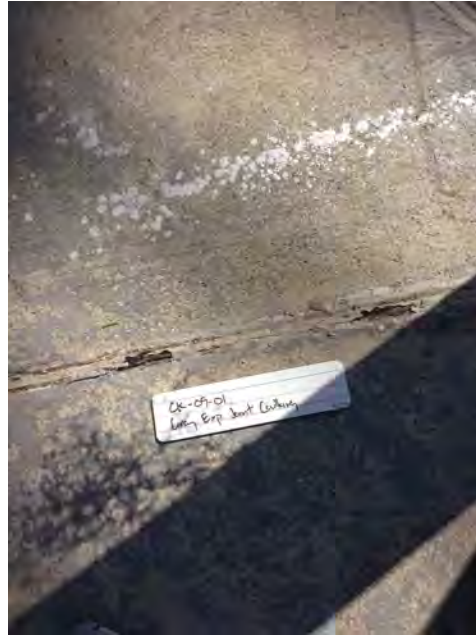
Sample Number: CK-09-01

Sample Location: Ground Floor Column Line 6, West Hangar

Material Description: Gray expansion joint caulking

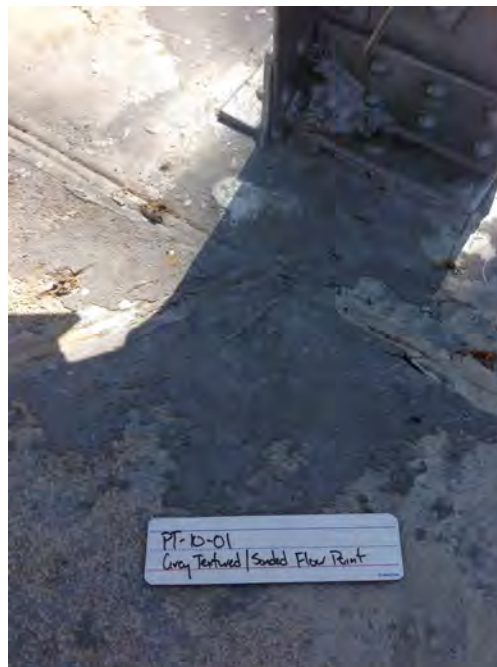
Sample Number: PT-10-01

Sample Location: Ground Floor Column Line 6, West Hangar

Material Description: Gray textured/sanded floor paint

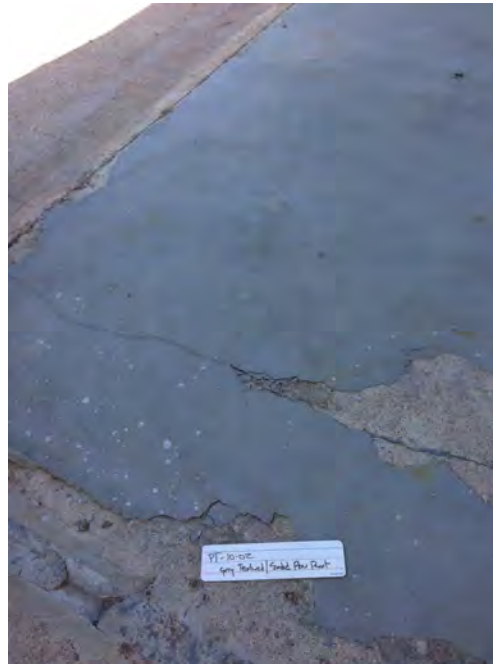
Sample Number: PT-10-02

Sample Location: Ground Floor Column Line 6, West Hangar

Material Description: Gray textured/sanded floor paint

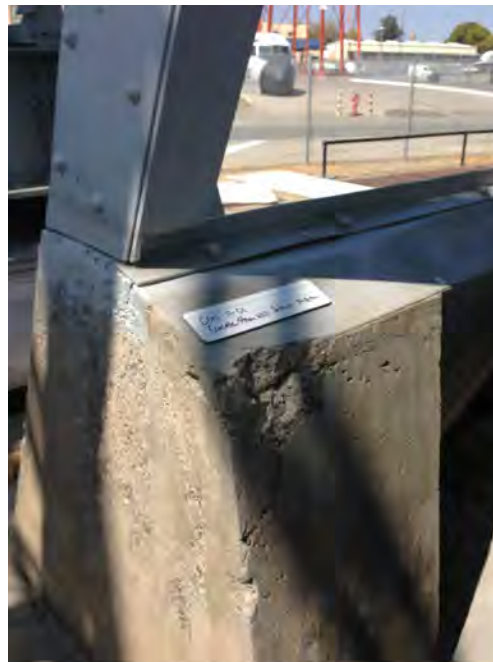
Sample Number: CON-11-01

Sample Location: Ground Floor Column Line 6, West Hangar

Material Description: Original Concrete Floor

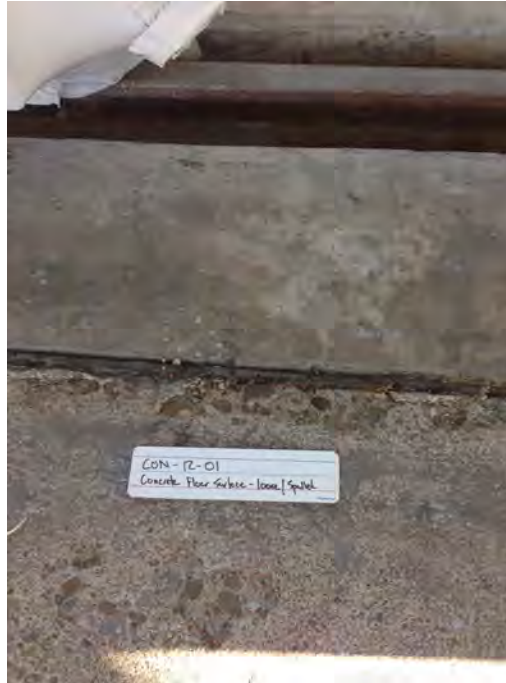
Sample Number: CON-12-01

Sample Location: Ground Floor Column Line 6, West Hangar

Material Description: Original Concrete Floor

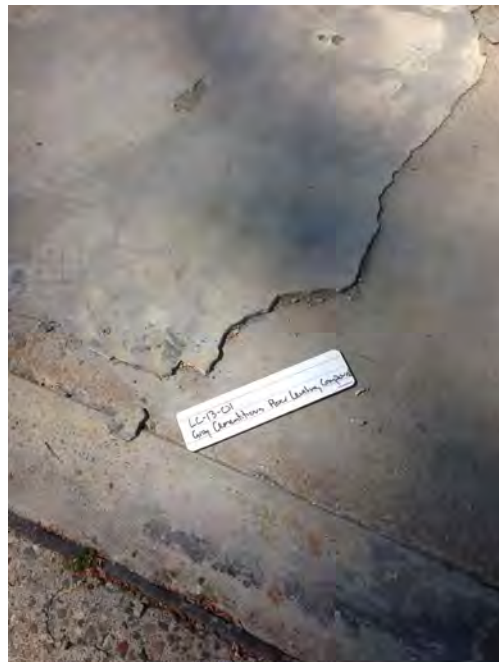
Sample Number: LC-13-01

Sample Location: Ground Floor Column Line 6, West Hangar

Material Description: Gray Cementitious Leveling Compound

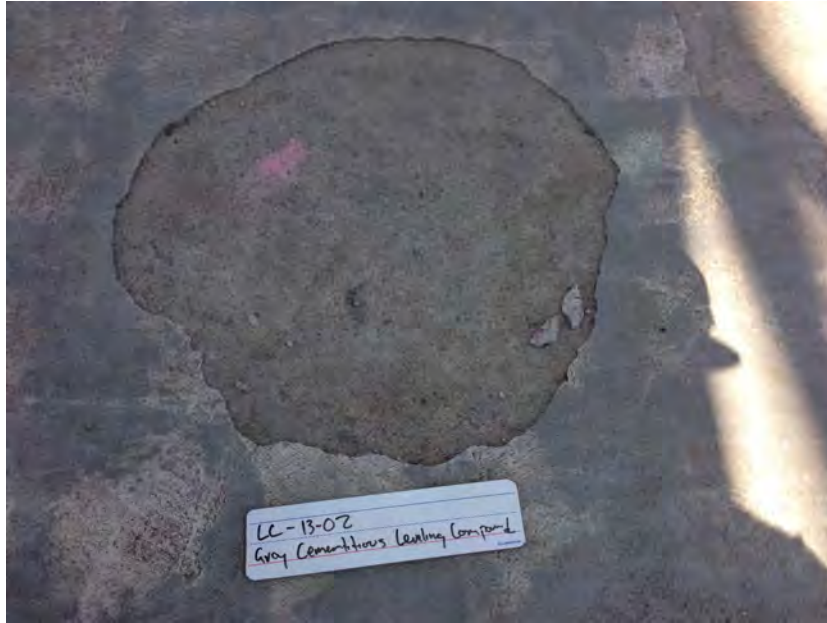
Sample Location: Ground Floor Column Line 6, West Hangar
Sample Number: LC-13-02
Material Description: Gray Cementitious Leveling Compound

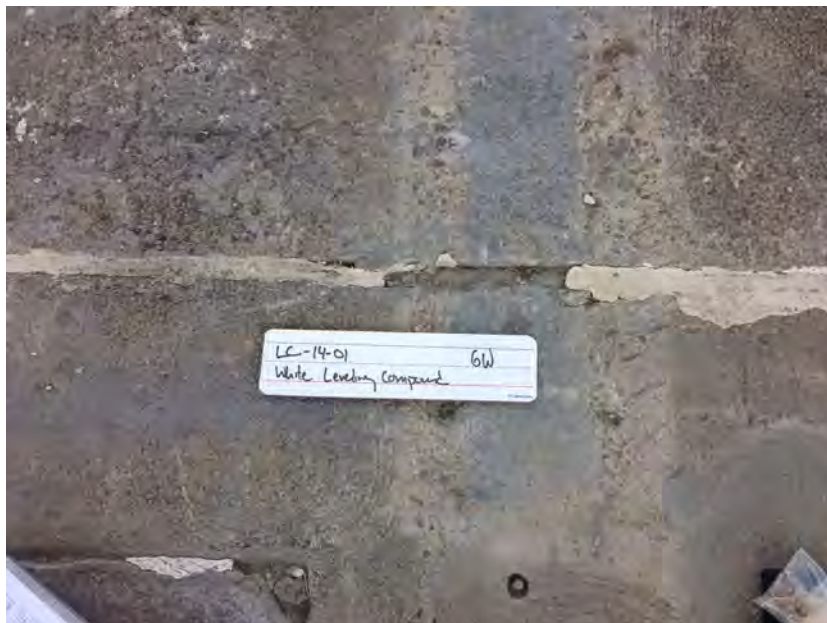
Sample Location: Ground Floor Column Line 6, West Hangar
Sample Number: LC-14-01
Material Description: White Cementitious leveling compound

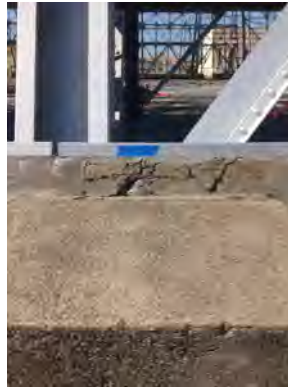
Prior to Sampling

Material Description: Carbocrete coated concrete perimeter stem wall

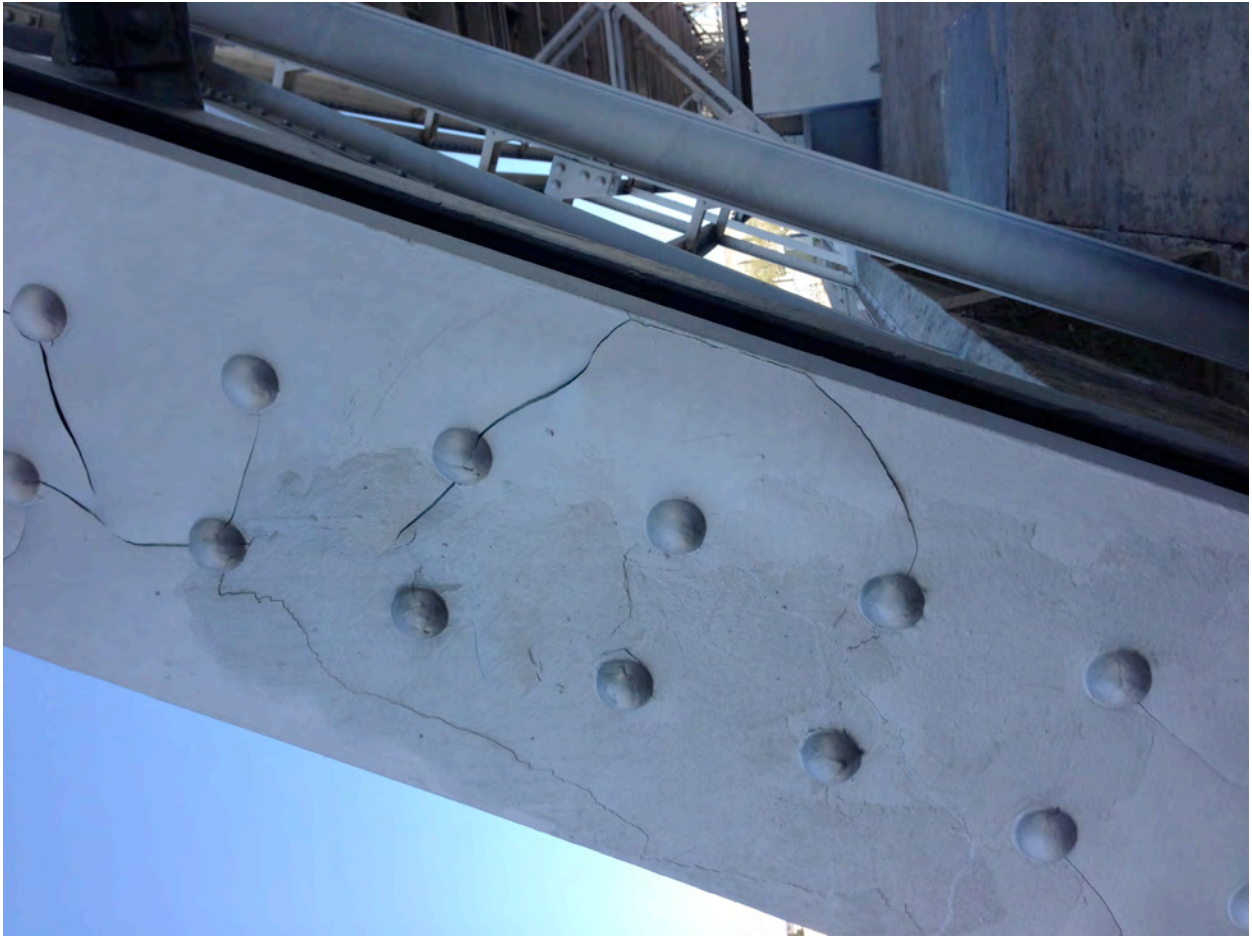
Photo Log 4 – Example Pictures of Deteriorated Hangar 1 NTCRA Coatings

Delaminating encapsulant and original paint, vertical steel

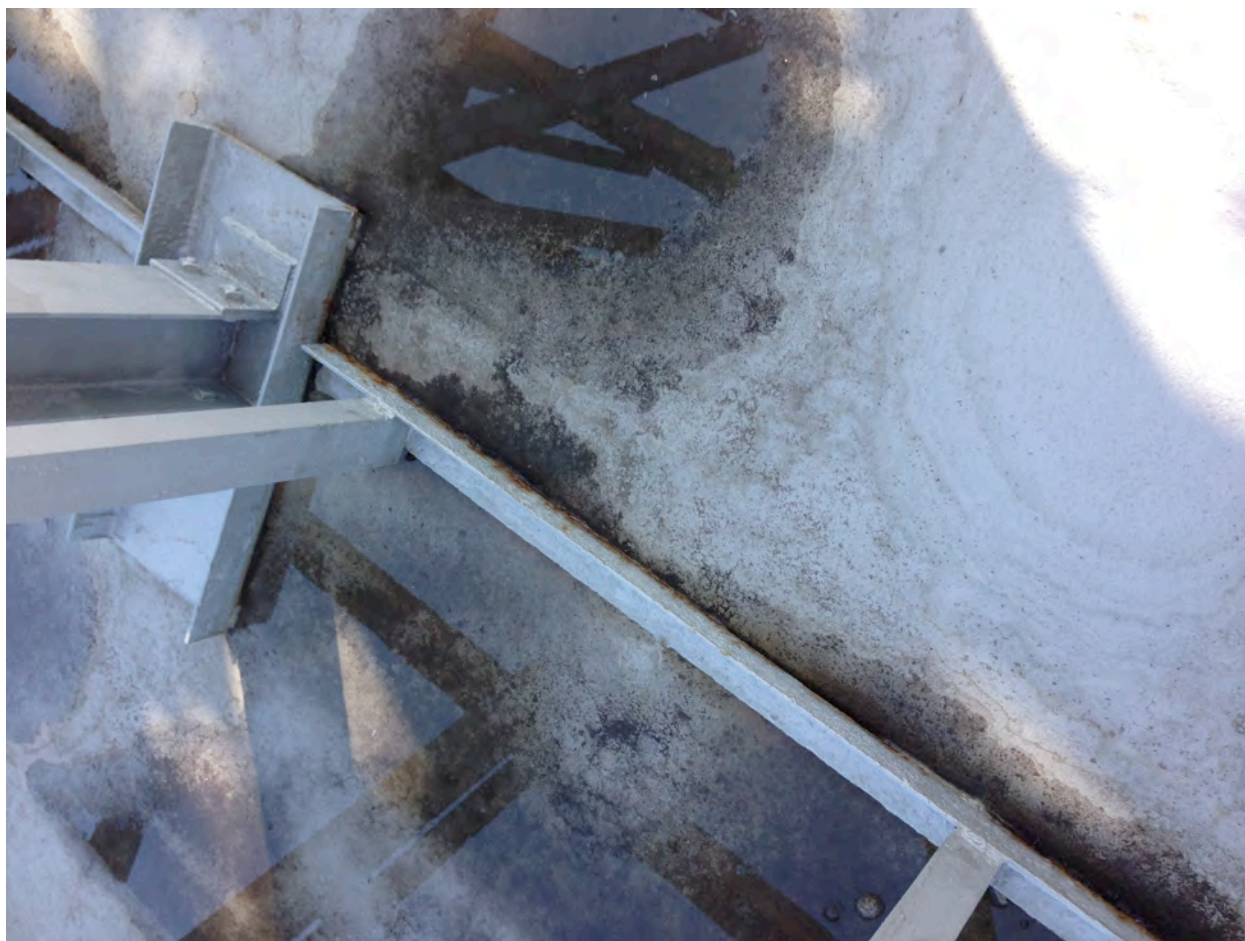
Mezzanine Pooling Water & Sediment

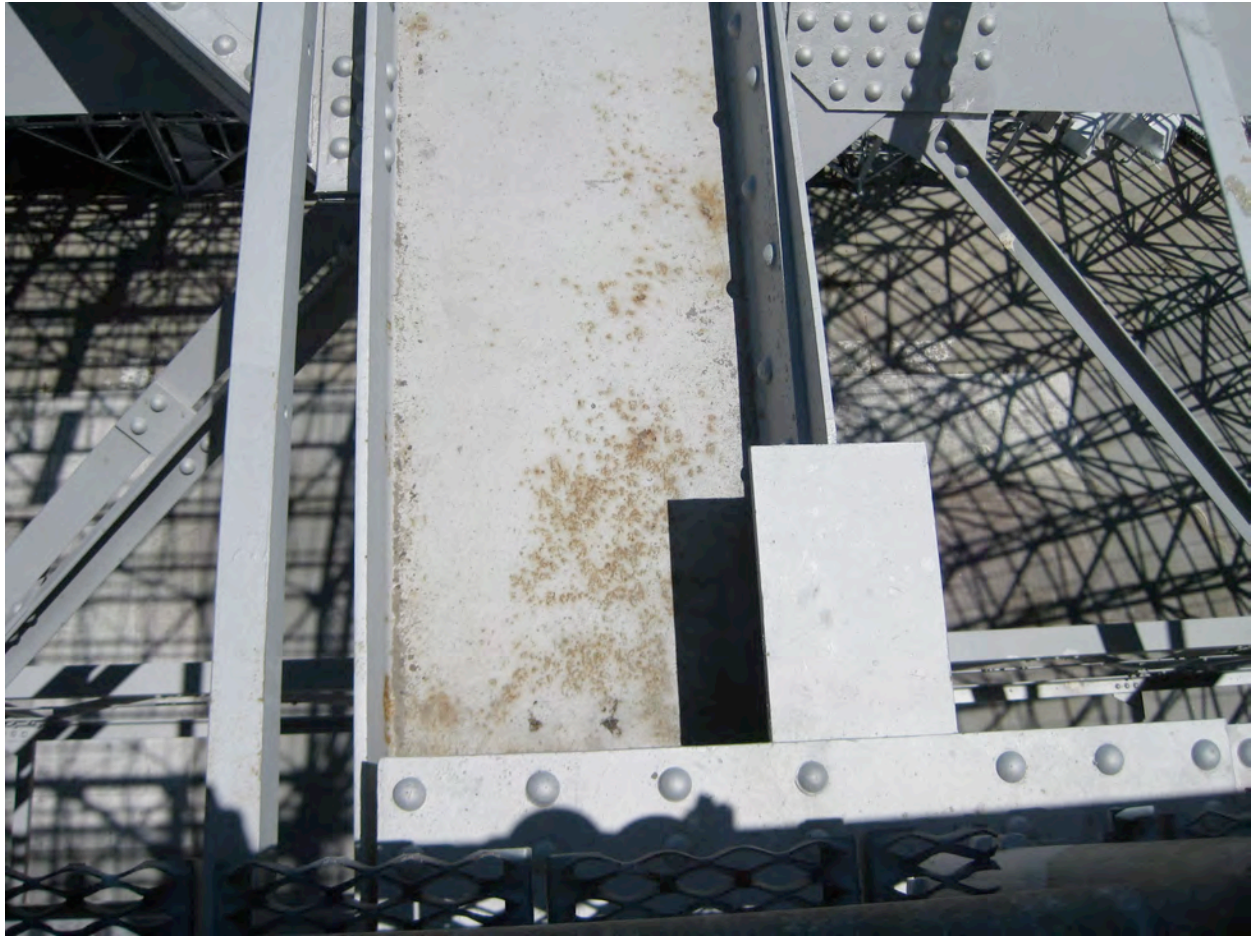
Roof-top rusting of NTCRA Coating

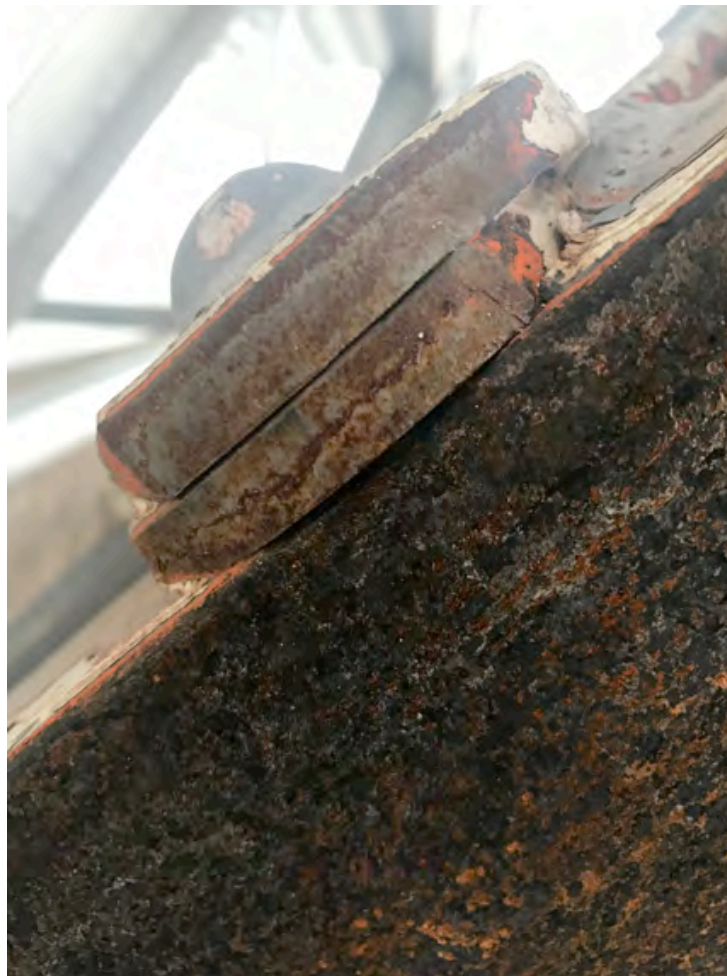
Photograph 1 – Structural Steel after abatement with UHPW. Note the presence of black mill scale, paint/coatings in tight-tolerance mated surfaces and rough surfaces.

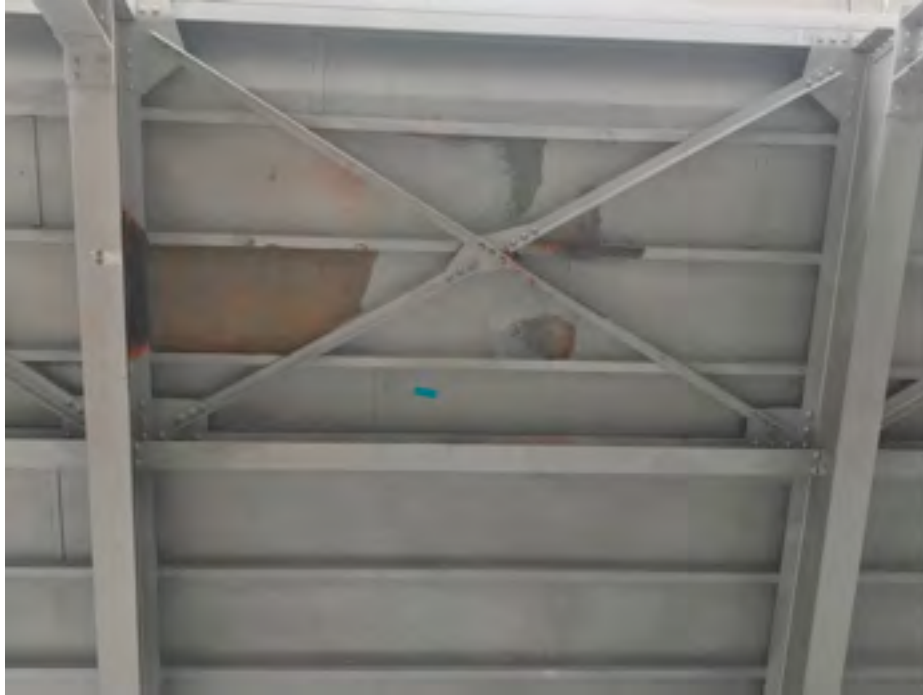
Photograph 5 – Underside of mezzanine after UHPW method was utilized.

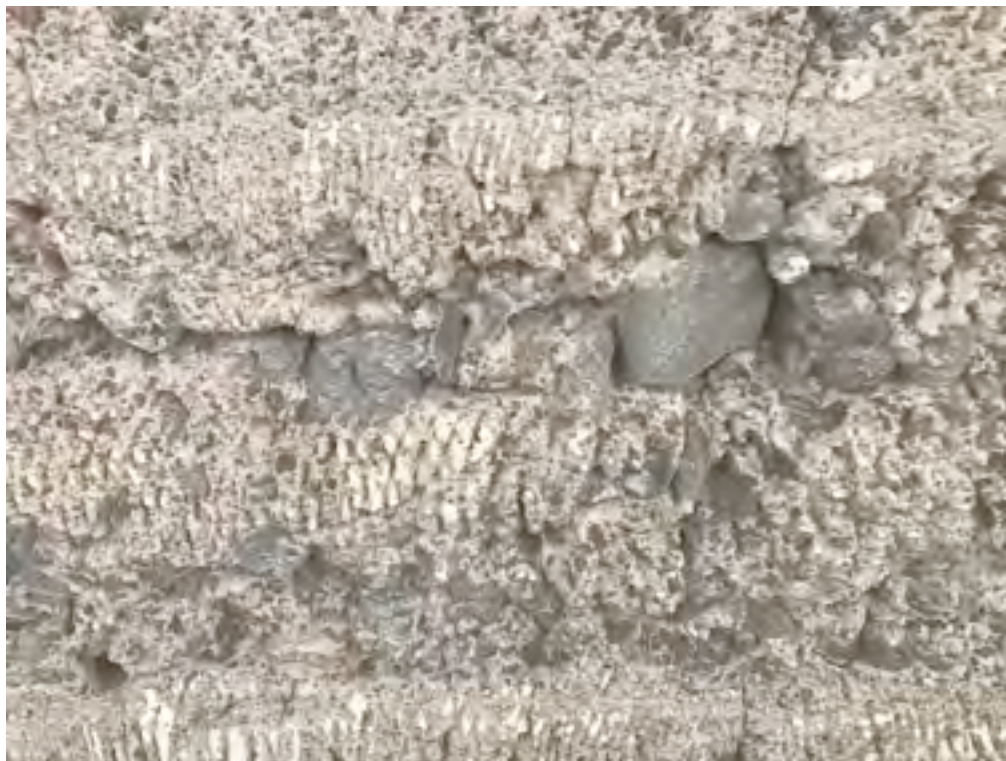
Photograph 7 – Damage to concrete and paint/coatings remaining on surface of CMU wall.

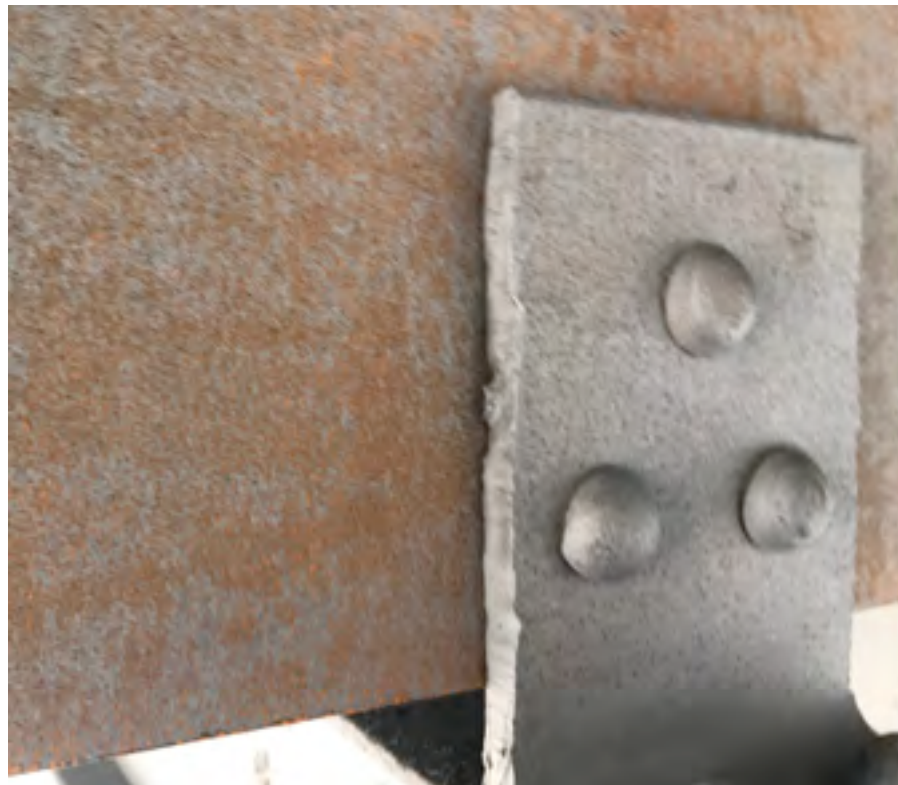
Photograph 9 – Tight-tolerance mated flange/beam connection after removal of paint/coatings with media blasting. (Note: the brown areas in the photo correspond to areas of rust formation due to the wet decontamination of the abated steel)

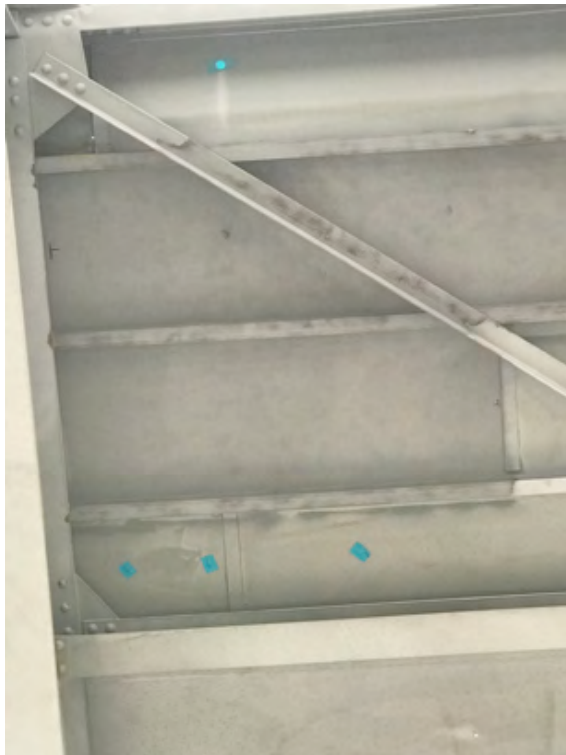
Photograph 11 – Under side of mezzanine after removal of paint/coatings with media blasting.

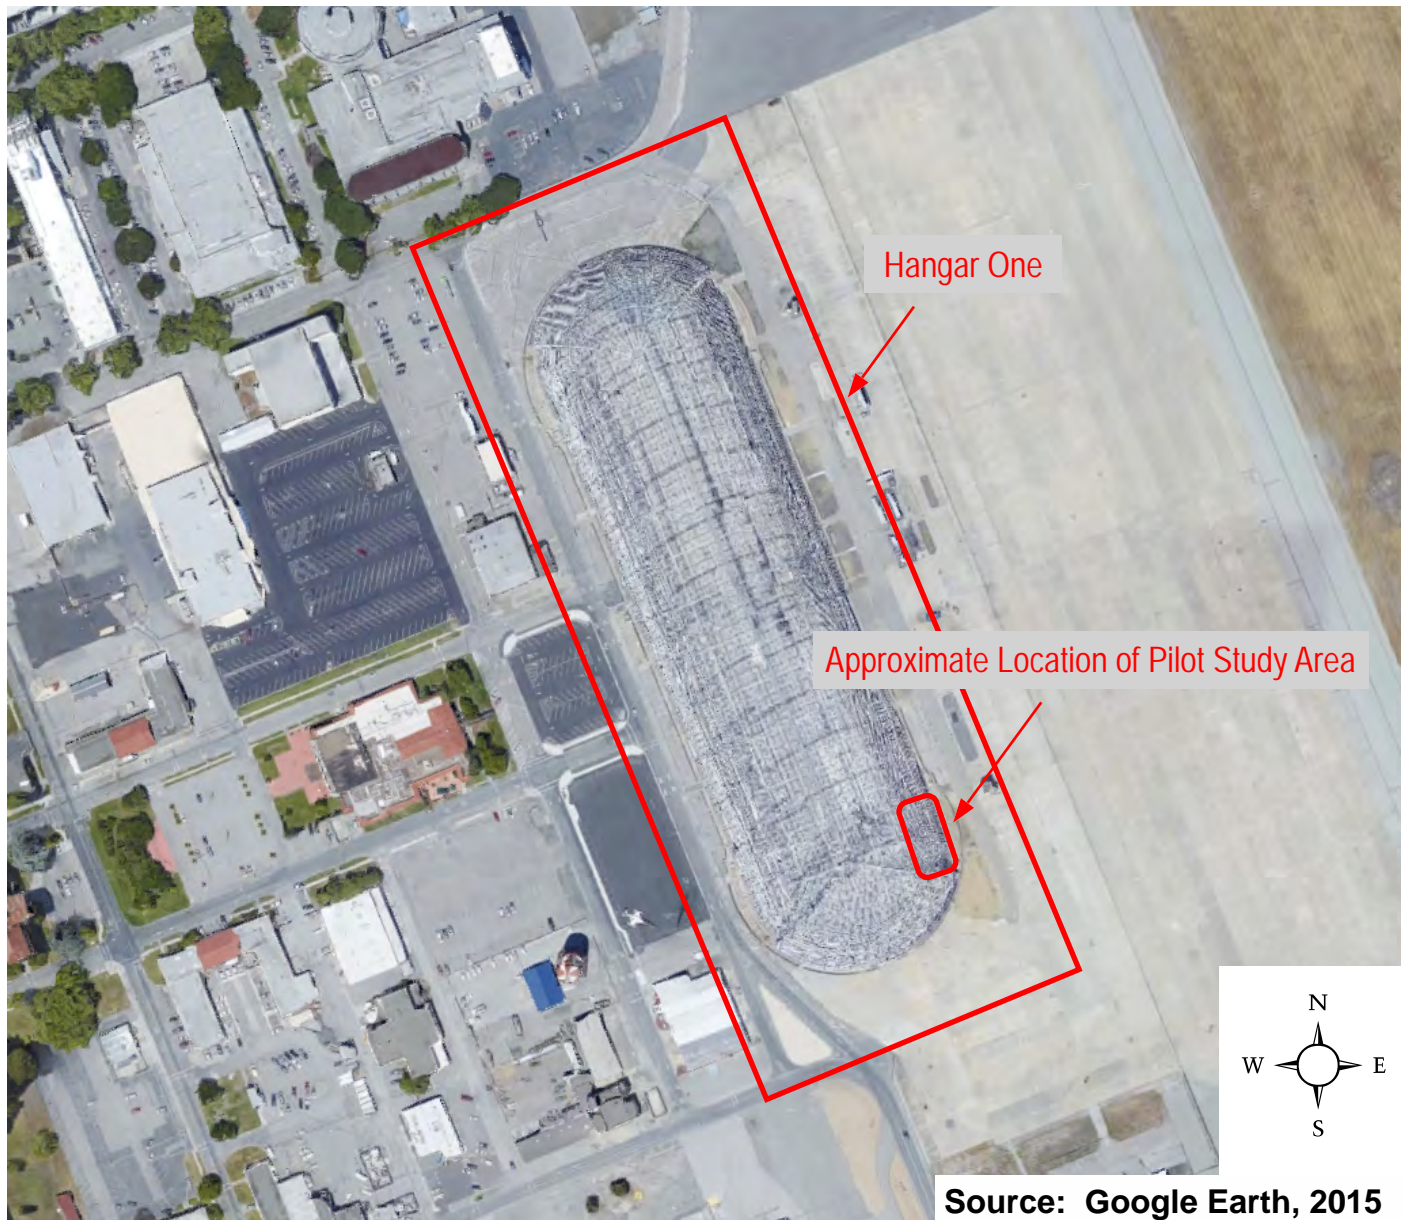
Pilot Study Location Map		
Drawn By: NA	Date: 7/10/17	Project Number: 1591-011.01
Figure A-1
