Final Hangar 1 Engineering Evaluation/Cost Analysis

Former Naval Air Station Moffett Field,
California

12 December 2019
EKI B20019.19

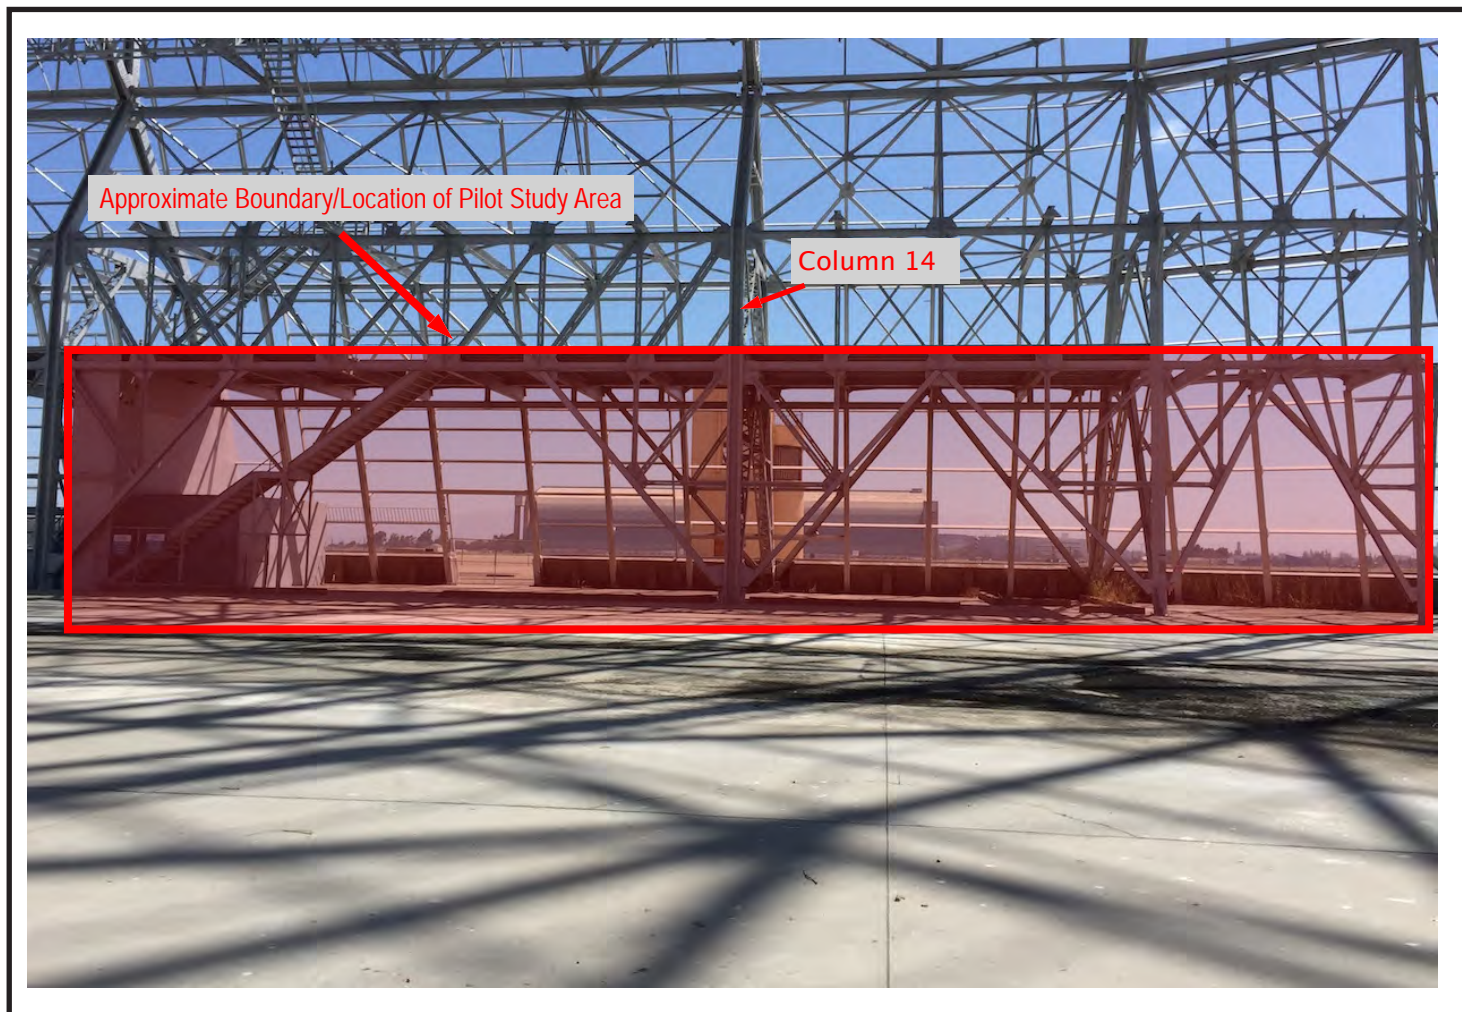
Pilot Study Area Photograph		
Drawn By: NA	Date: 7/10/17	Project Number: 1591-011.01
Figure A-3

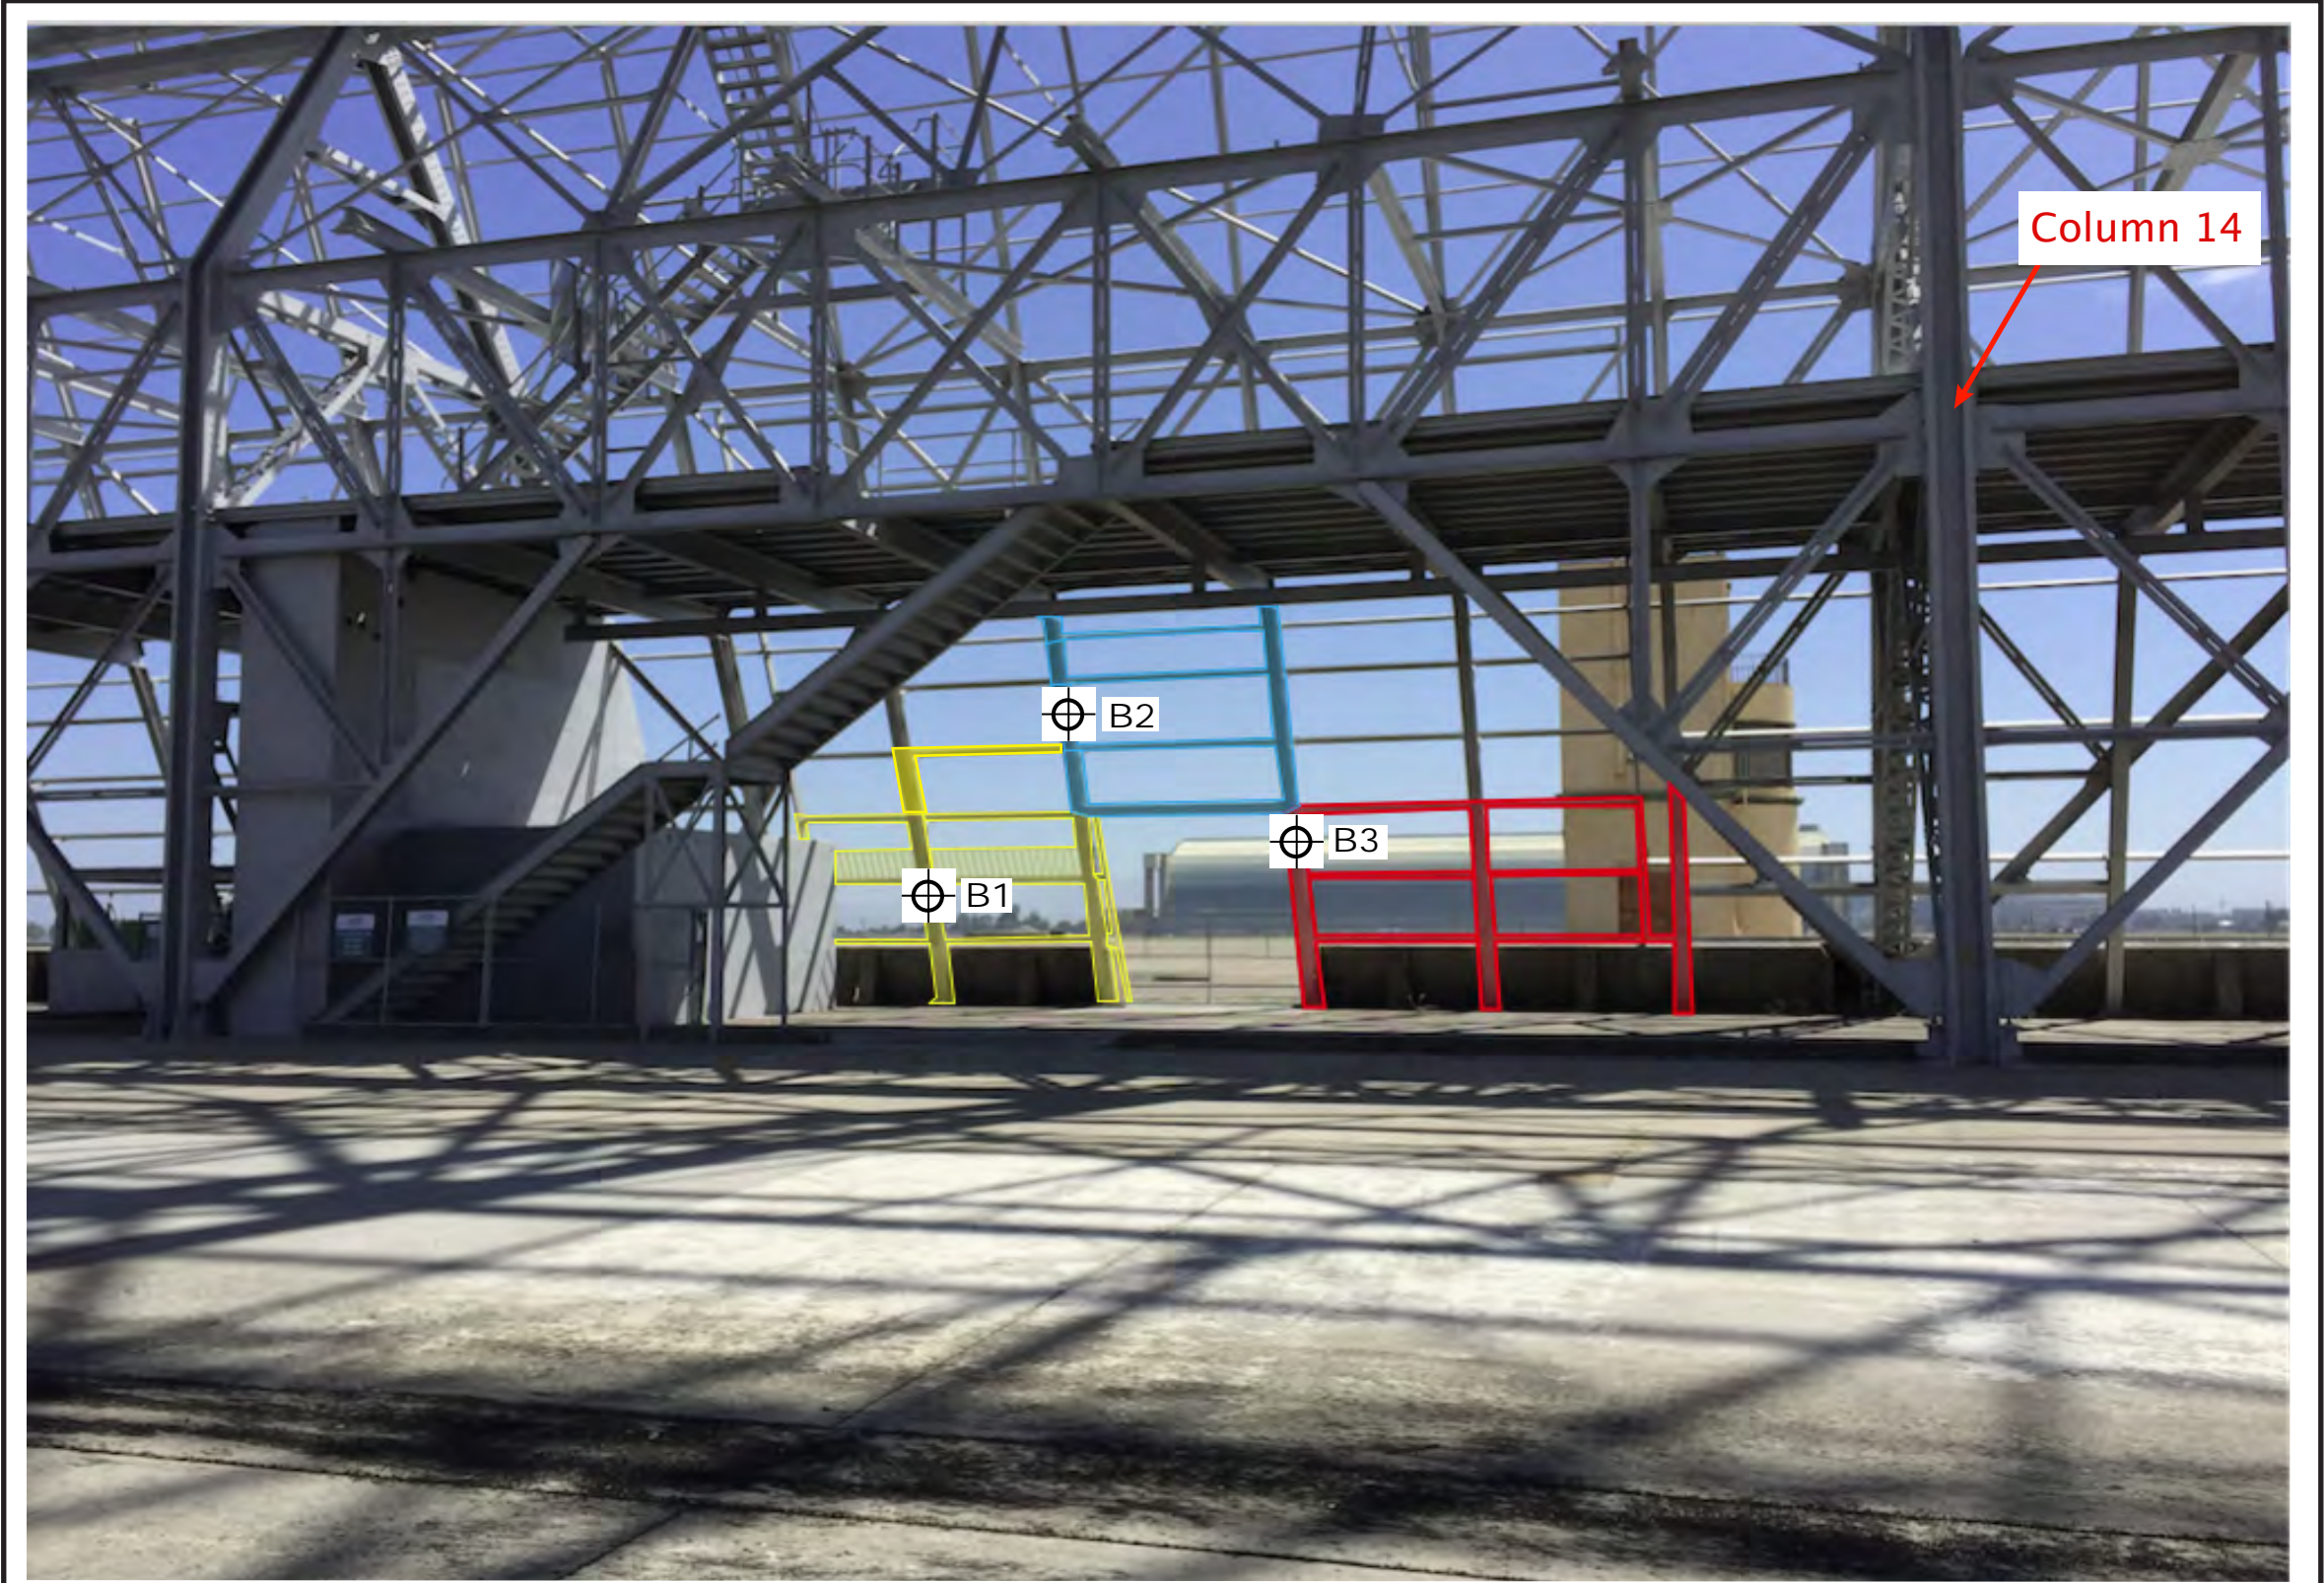
Figure E-1

Bulk Paint Sampling Locations and Results

Note: Lead and PCB Bulk Sampling Results Included as Tables E-1 and E-2 in this Appendix.

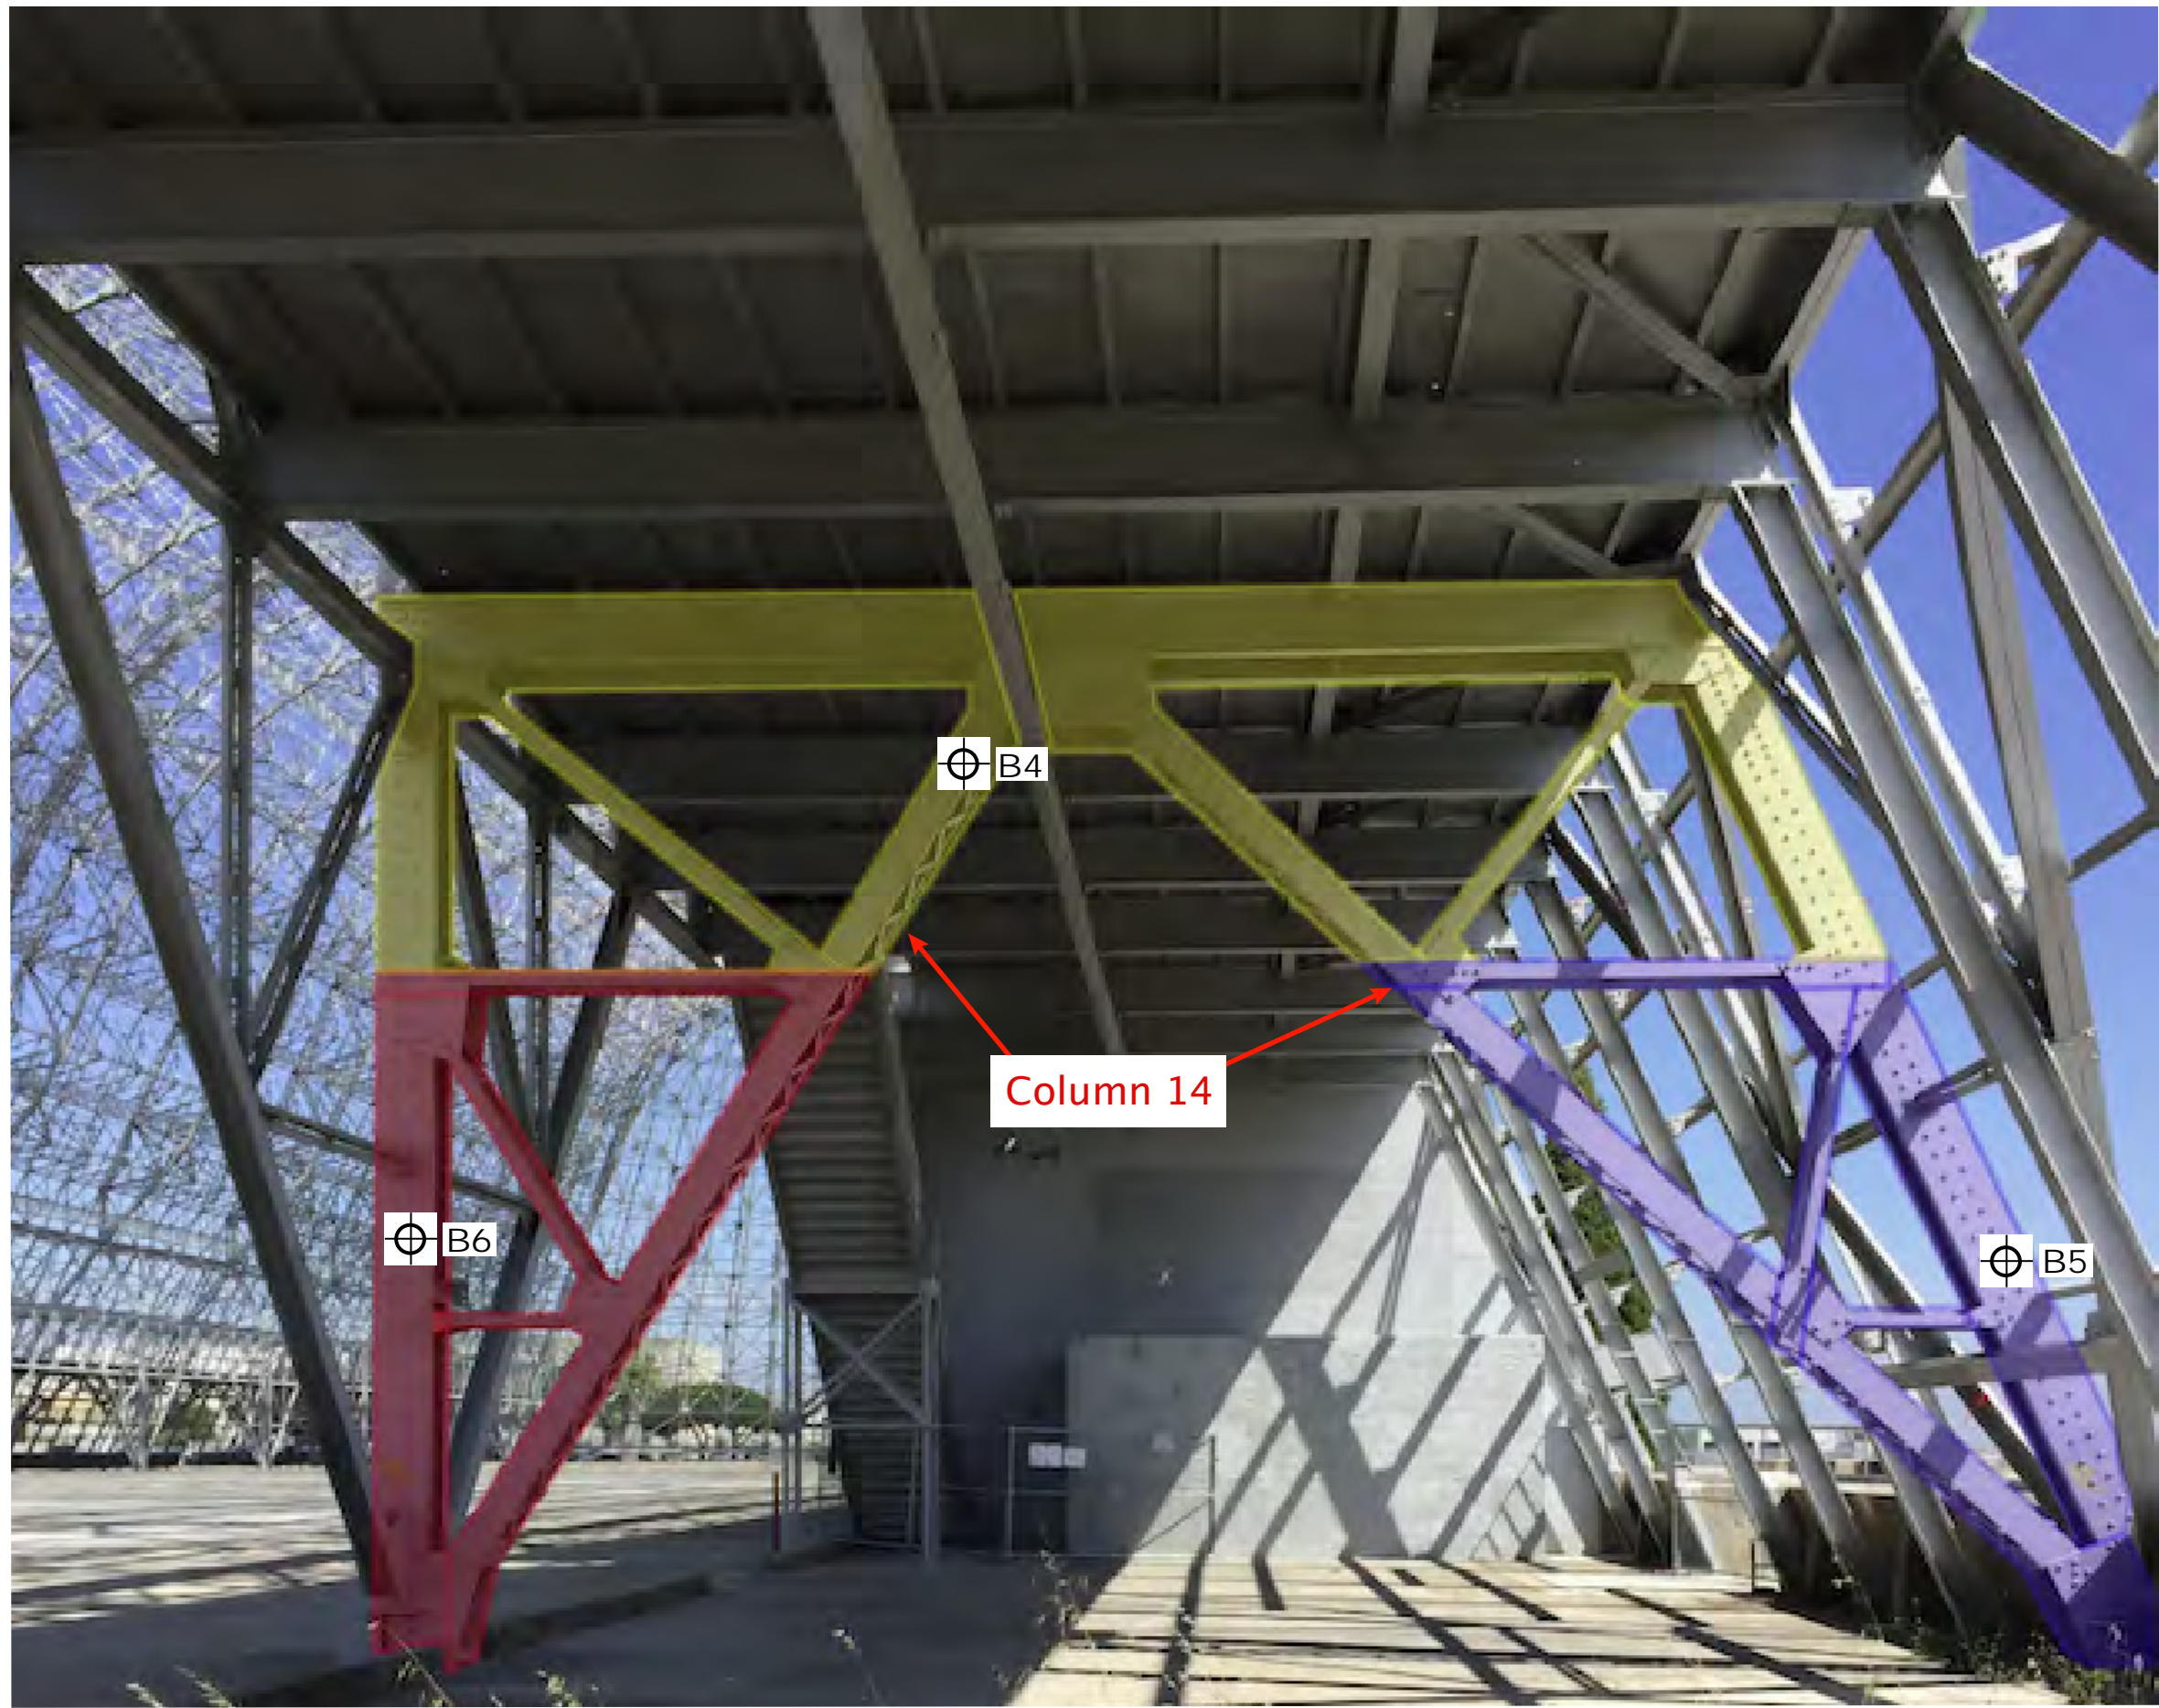
Figure E-2

Note: Lead and PCB Bulk Sampling Results Included as Tables E-1 and E-2 in this Appendix.

Bulk Paint Sampling Locations: Structural Steel Support Member		
Drawn By: NA	Date: 7/10/17	Project Number: 1591-011.01

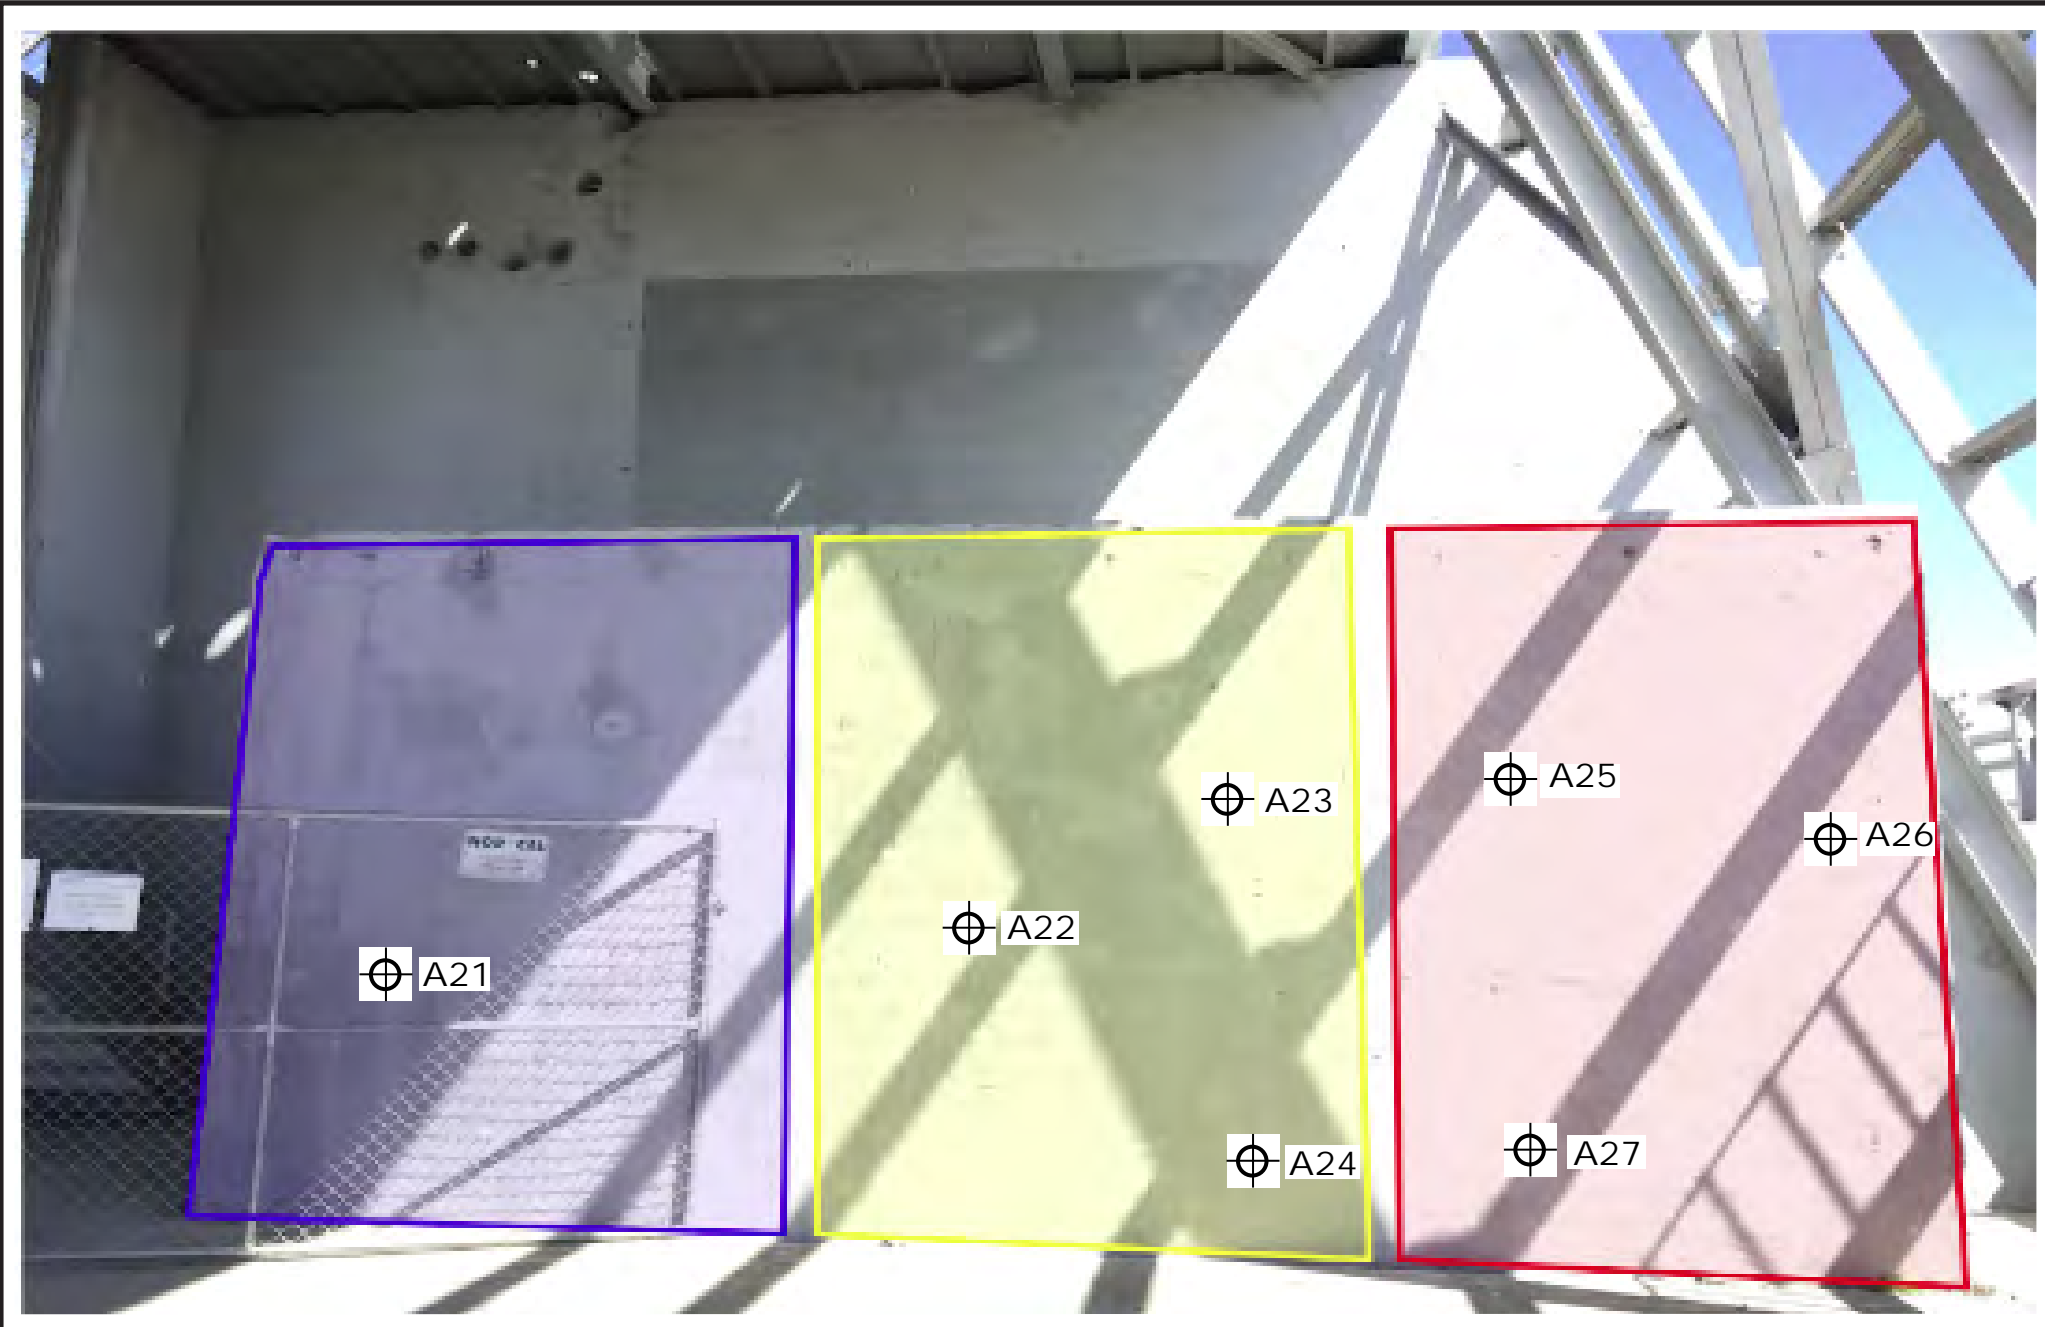
Figure G-2

Note: Lead and PCB Wipe Sampling Results Included as Tables G-1 and G-2 in this Appendix.
