MFA Hangar 3 Hazard
Remediation Section 106
Technical Report

SHPO# NASA_2019_1216_001

Moffett Federal Airfield,
Santa Clara County, California

May 11, 2020

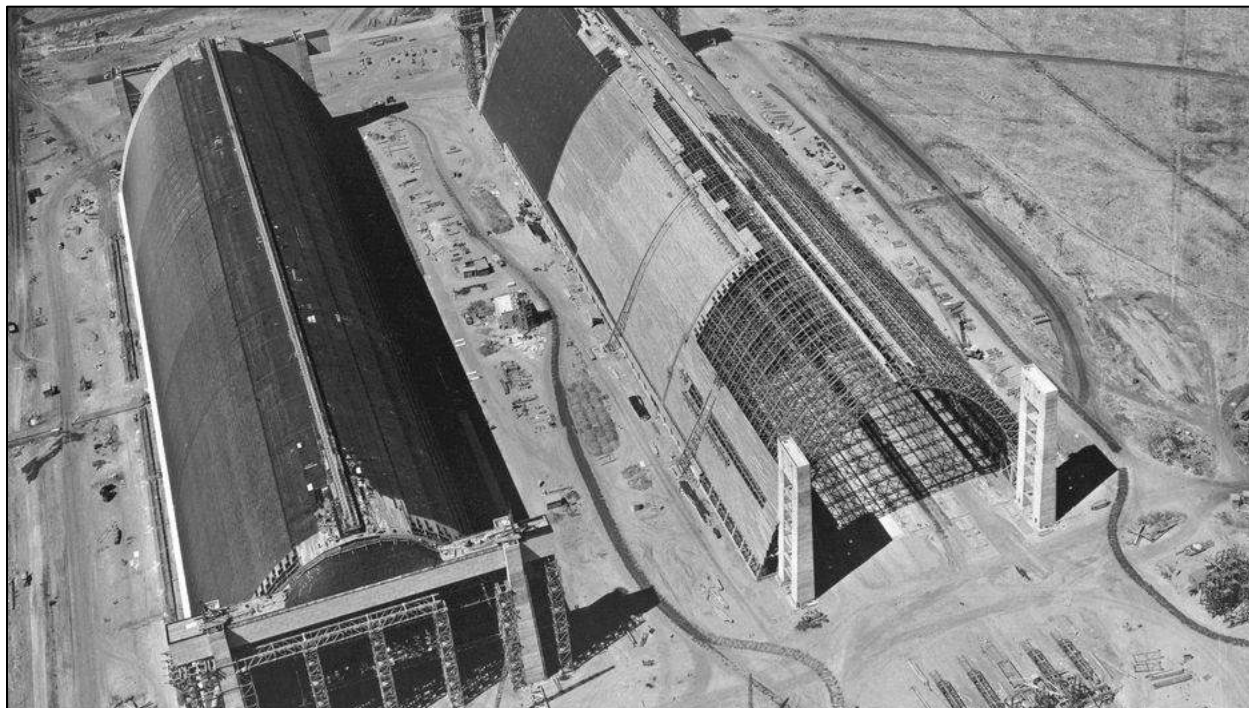
Figure 2: Ca.1943 aerial photograph showing Hangar 2 (left) and Hangar 3 (right) under construction. Source: Moffett Field Historical Society.

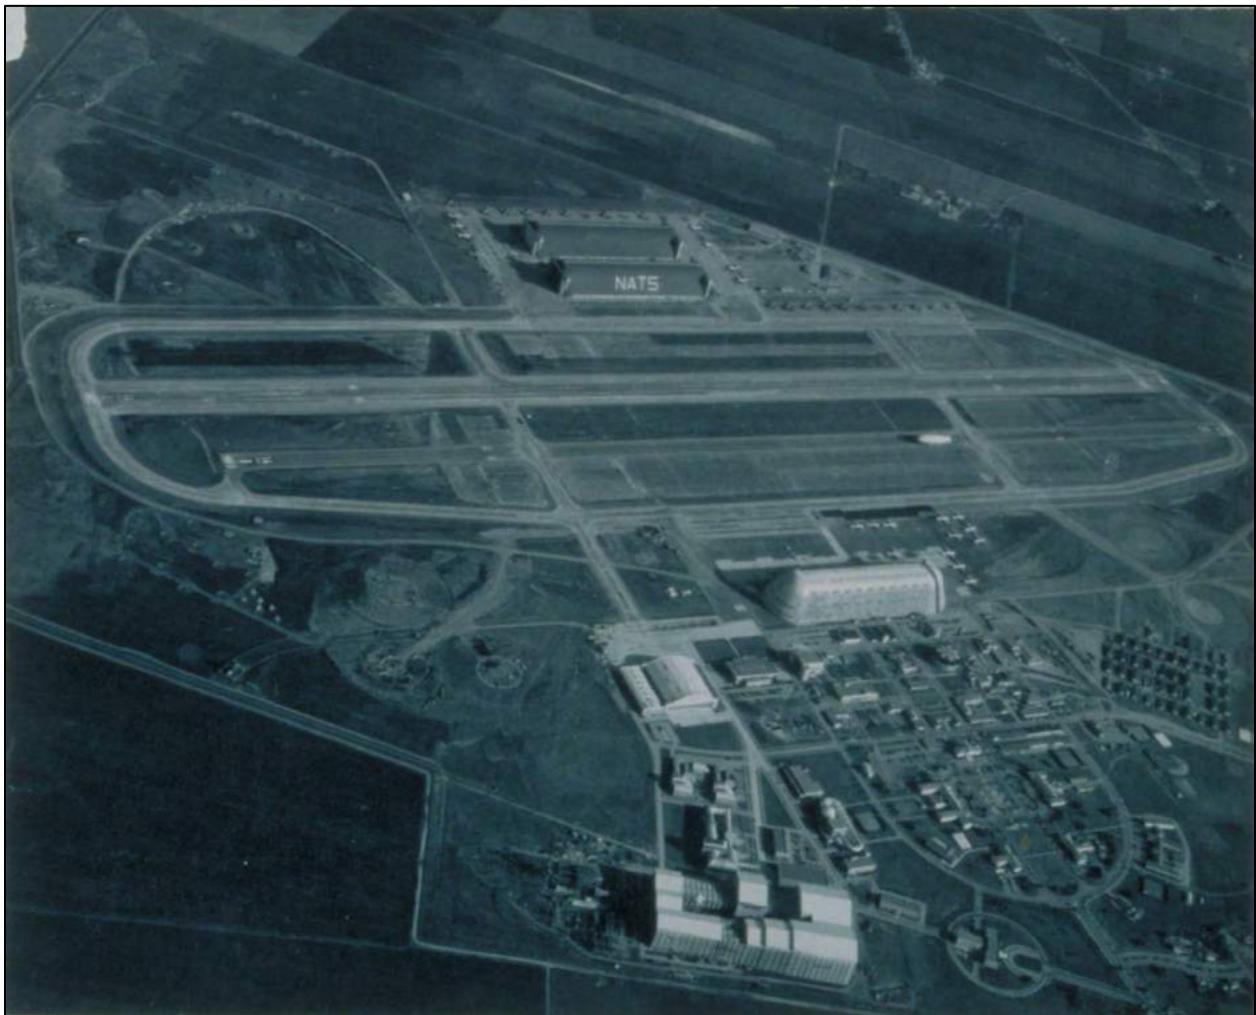
Figure 3: 1947 Aerial Photograph of MFA, looking southeast with Hangars 2 and 3 in the background. Source: Moffett Field Historical Society.

By the end of World War II in 1945, the LTA program was rendered obsolete, and MFA's mission returned to use of fixed wing aircraft. In 1947, the Naval Air Transport Service (NATS) utilized Hangar 3 for housing and maintenance of aircraft (**Figure 3**). With the outbreak of the Korean War, MFA supported several jet aircraft squadrons, which continued to operate at the airfield until 1961.

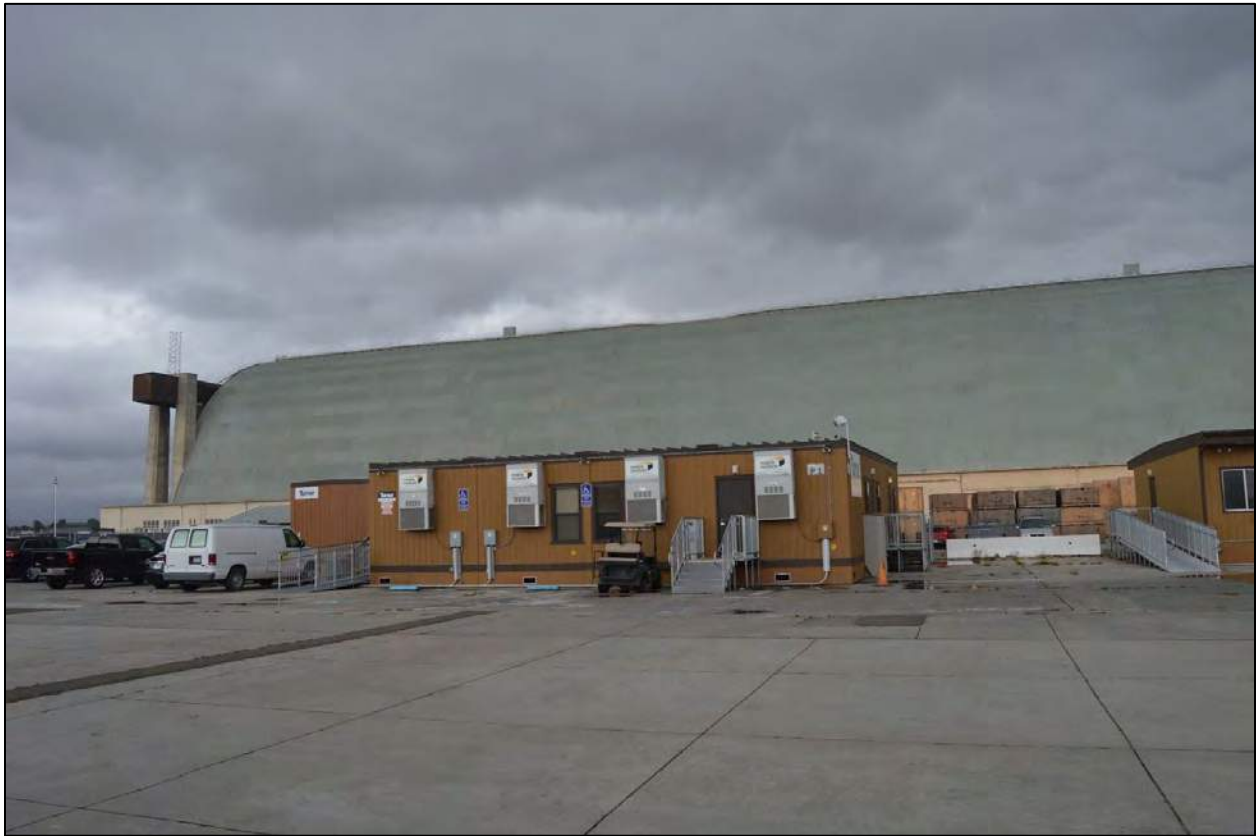
Photograph 1: East elevation of Hangar 3, looking southwest. Note the dip in the roofline at center, indicating the partial roof failure.

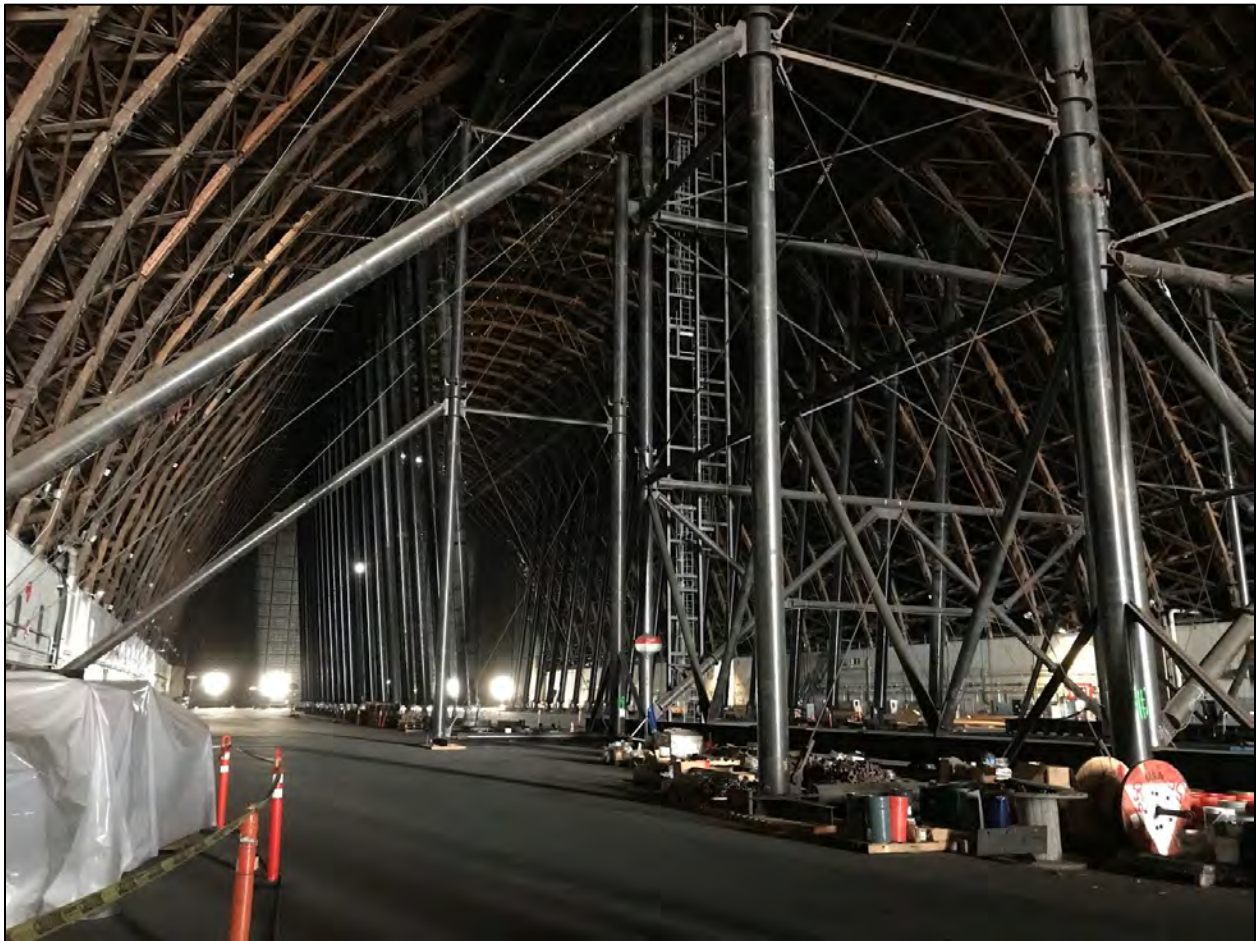
Photograph 2: Interior volume Hangar 3 showing the hydraulic jack system which runs the length of the main structure and the repair scaffolding deck at center.

- Installation of 17 steel exoskeletons (in between each truss from 9.5 to 25.5). The roof is currently supported by the steel exoskeletons, which are connected to the damaged trusses and jacking system.

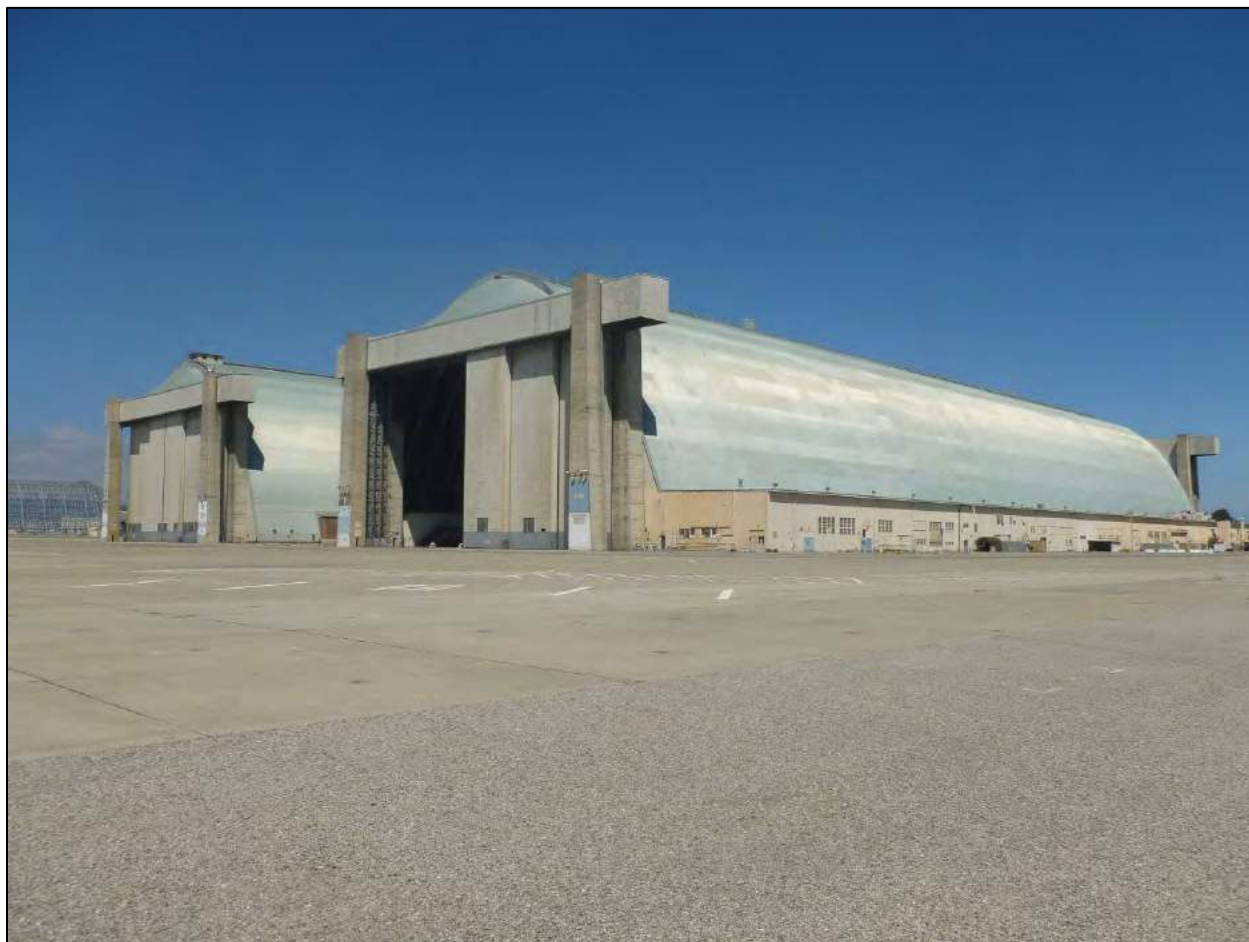
Photograph 4: South and east elevation of Hangar 3 with Hangar 2 in the background.

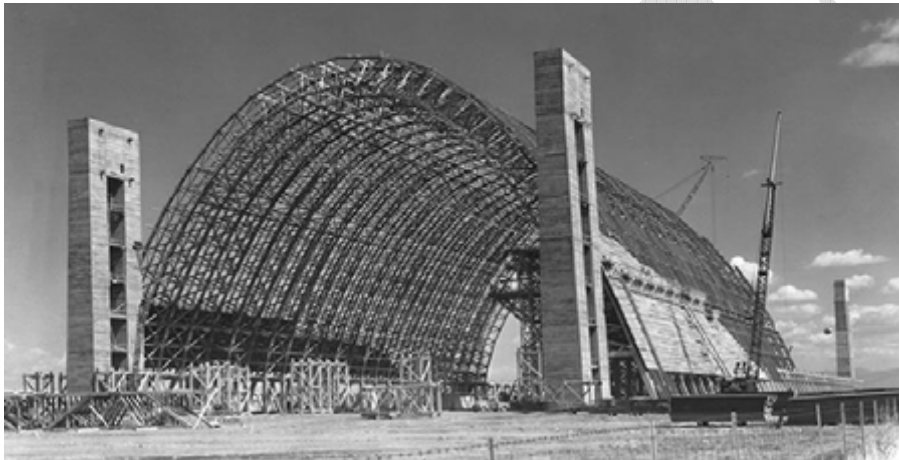
Figure 1. 1942 Hangar 2 Construction.

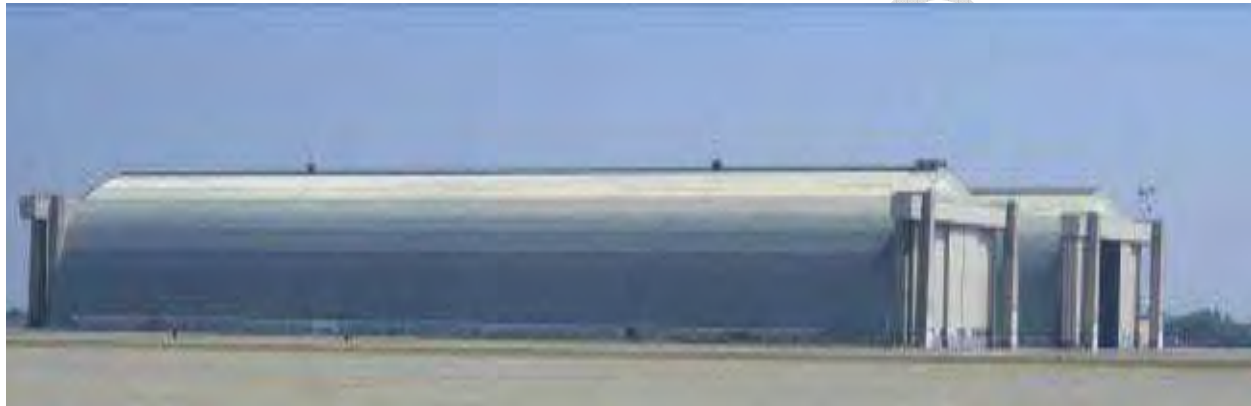
Figure 2. 2013 Hangar 2 (nearest hangar) and Hangar 3.

The doors at the north and south ends of each hangar consist of six aluminum and wood frame sliding panels. These doors are guided by rails on slab as well as through a transverse box beam spanning between two concrete towers. The box beam is a double-height wood truss sheathed with wood diagonal tongue and groove patterns. The box beam is approximately 20 ft square and cantilevers 20 ft beyond

each tower, as shown in Figure 2. The tower and box beam assembly are attached to the timber hangar through anchor bolts embedded into the concrete towers. The supporting structure for the hangar doors is a free standing structure and separated from the timber hangar by a gap separating the two structures. Similar to the concrete bents, the towers are supported on concrete pile caps and timber piles with an allowable load of 30 tons each. A total of 816 piles were used for all towers of a single hangar. The main footprint of both hangars is approximately 296'6"x1000'. A two-story annex building measuring 62'x1000' was added to the east side of Hangar 3 in 1945 for additional office and shop space.

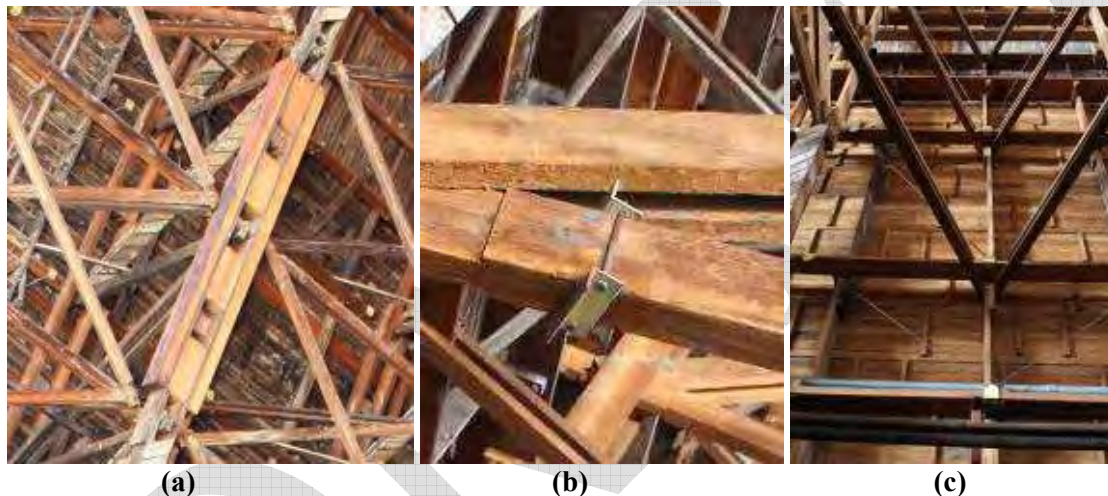
Figure 3. Retrofit techniques observed throughout Hangars 2 and 3 (a) Strengthening of arch chords by addition of glulam bypass members (b) Clamps and stitch bolts to close small cracks (c) Replacement of wood sag braces with steel cables and bolts.

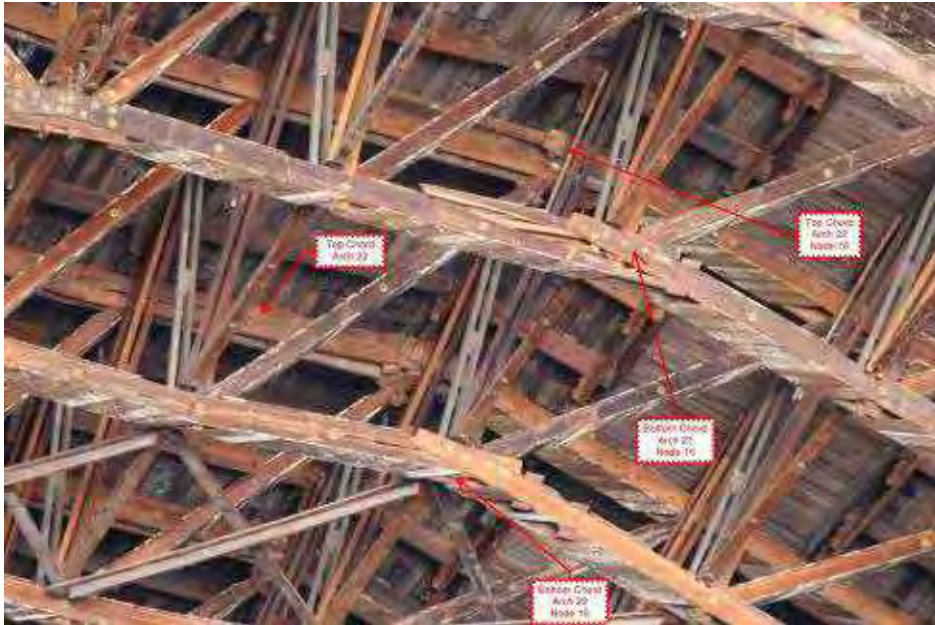
Figure 4. Observed cracks and distortion of the timber arch bottom and top chords in Hangar 3.

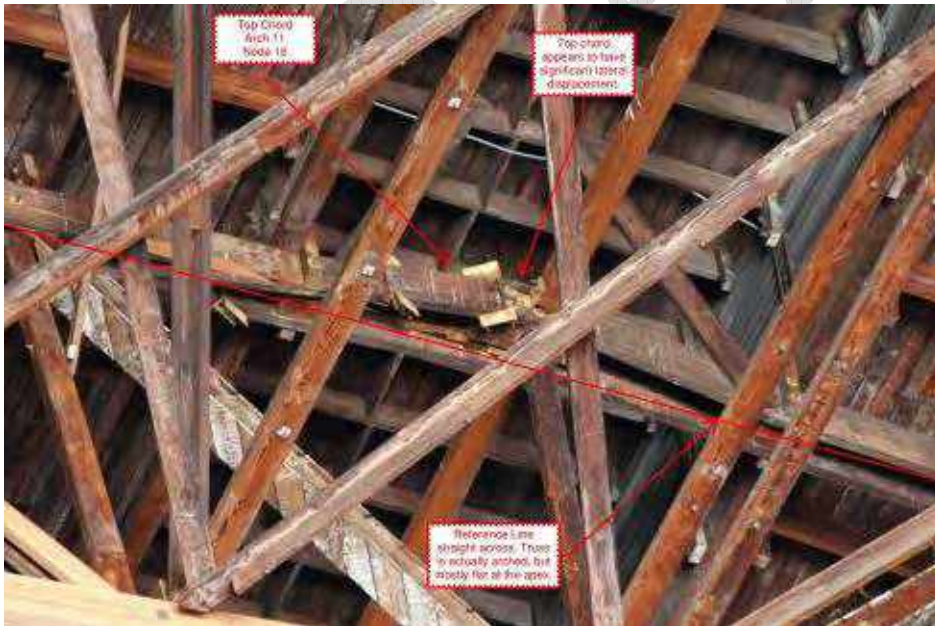
This general observation is emphasized in Figure 5 with the relative lateral displacement between the apex of the arch and a theoretical reference line connecting adjacent arch nodes. Similar results are also displayed in Figure 6 for the top chord of arch 18.

Figure 5. Relative lateral displacement between arch apex and reference line for Hangar 3 single arch.

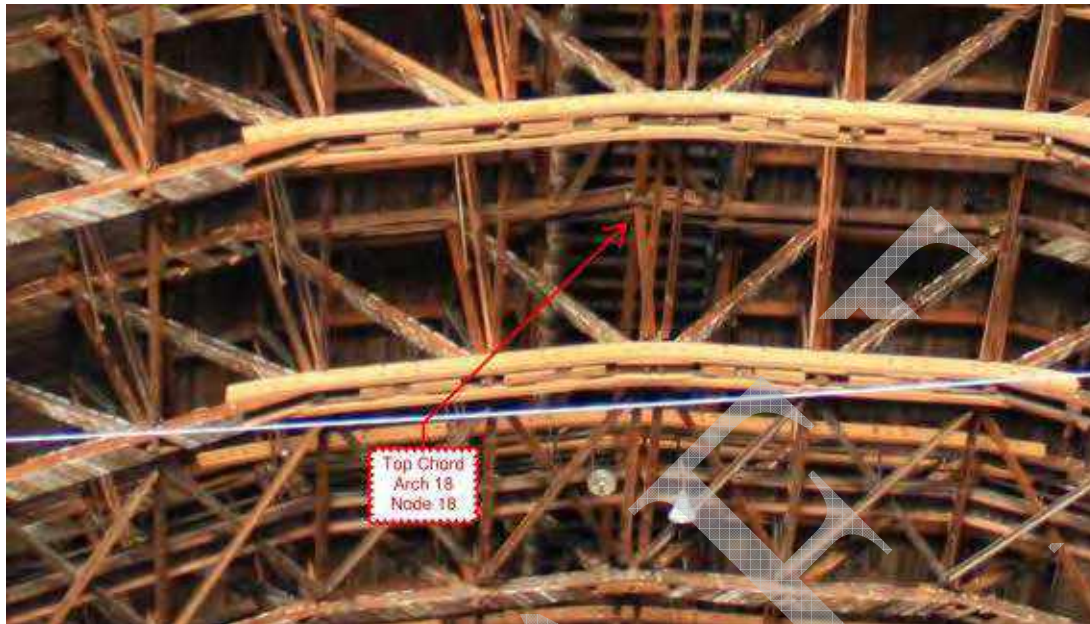
Figure 6. Observed cracks and lateral displacement of arch top chord in Hangar 3.

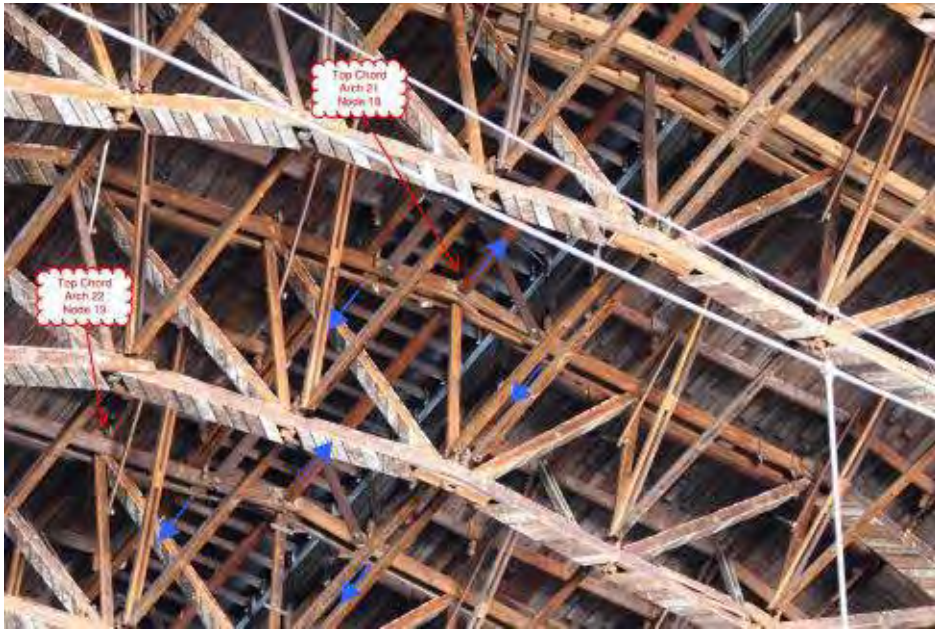
In addition, it was observed that the apex of numerous arches contain a consistent trend of node 18 displacing relative to the adjacent nodes supporting the monitor (exterior protrusion of the hangar at the apex outer chord). This is displayed in Figure 5 for arch 11, Figure 6 for arch 18, and Figure 7 for arches 21 and 22. The latter contains blue sketch-up arrows displaying the relative lateral displacement of the nodes, where node 18 appears to display south. It is unknown whether or not if all of the observed cracks and distortions propagated from the 1995 retrofits or if their origin emanated within the past couple of months.

Figure 7. General trend of relative lateral displacement at the arch apex top chord in Hangar 3.

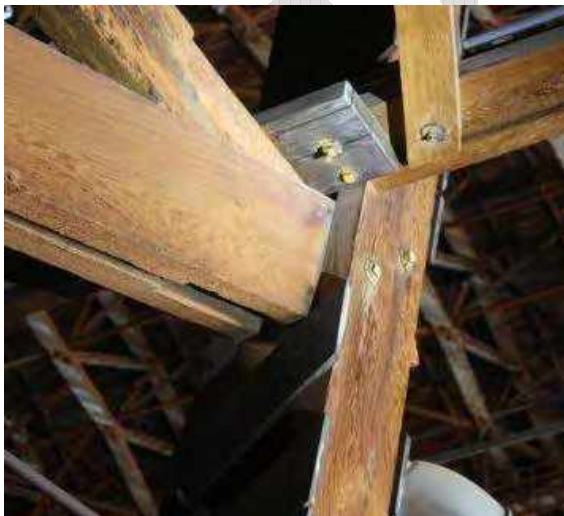
Figure 8. Example location of end split in cross brace member within Hangar 2.

Hangar 2 did not have the extent of distress as seen in Hangar 3. There was only one location where the main arches were strengthened by glulam bypass members. This location was on arch line 14 and between nodes 28 and 30. The only visual signs of distress were observed through end splits of cross braces, as shown in Figure 8. This distress was common at locations where the fasteners were too close to the end grains.

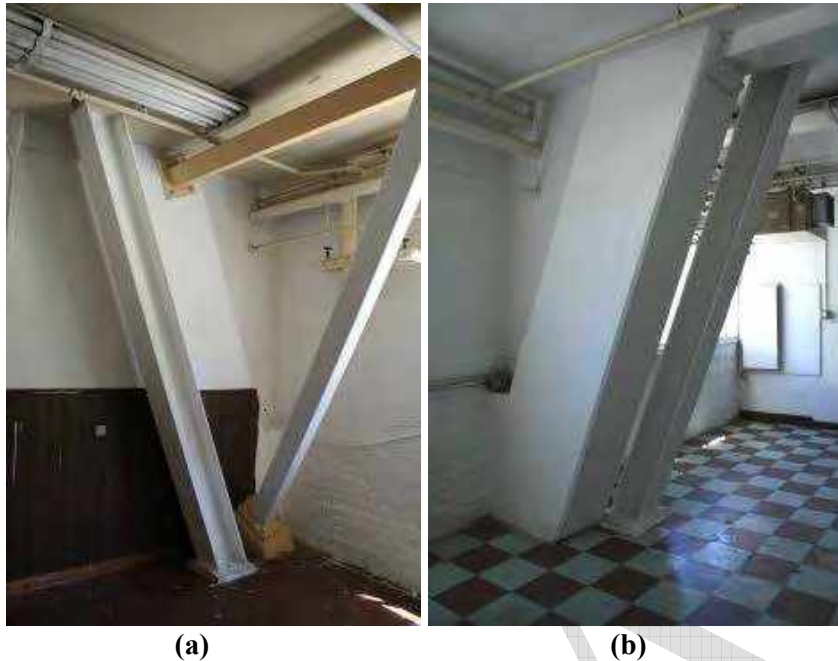
Turnbull (2006). However, wide flange steel shapes were also observed for additional reinforcement of the concrete bents in the strong axis, as shown in Figure 9.

Figure 9. Hangar 2 office space retrofits (a) Longitudinal HSS and Lateral I-Shape bracing (b) Lateral I-Shape and HSS bracing.

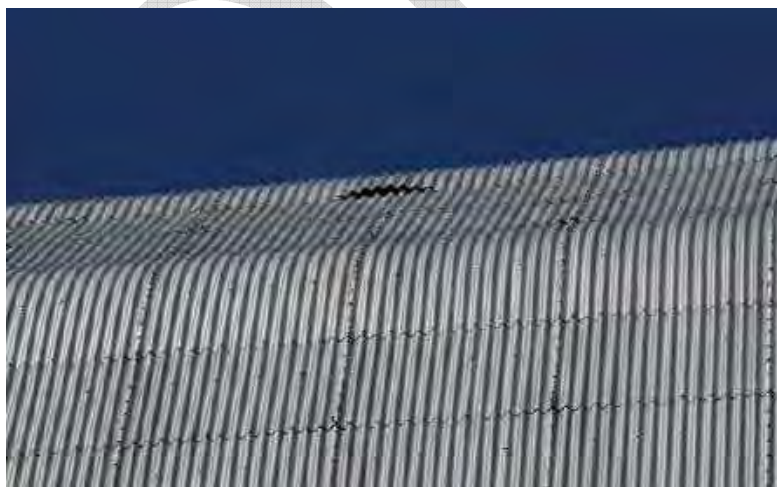
While on the recent site visit, it was also observed that the doors on the southwest corner of Hangar 3 were open while all other doors between both hangars were closed. Therefore, future observations must verify if the doors are operable. In addition, the existing corrugated aluminum sheathing was detached at various locations along the roof of Hangars 2 and 3, as shown by example in Figure 10.

Figure 10. Example location of detached corrugated aluminum sheathing on roof exterior of Hangar 2.

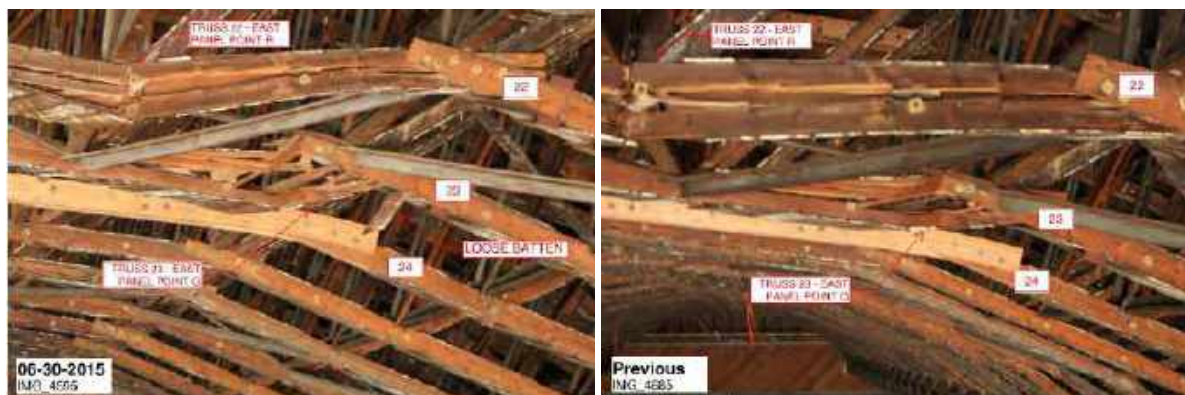
Figure 1. Truss damage progression at Trusses 22 and 23 East near Panel Points R and O.

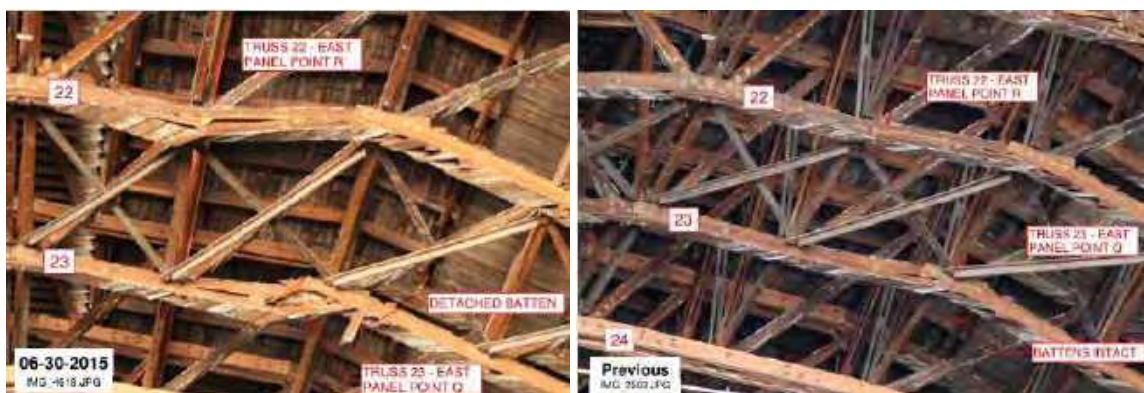
Figure 2. Truss damage progress at Trusses 22 and 23 East near Panel Points R and Q.

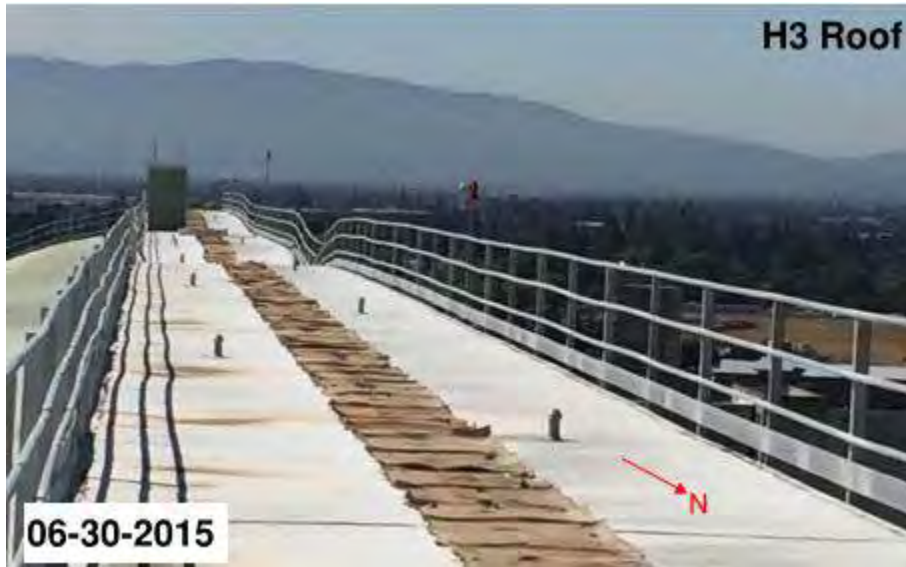
Figure 3. Damage observable at ridge line from building exterior.

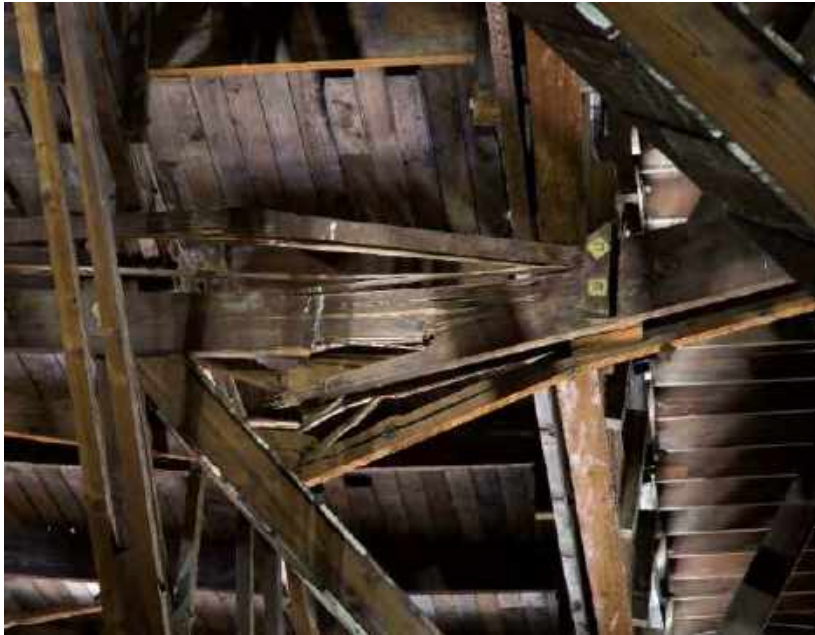
The following photos (Figure 5, Figure 6) demonstrate the severity of existing damage and the immediate danger of partial structure collapse.

Figure 5. Broken top chord near roof monitor at top of truss

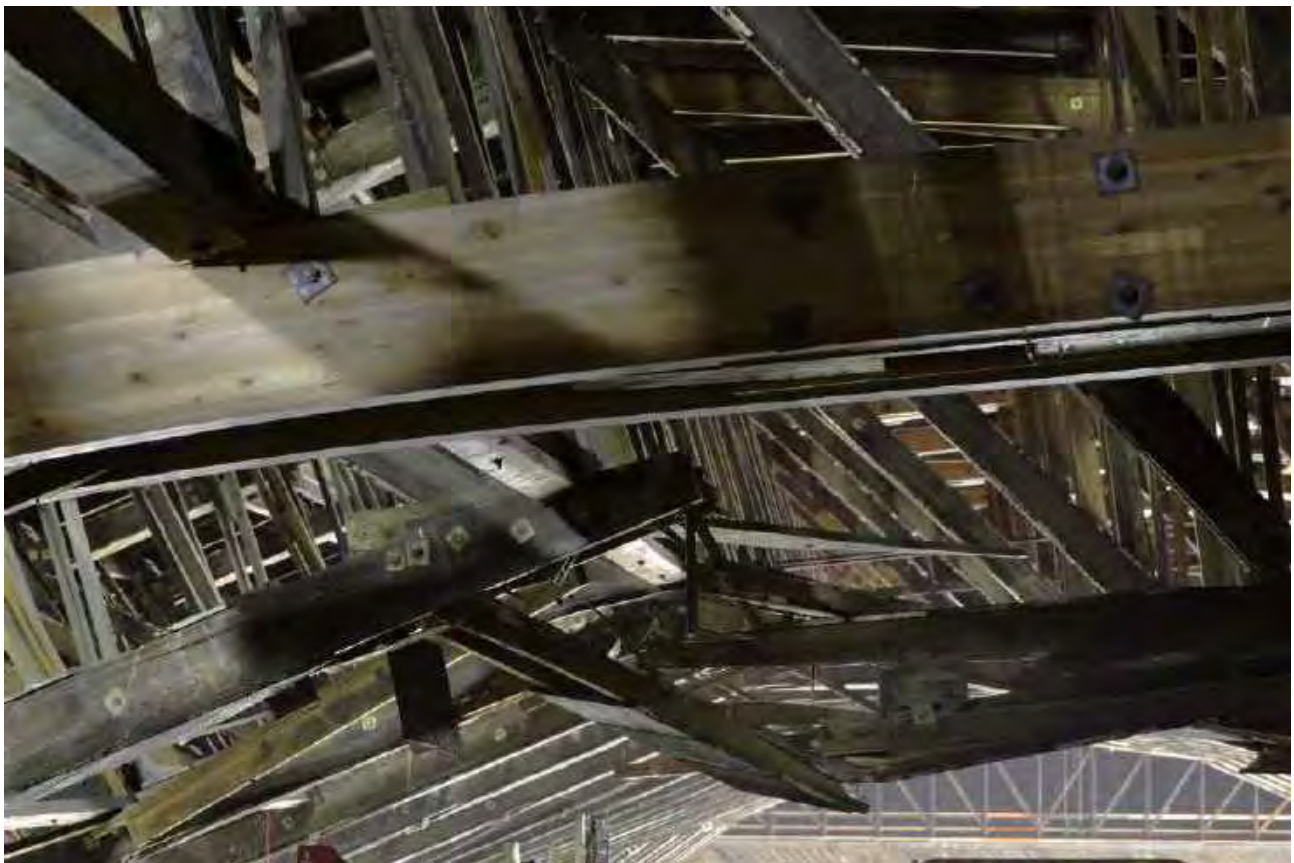
Figure 6. Broken bottom chord near top of truss.

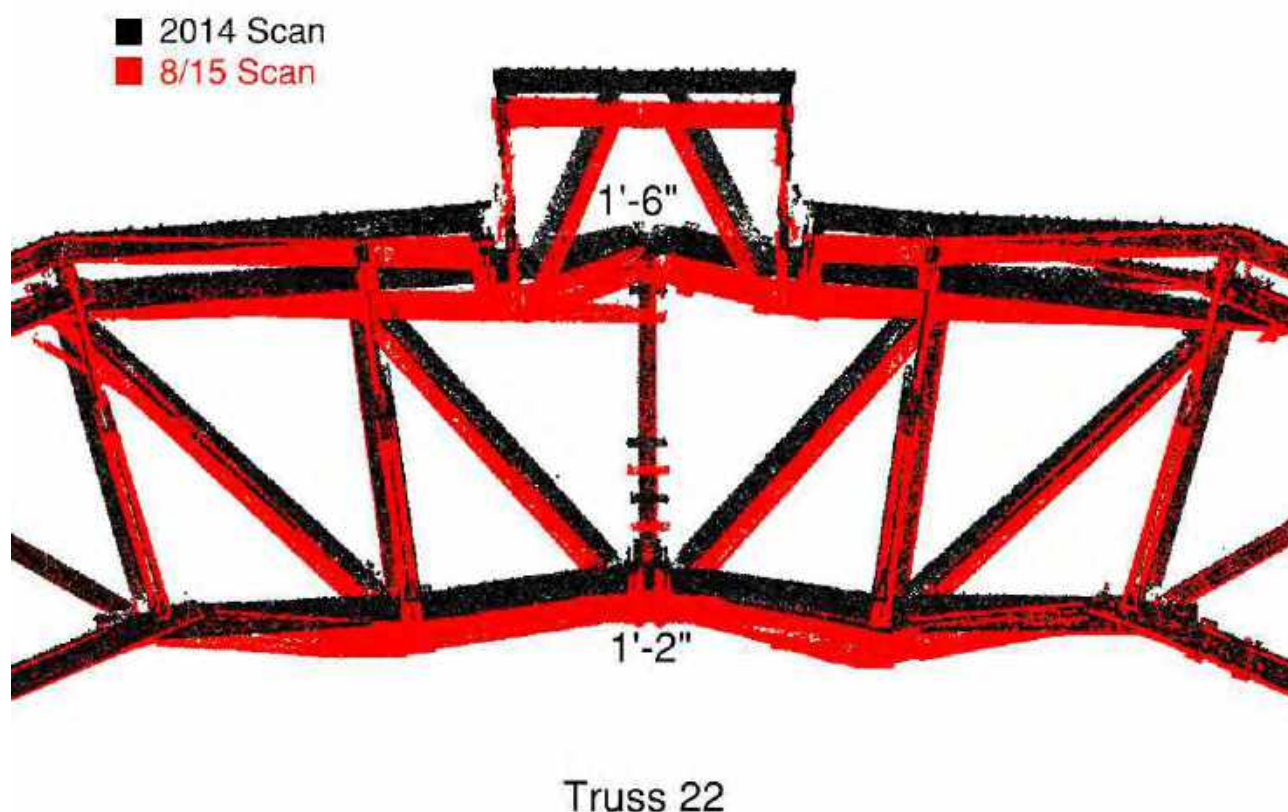
Quantitative measurements of the truss deflections were taken from successive point cloud surveying of the hangar interior. The damage progression is shown in an example processed image from the 3D point cloud scans taken in 2014 and 2015 (Figure 7). In that figure, the black portion represents the actual position of Truss 22 between Panel Points Q-West and Q-East in 2014, while the red portion shows the position in August 2015. The measurements on the image show the increase in downward deflection between the surveys. A summary of deflections at Panel Point S indicate zones of damage concentration (Figure 8).

Figure 7. Approximately 18" of additional deflection observed between 2014 and 2015 point cloud surveying scan at top of truss.

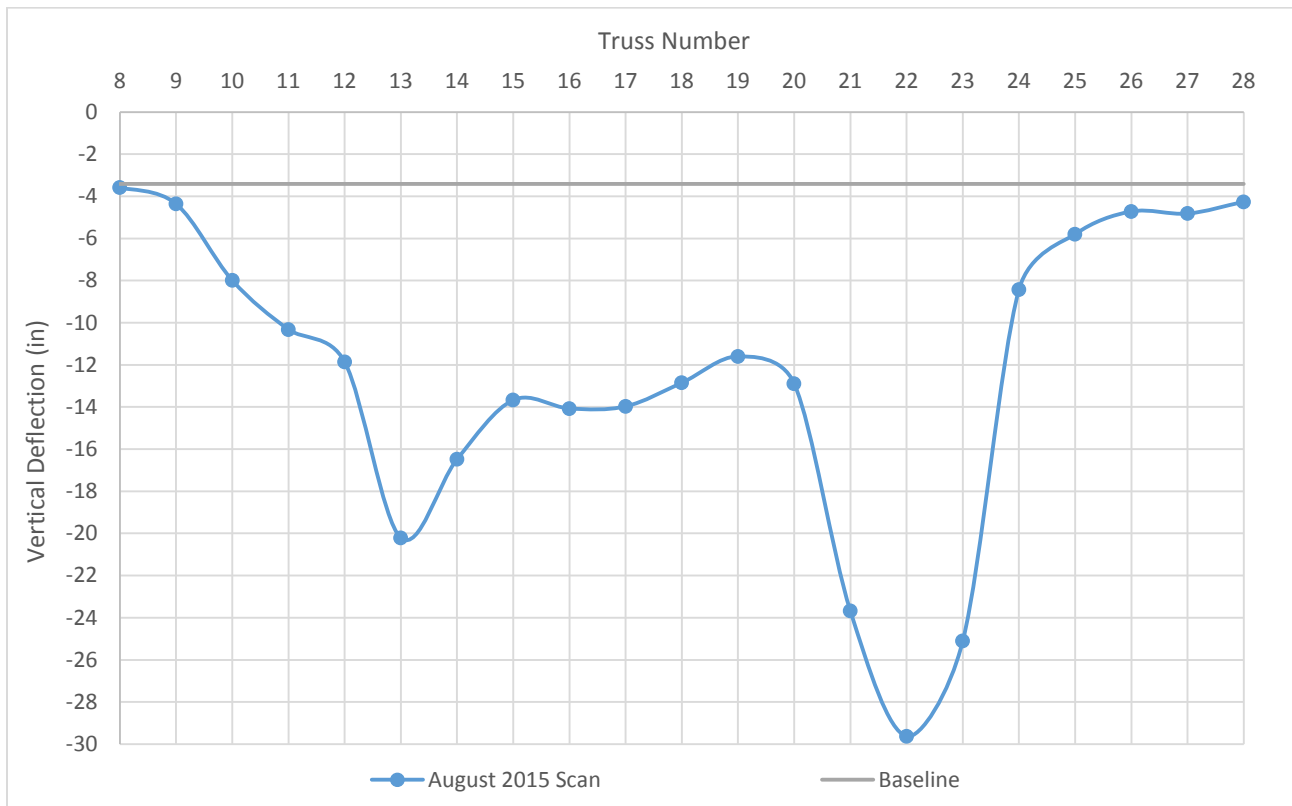
Figure 8. Deflections relative to baseline at Panel Point S.

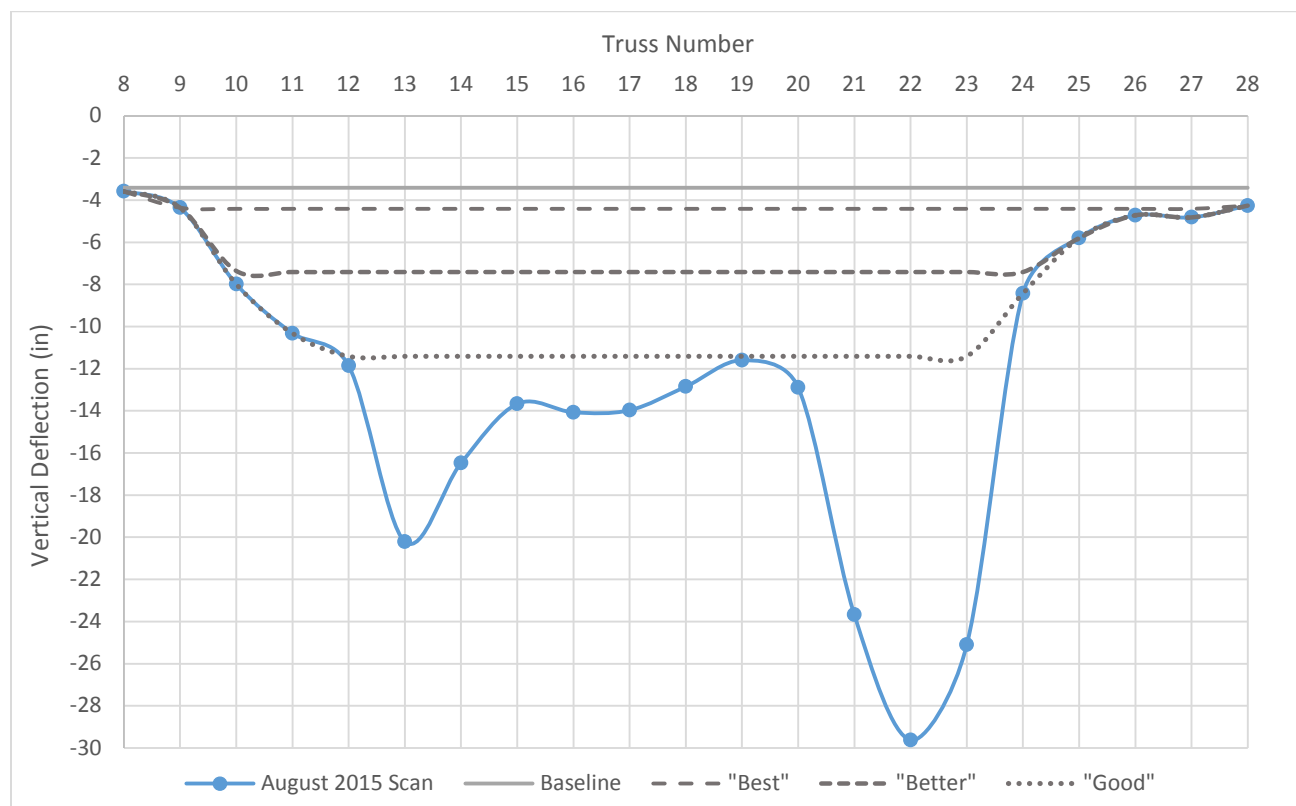
Figure 9. Hangar 3 Panel Point 18 Deflection with Deflection Criteria Options

Table 1. Deflection criteria options considered.

Good	Better	Best-A	Best-B
Truss and Roof Framing Maximum Deflection Relative to Average "Undamaged" Truss Elevation	± 8"	± 4"	± 1"	± 1"
Truss and Roof Framing Deflection Relative to Adjacent Trusses	± 4"	± 3"	± 2"	± 2"
Roof Monitor Deflection between Adjacent Trusses	± 4"	± 3"	± 2"	± 2"
Exoskeleton Locations	Trusses 11.5–23.5	Trusses 9.5–24.5	Trusses 9.5–25.5	Trusses 8.5–26.5
Number of Exoskeletons	13	16	17	19
Number of Exoskeleton Jacks	104	128	136	152
Number of Bays Where Jacking from the Shoring Tower is Required	0	0	3	1

The selected emergency repair strategy is best for preservation because we are achieving the best restoration of the hangar ridge line deflection with the intent of replacing damaged truss members in-kind with timber similar to the original truss configuration. The project team decided to pursue the “Best” deflection criteria which targets restoration of the truss and roof framing nearest to the average “undamaged” truss elevation. In the event that “Best” is unachievable due to field conditions, a lesser criteria can still be achieved which is acceptable from a structural and architectural standpoint.

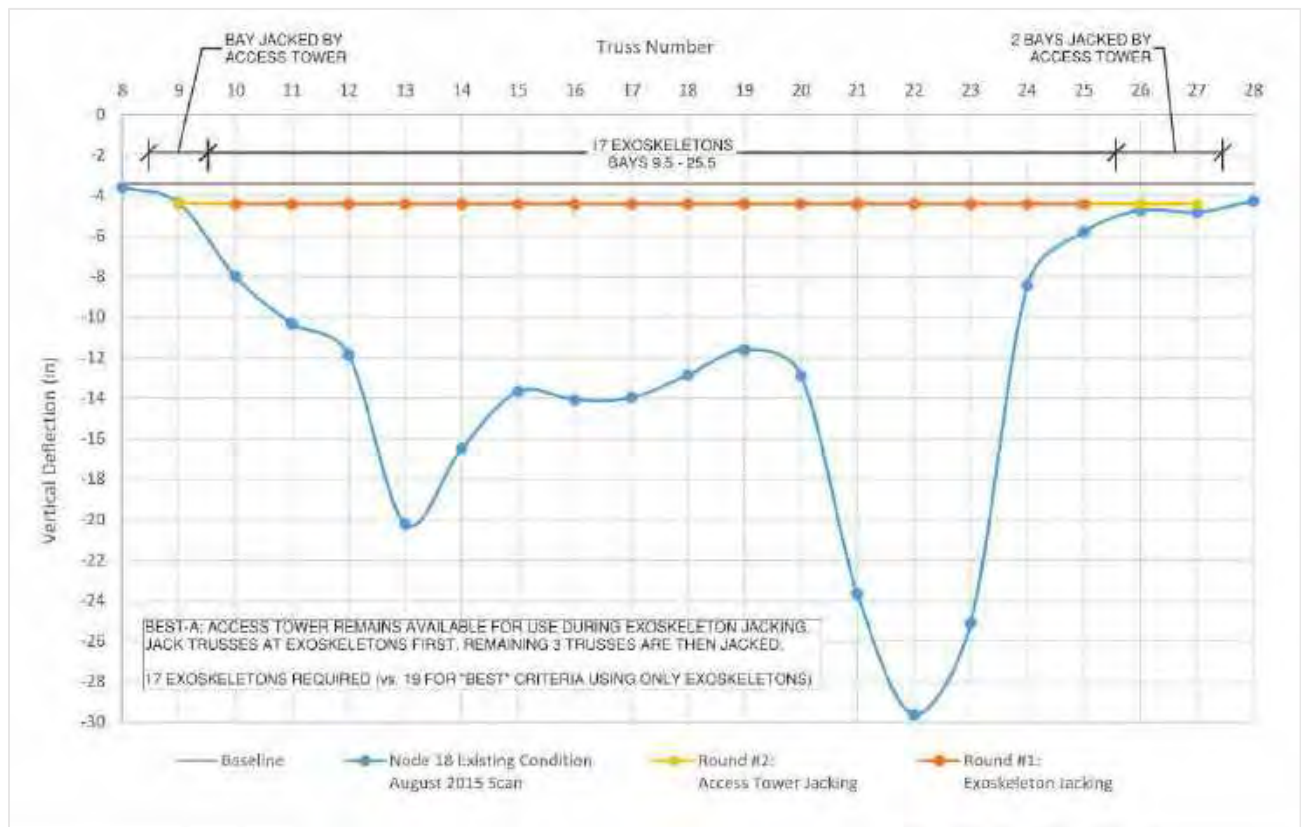
Figure 10. “Best-A” Target Deflection Criteria

Two options were studied by the design and construction team for the “Best” criteria. The difference between the two options is the sequence of construction and amount of Exoskeletons and jacks required. The first scenario (Best-A) utilizes both the access shoring tower and the Exoskeletons for jacking. Sequentially, the jacking at the trusses with the Exoskeletons are performed first, and then the shoring tower is moved to the ends of the severe damage zone to access the final 3 trusses (see Figure 10). In this scenario, an additional four Exoskeletons are required relative to the “Good” criteria.

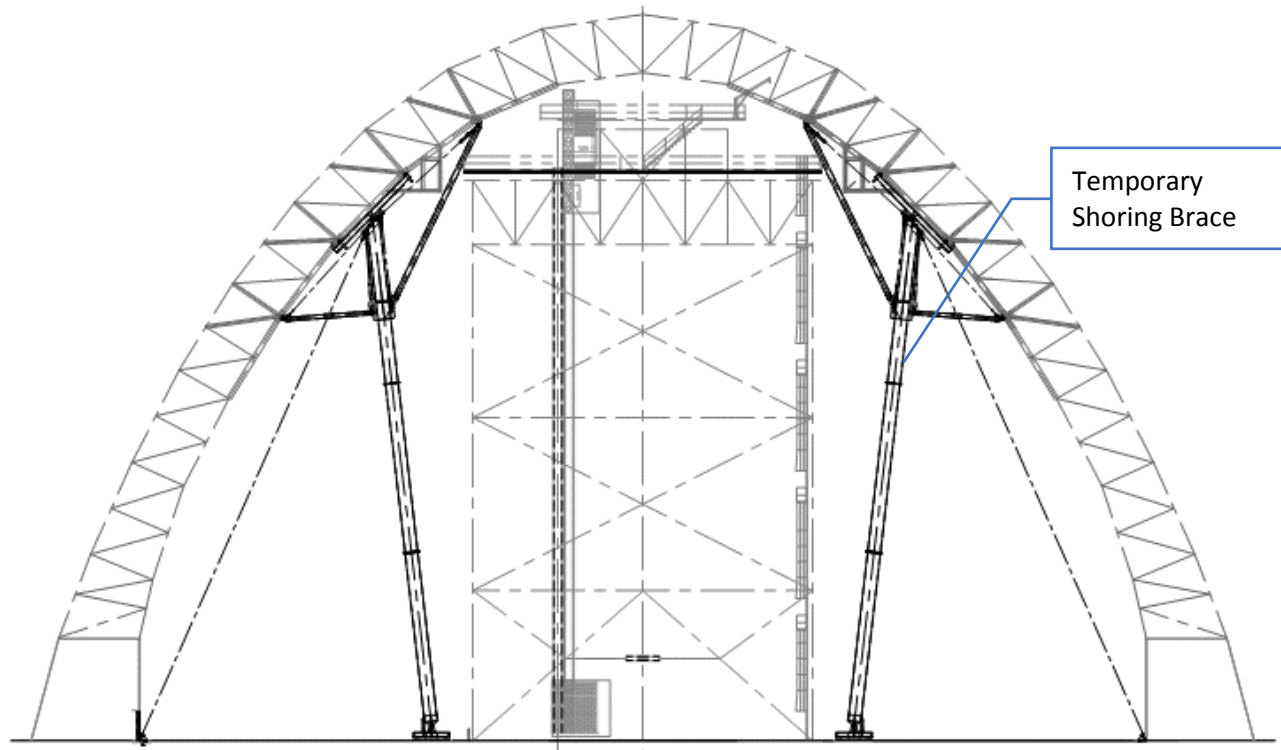
Figure 11. Temporary Shoring + Shoring Tower

Step 1: Install temporary shoring braces to prevent full collapse of hangar (Figure 11 and Figure 12). The upper portion of the hangar remains unsupported and local damage progression and partial collapse of the upper zone is still possible.

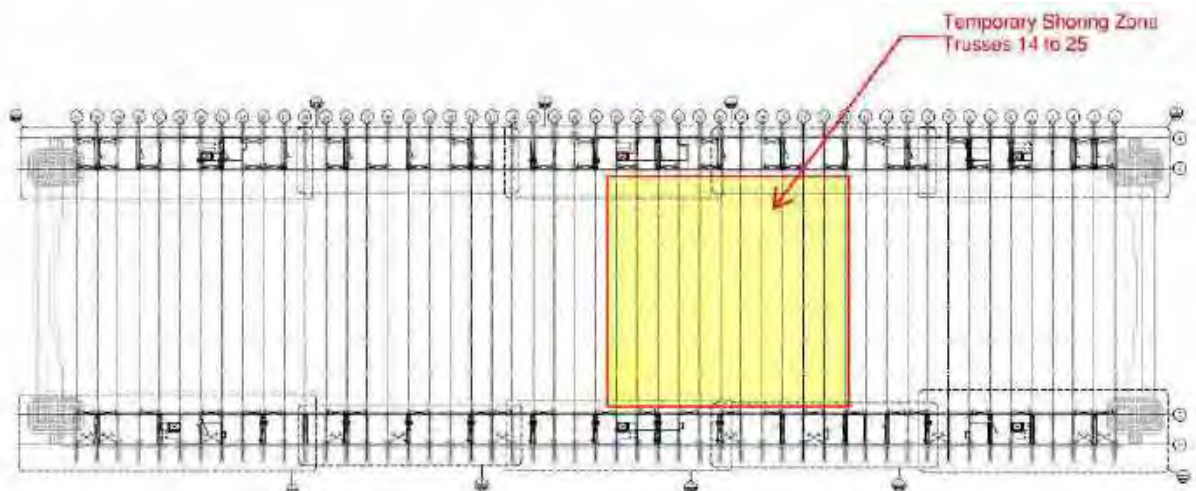
Figure 12. Zone of temporary shoring.
