MFA Hangar 3 Hazard
Remediation Section 106
Technical Report

SHPO# NASA_2019_1216_001

Moffett Federal Airfield,
Santa Clara County, California

May 11, 2020

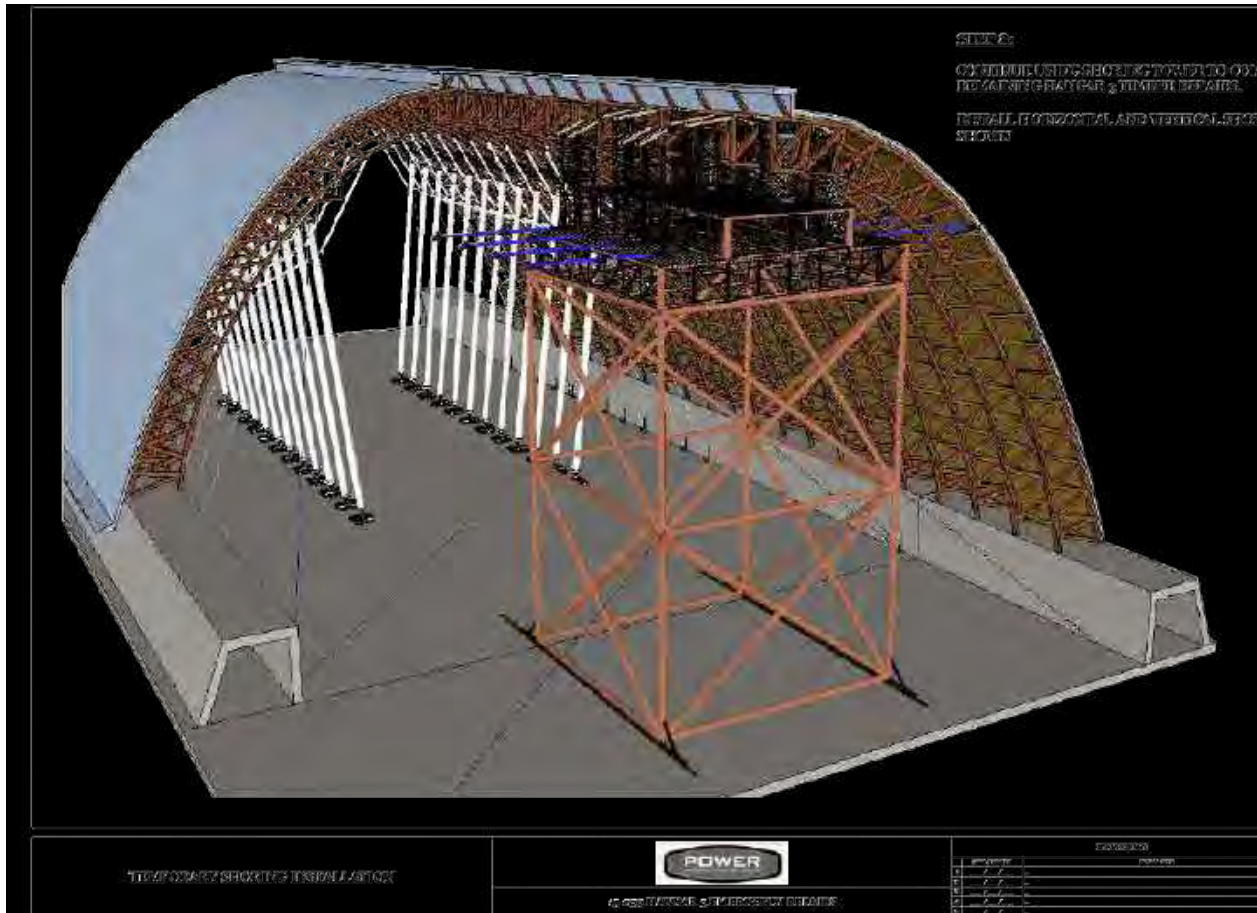
Figure 13. Isometric of Temporary Shoring & Shoring Tower

Step 2: Fabricate shoring tower and move shoring tower into the hangar to begin temporary support of the upper zone, and installation of support “Exoskeletons”. A computer rendering by Power Engineering Construction of these pieces is shown in Figure 13.

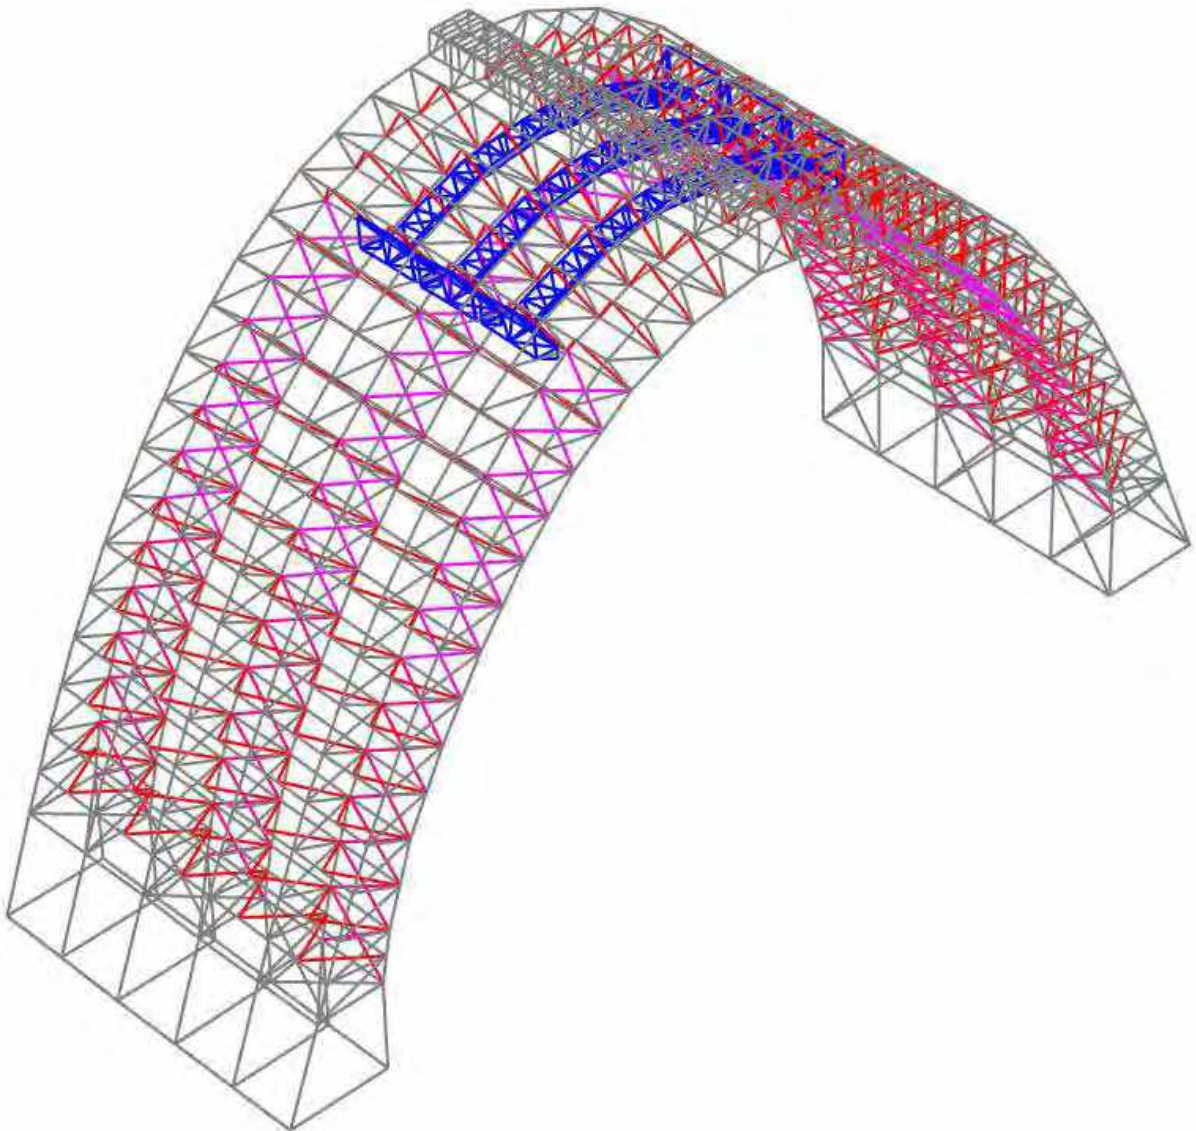
Figure 15. 3D Isometric of Exoskeletons Installed between Existing Wood Trusses

- Installation of 17 steel exoskeletons (in between each truss from 9.5 to 25.5). The roof is currently supported by the steel exoskeletons, which are connected to the damaged trusses and jacking system.

Step 4: Jack existing gravity framing from Exoskeletons to take gravity load off of the existing trusses and restore roof profile as close as possible to its undamaged state.

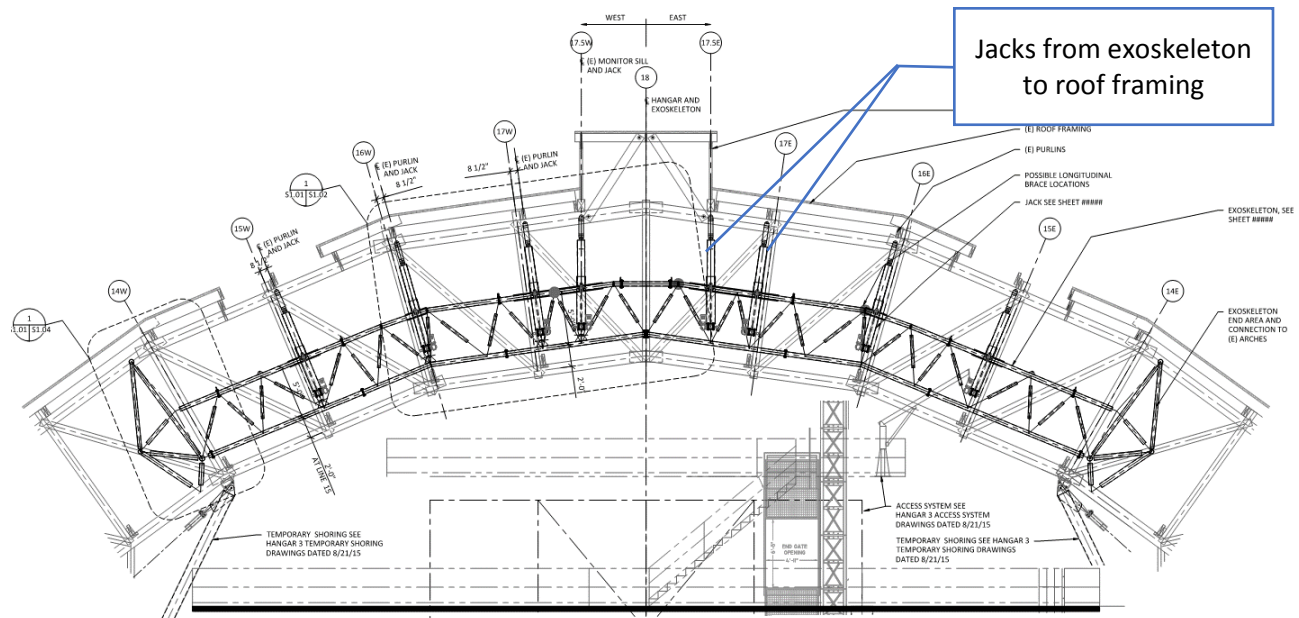
Figure 16. Exoskeleton Elevation (Preliminary Drawings)

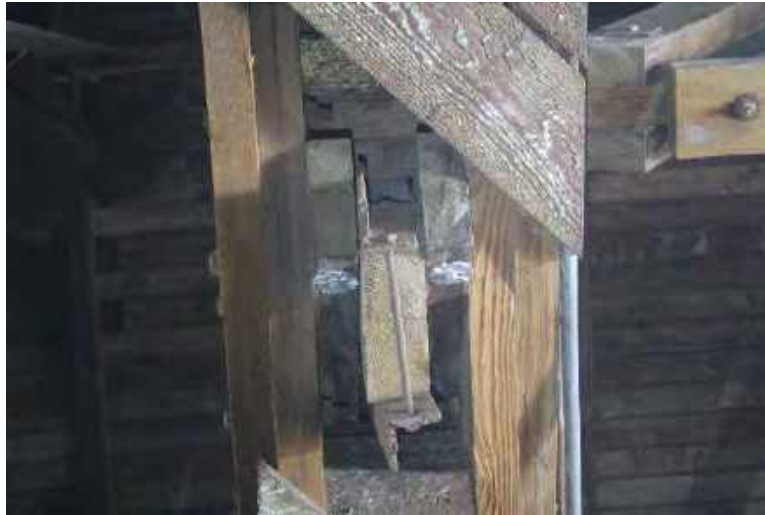
Figure 17. Example of new minor connection strengthening stitch bolts adjacent to existing angle clamp.

Permanent minor connection strengthening consists of stitch bolts at wood arch truss connection ends, and clamps at splits along the lengths of members (Figure 17). These have been installed in areas which require strengthening as part of the jacking sequence and emergency truss repair installation.

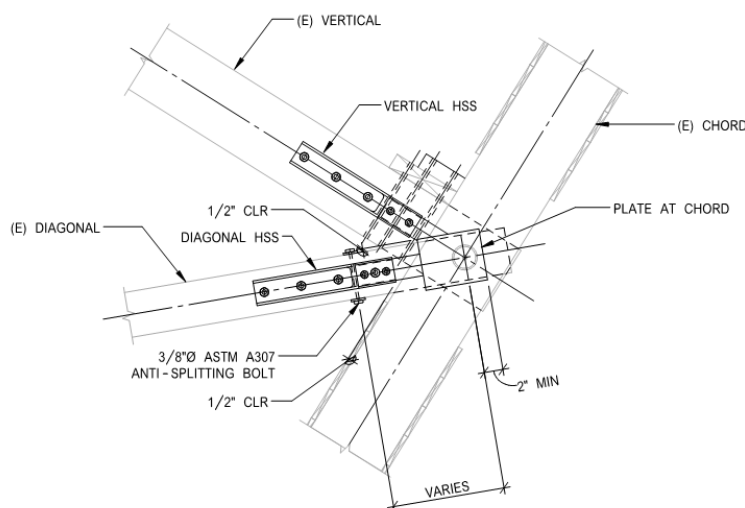
Figure 18. Permanent major connection strengthening.

Permanent major connection strengthening consists of galvanized and painted cut HSS steel tubes, steel plates, and bolts (Figure 18). These items are currently being fabricated and coated and are pending installation. This type of repair will be installed in locations of severe damage within truss panel point connections, where the connection is damaged, but the timber is in fair condition outside the connection zone.

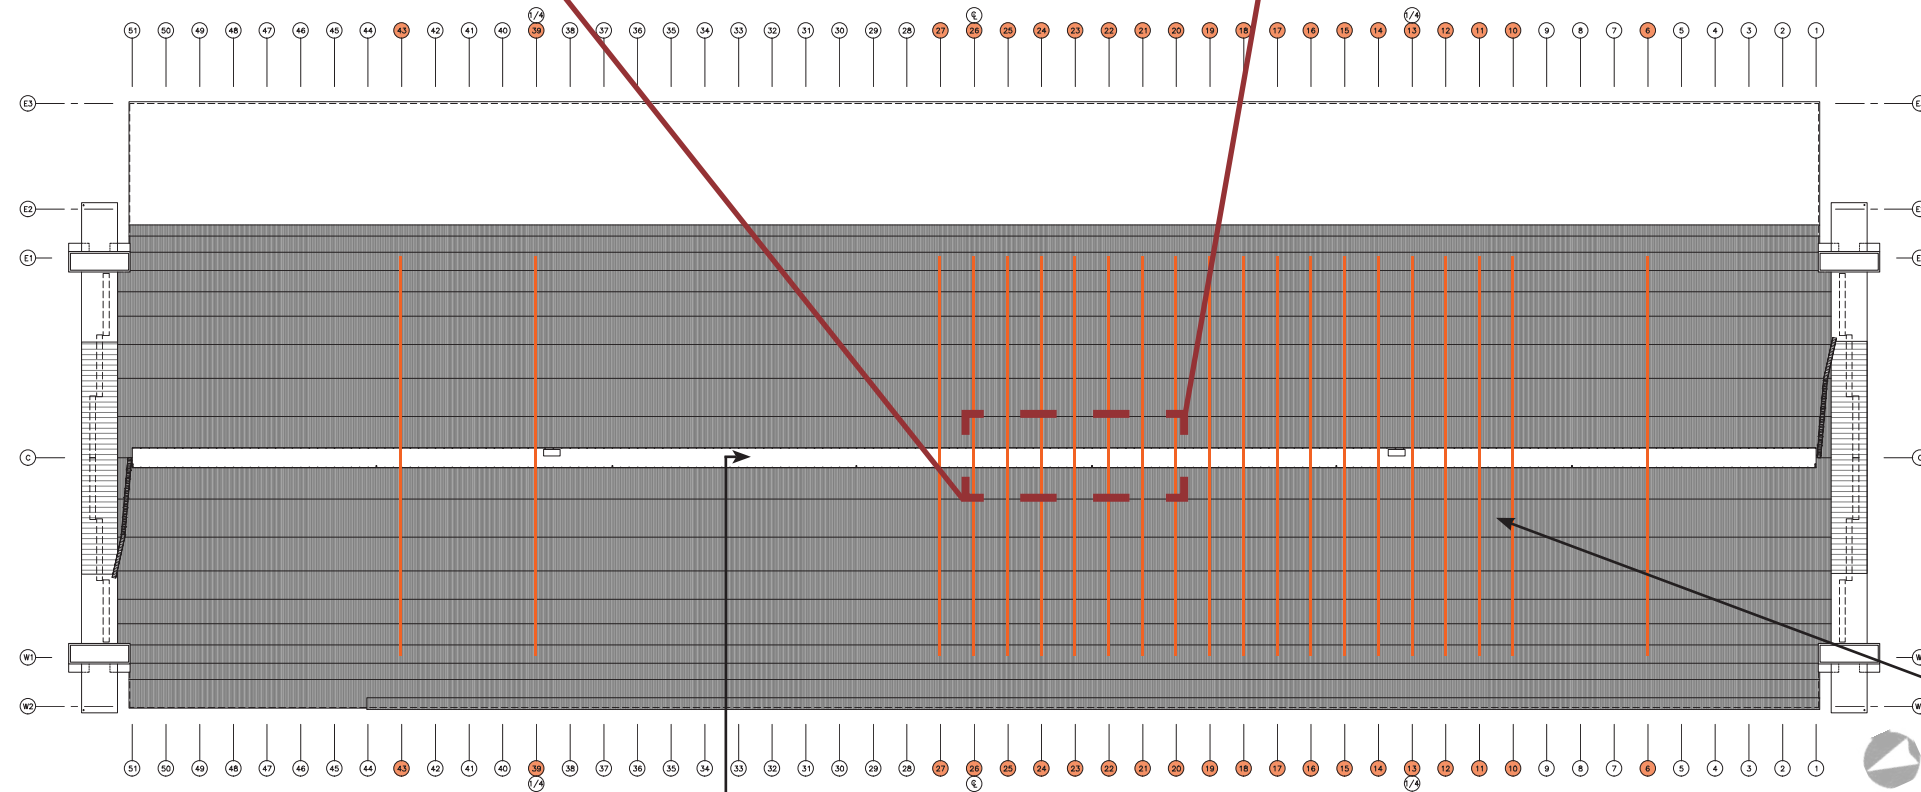
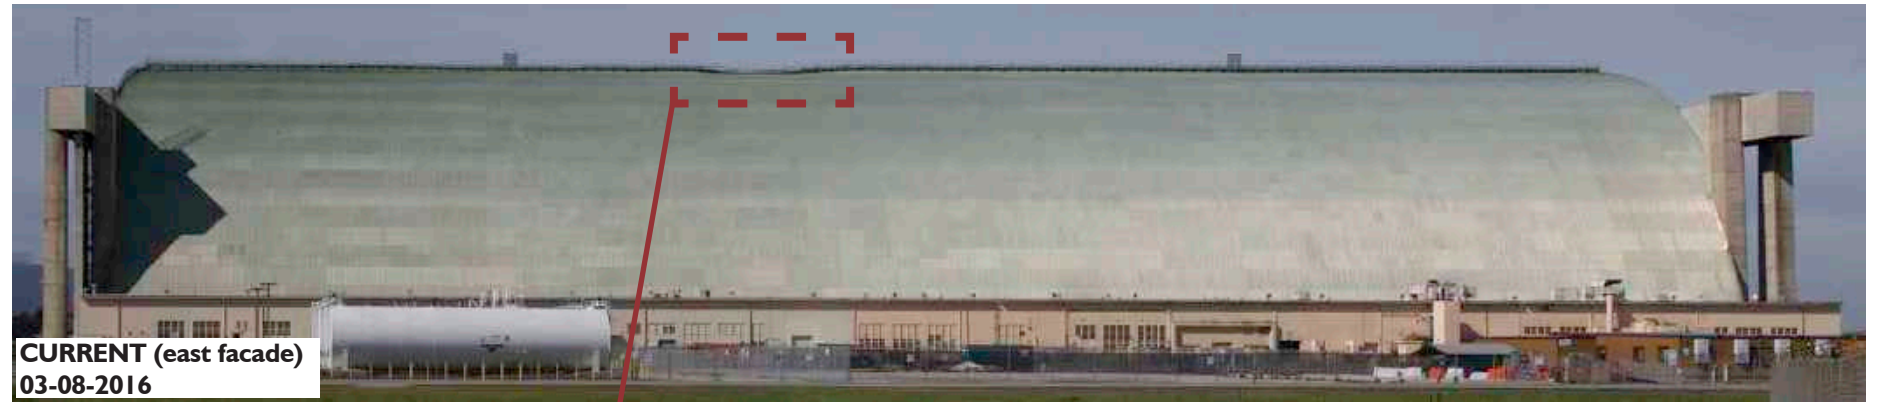
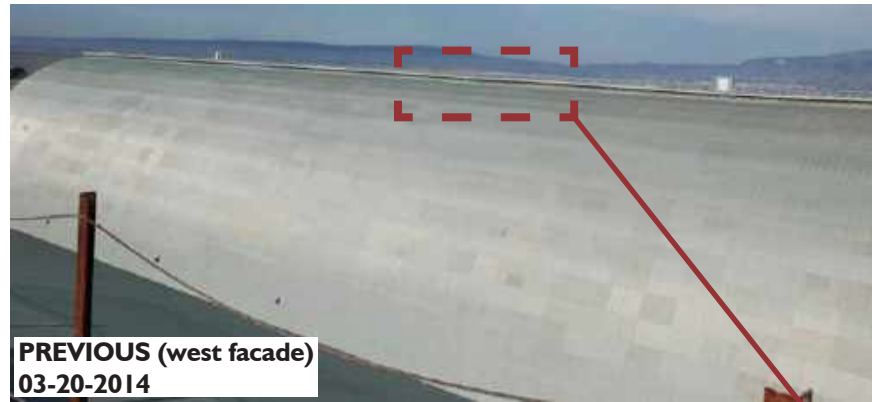
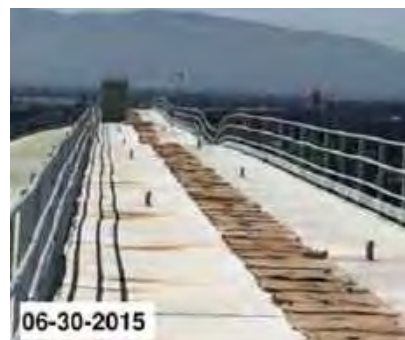
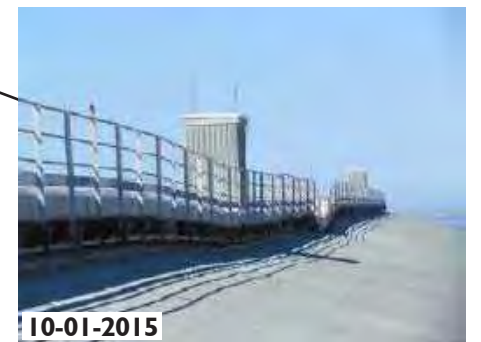
EXTERIOR CONDITIONS

Roof plan from Hangar 3 Existing Roof Plan by Page & Turnbull on 03-30-2015, with photographs by Erin Ouborg, Steven Aiello, and Mark Citret on behalf of Page & Turnbull, as well as photographs from Engineer's Field Report by KPFF on 06-30-2015

KEY
— Location of trusses for emergency repairs

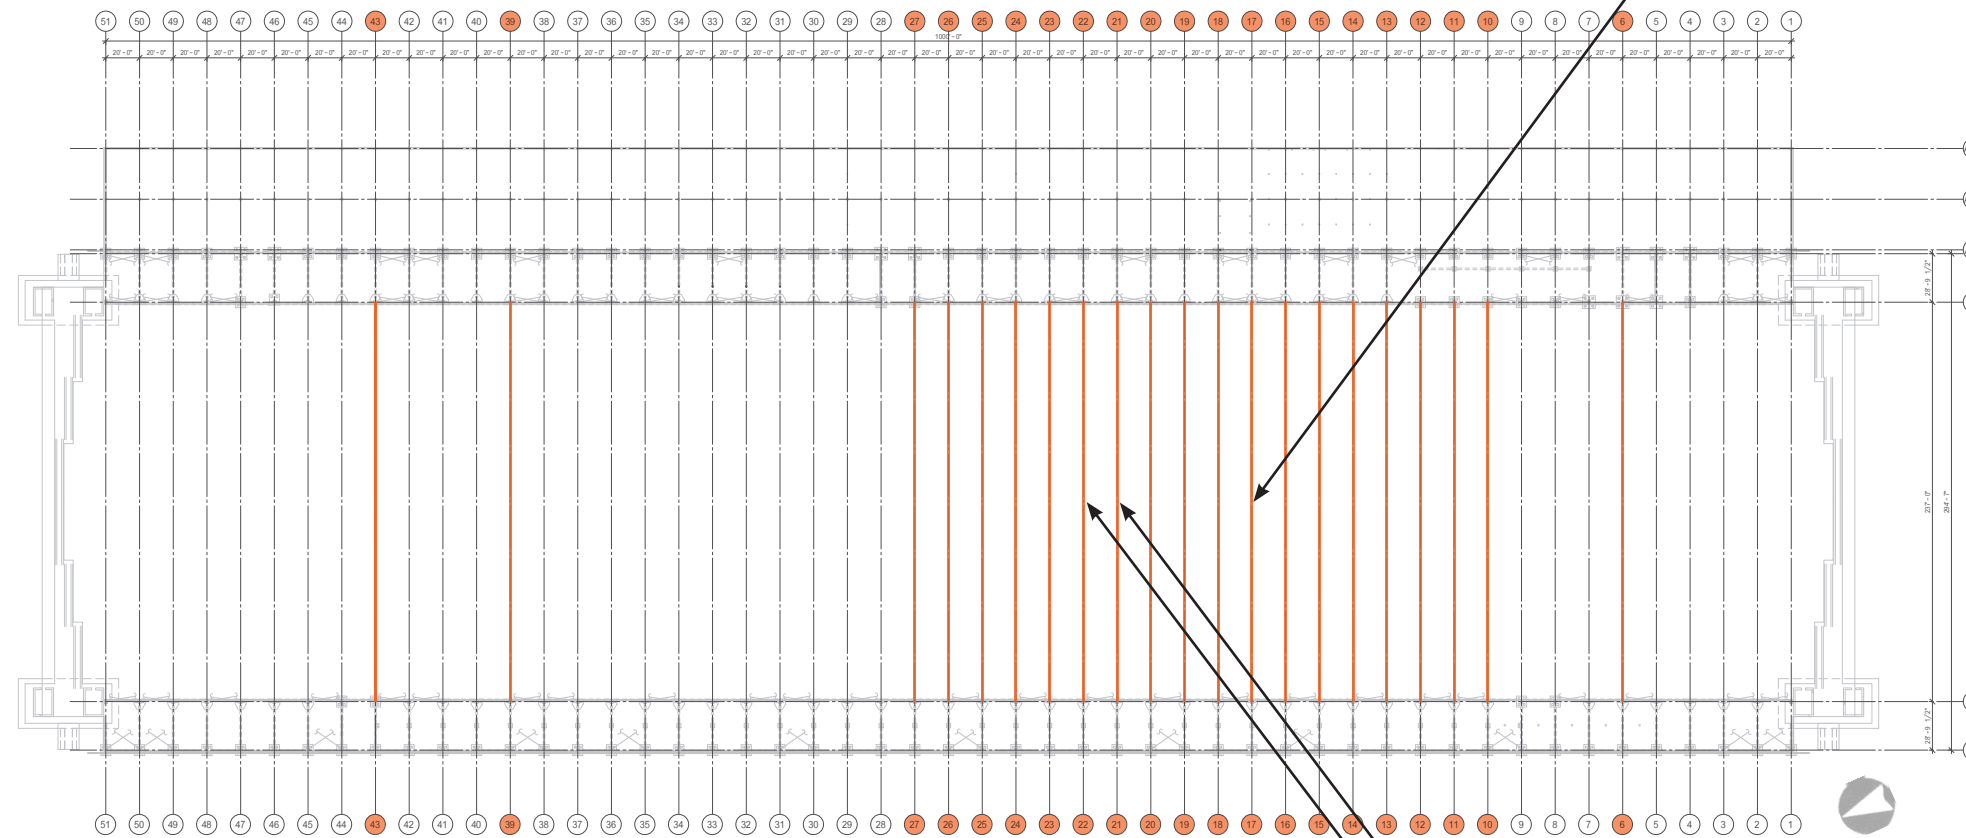
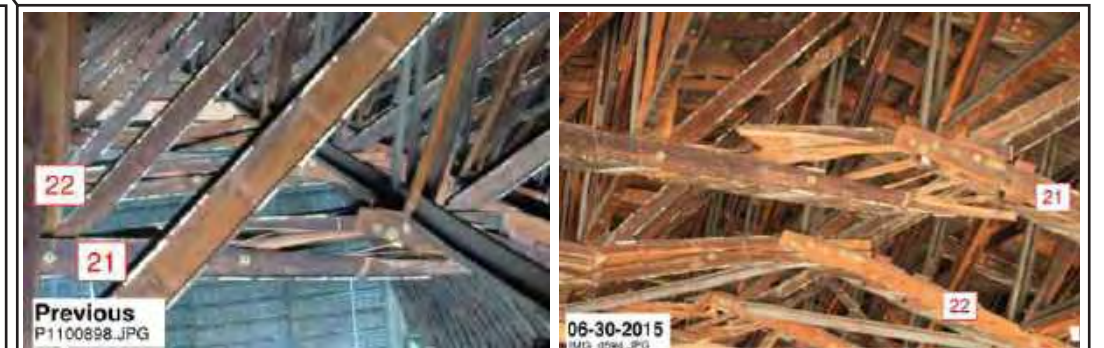
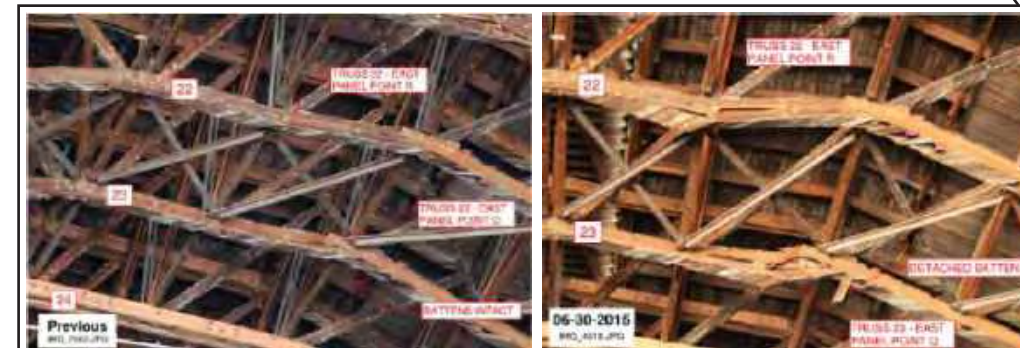
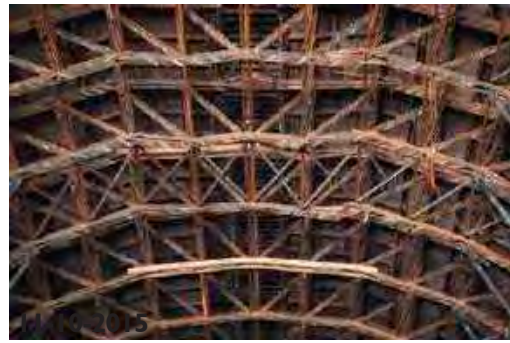
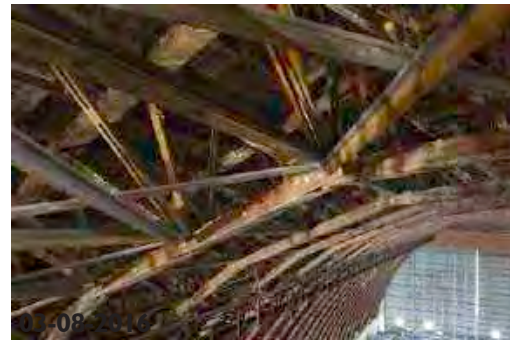
INTERIOR CONDITIONS

Foundation Plan from Moffett Federal Airfield - Hangar 3 Emergency Truss Repairs Set, Permit Revision 1 by KPFF on 03-17-2016, with photographs by Erin Ouborg and Mark Citret on behalf of Page & Turnbull, as well as photographs from Engineer's Field Report by KPFF on 06-30-2015

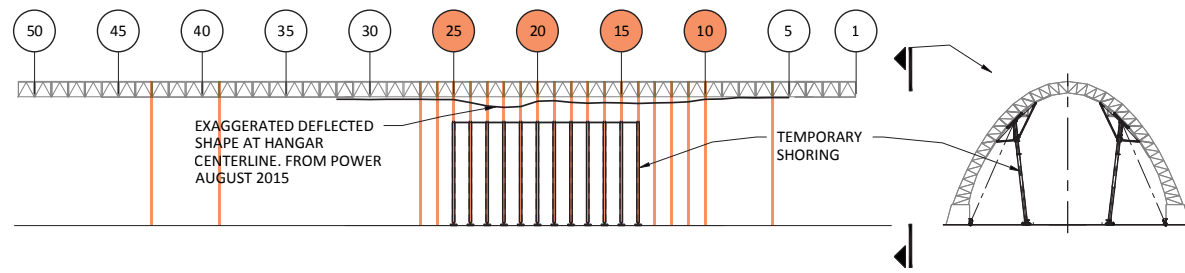
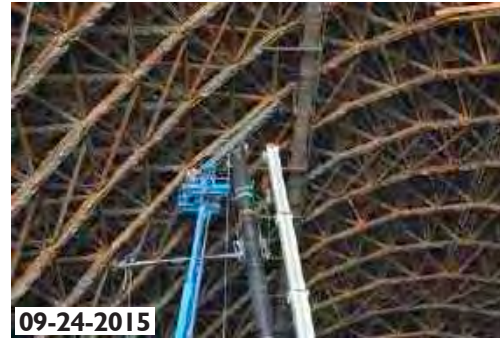
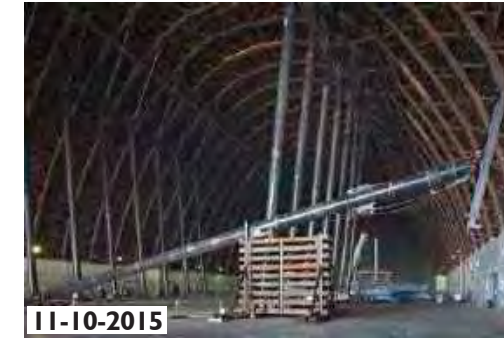
1. INSTALL TEMPORARY SHORING

Step 1: Install temporary shoring braces to prevent full collapse of hangar (Figure 11 and Figure 12). The upper portion of the hangar remains unsupported and local damage progression and partial collapse of the upper zone is still possible.

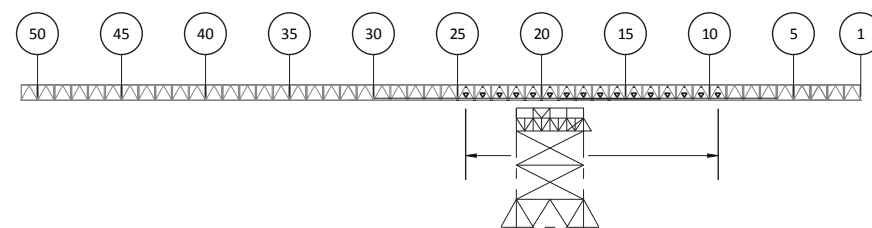
6. REPAIR OR REBUILD HANGAR TRUSSES AT RAISED LOCATIONS

Step 5: Perform emergency repairs to existing trusses and restore trusses as close as possible to original undamaged position from shoring tower.

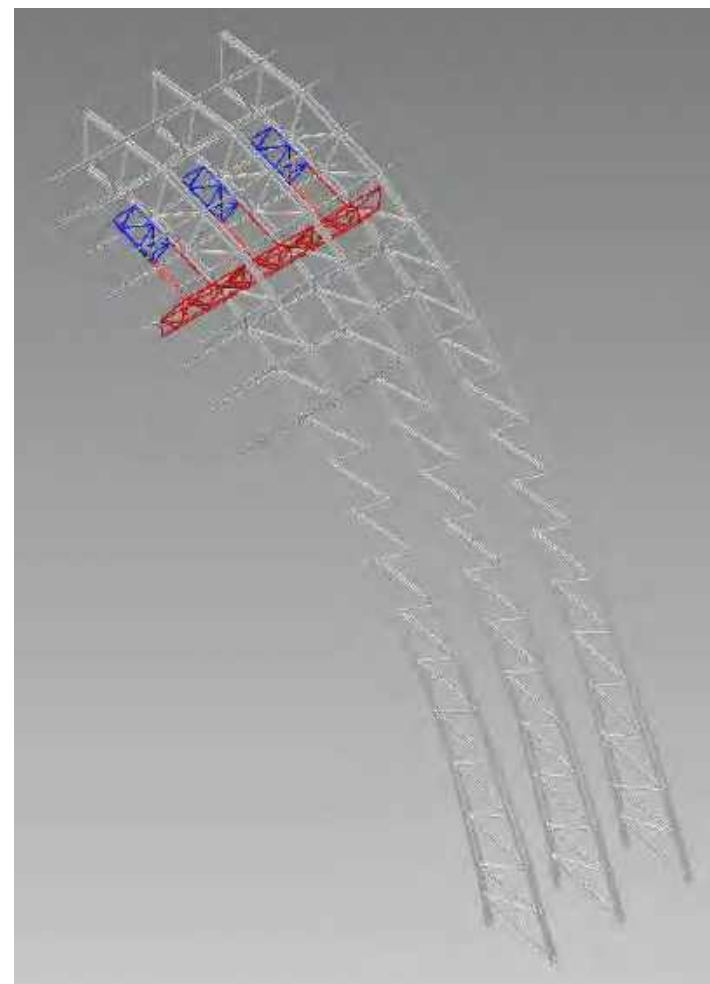
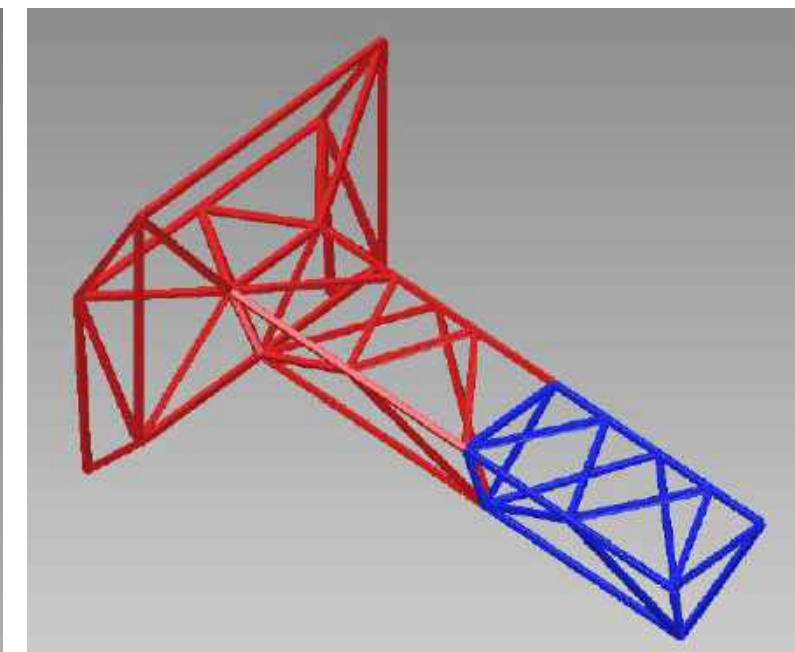
3D Model of Exoskeleton (colors are for visual aid only)

Step 3: Install steel truss support frames called “Exoskeletons” (Figure 14) in between existing wood trusses that have exhibited significant damage and deflection. The Exoskeletons are shop welded in segments which are field bolted together. The Exoskeletons are to be installed in the space between the existing trusses and will be attached to the existing trusses with bolts and steel plates (Figure 15).

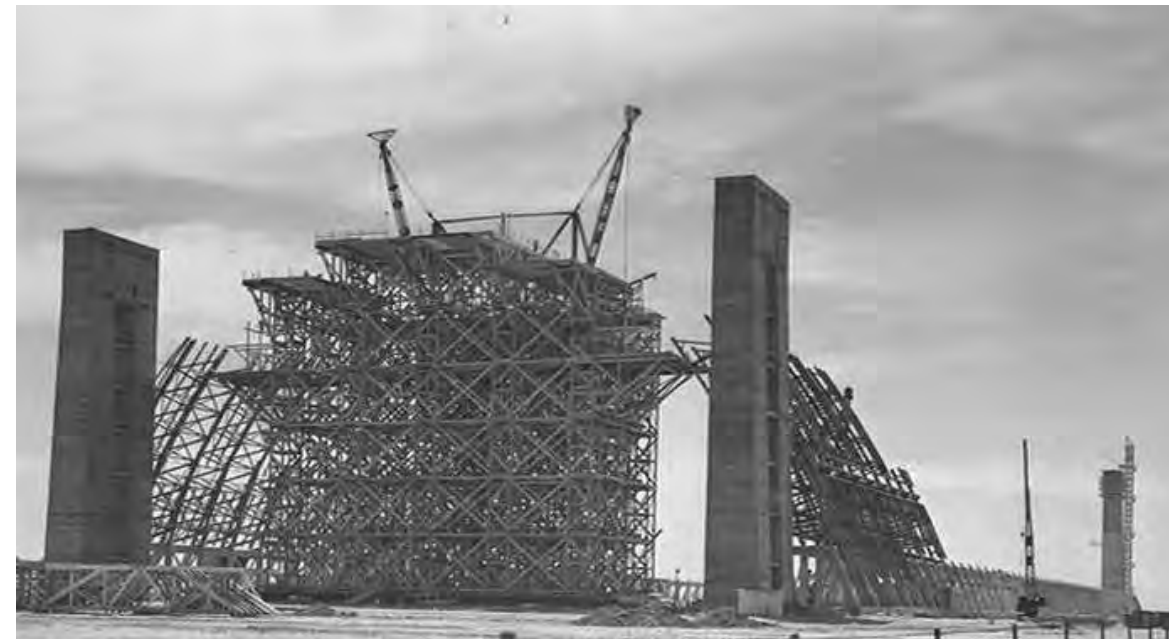
*Hangar 3 under construction
-US Navy Historic Photos*

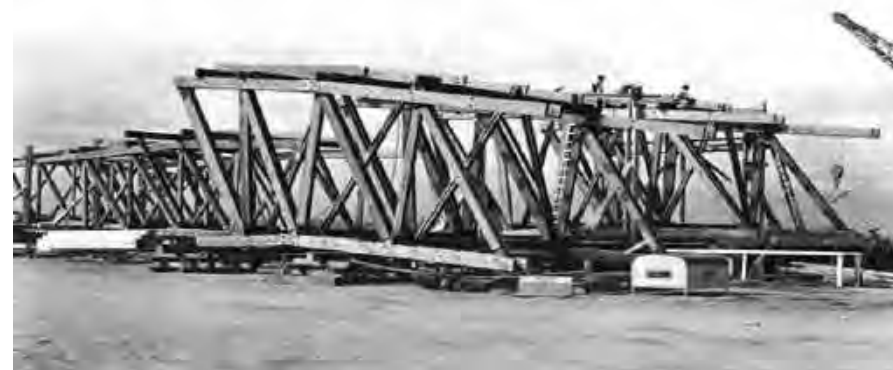
*Pre-assembled truss panels awaiting erection
-US Navy Historic Photos*

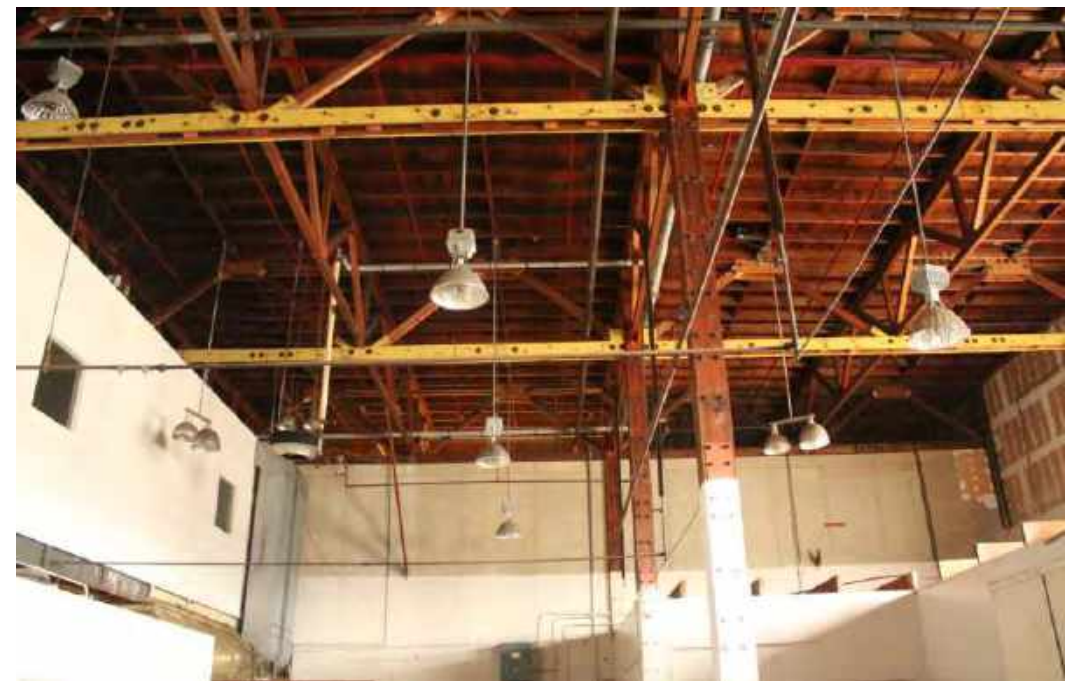
Interior view of Hangar 3 East Shed Annex

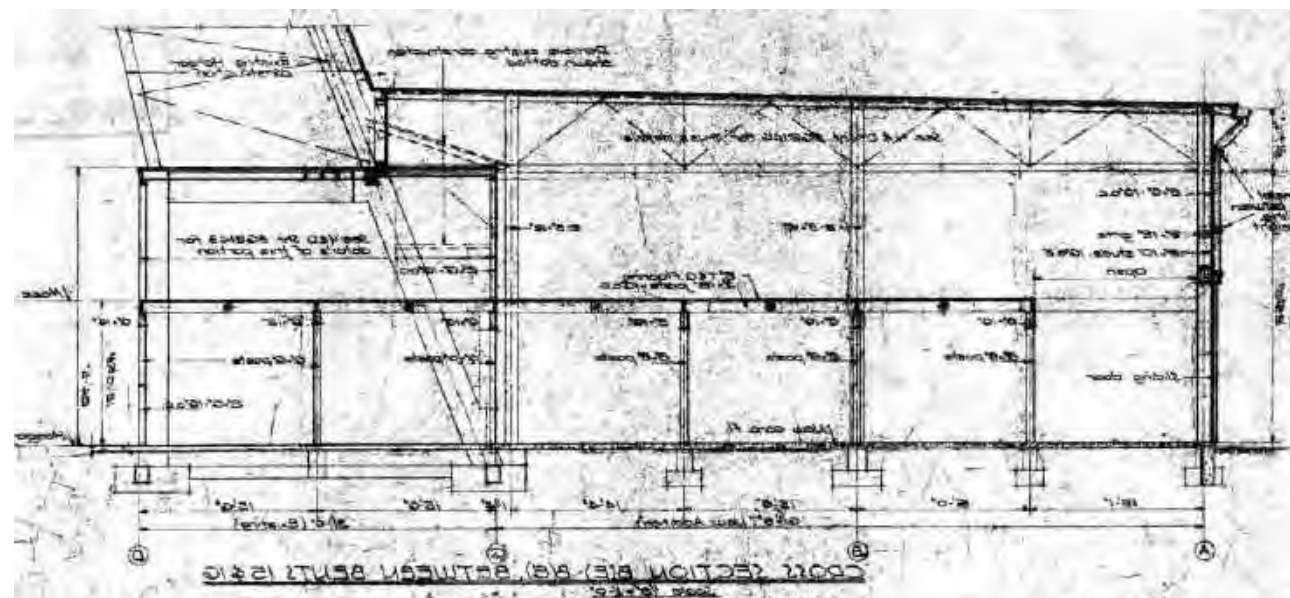
Elevation view of Hangar 3 East Shed Annex

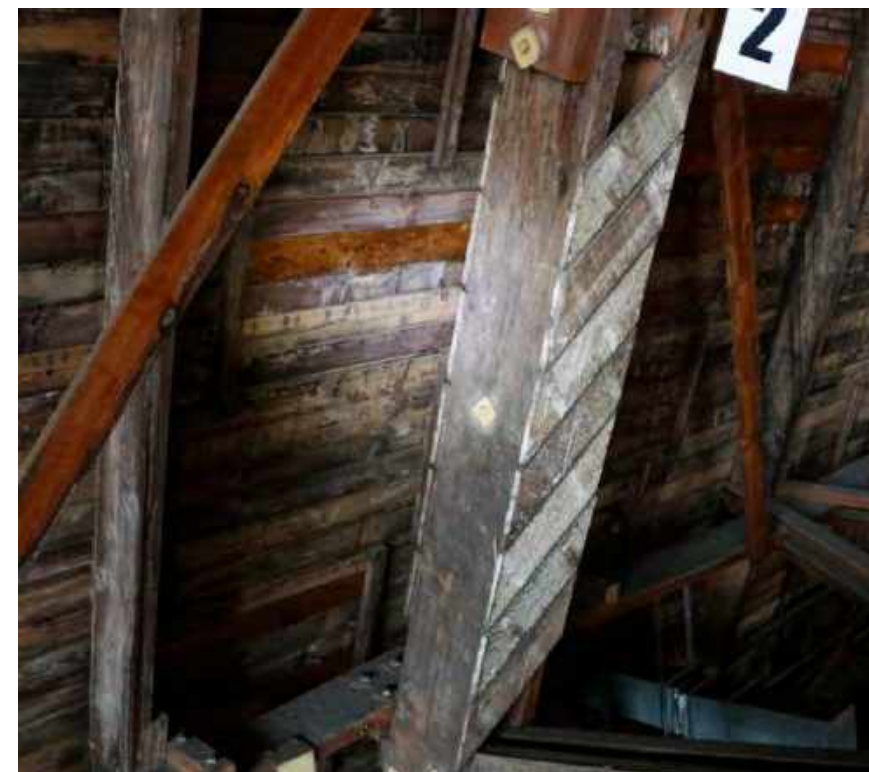
- Battens were added to bottom chords, and some top chords and diagonals to increase stability and help prevent buckling
- Upgrade was intended to increase the longevity of the temporary structure
- Battens added to **2244** members per hangar
- Batten wood was treated with a mixture of borax, white lead, and linseed oil paint.
- "These battens, with a few additional bolts and blocking at the chord splices, are the principle measures taken in strengthening and making permanent these wood buildings."
"Strengthening of LTA Hangars, Naval Air Station, Moffett Field, California", J.S. Marsh, 1946

Typical chord member with battens

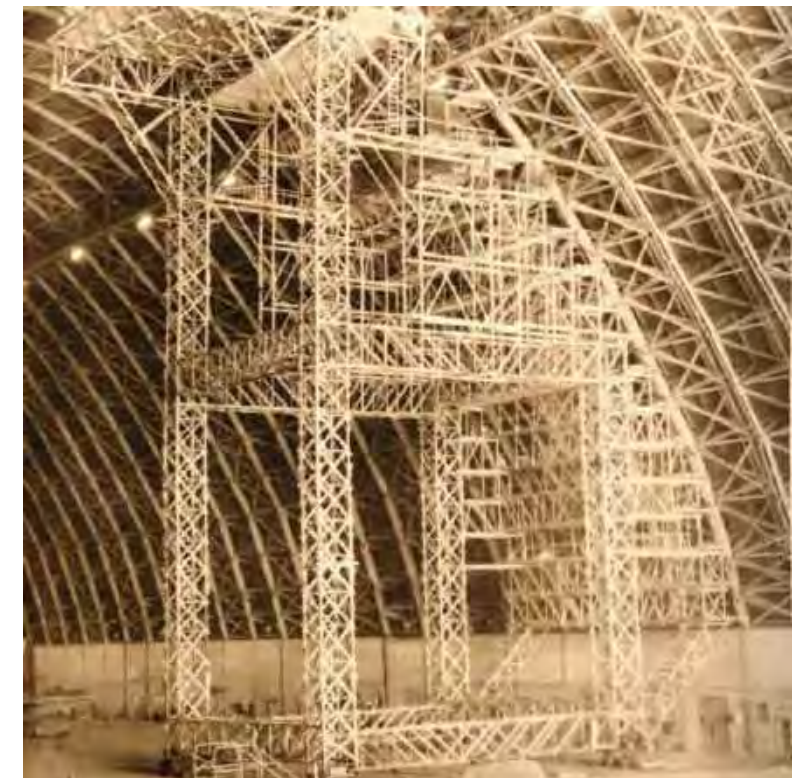
Rolling scaffold used to install battens
- Seabees Historic Photos

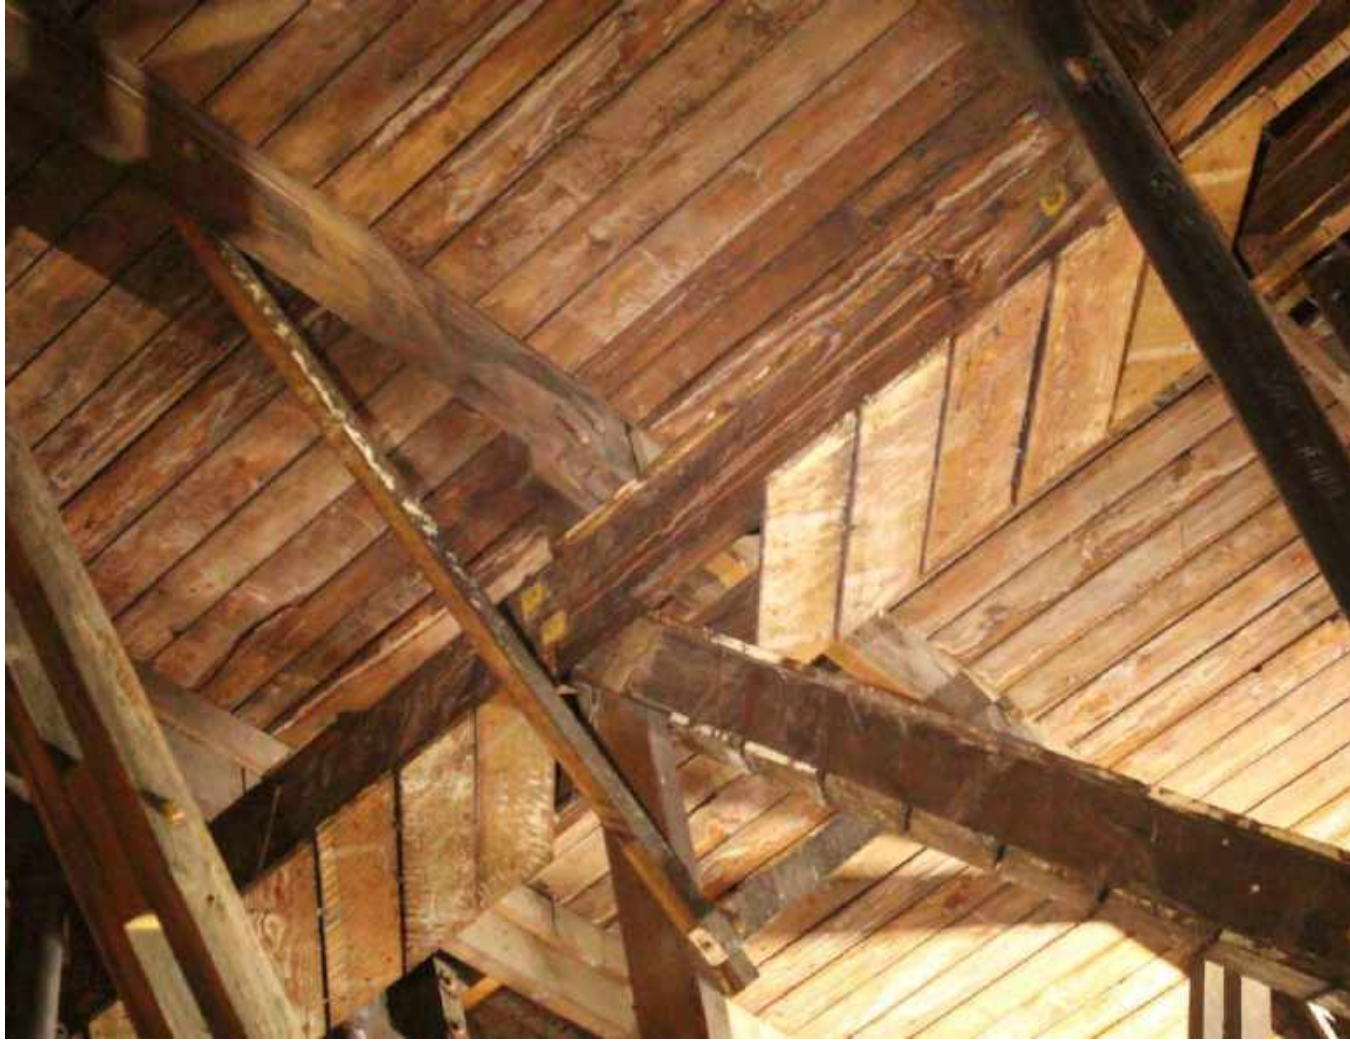
- Knee-braces were added to reduce the unbraced length of certain vertical web members
- These braces were part of the 1946 strengthening measures described by J.S. Marsh.
- Knee braces added to **700** vertical web members

Typical vertical web member with added knee-braces

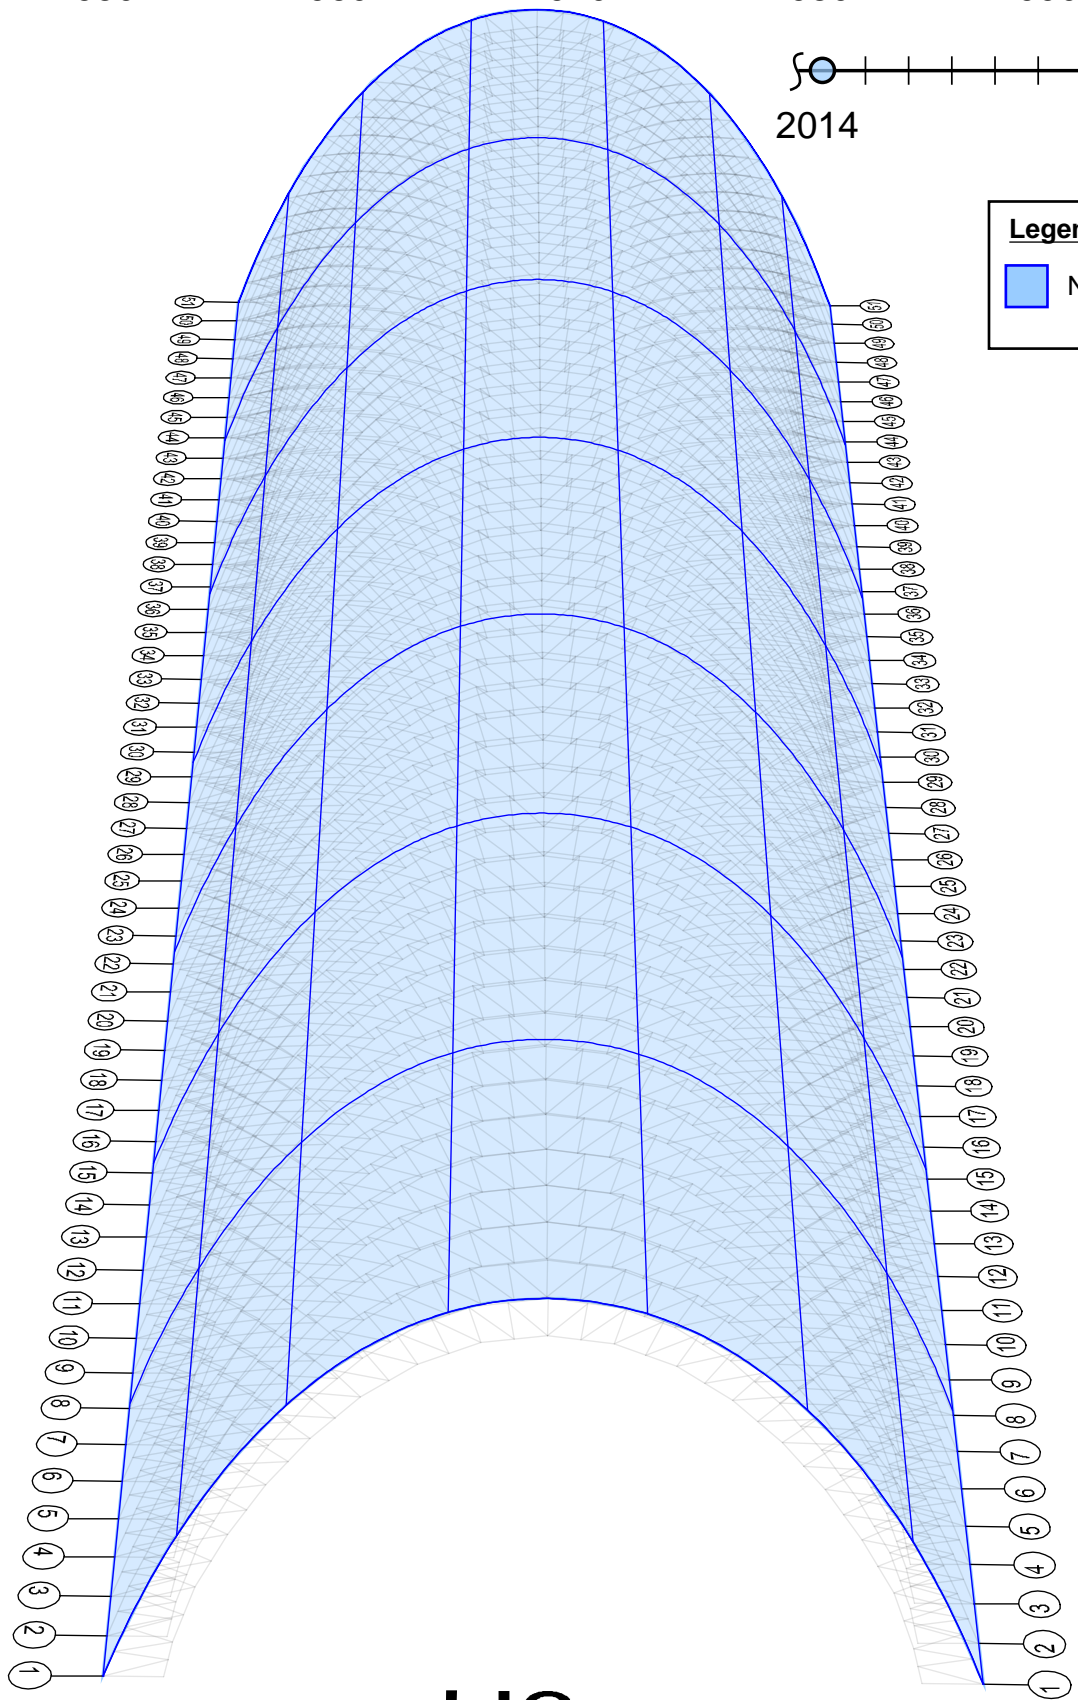
H3

New Roofing

- Original roofing system was roll-roofing over panelized wood sheathing
- Roof was upgraded to corrugated aluminum panels over roofing felt in 1956
- Approximately **466,000** ft² of roofing per hangar

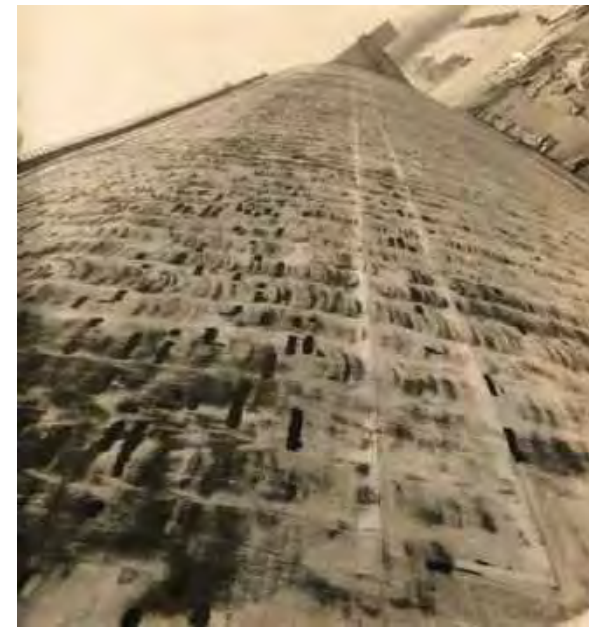
Original roofing system
-Seabees Historic Photos

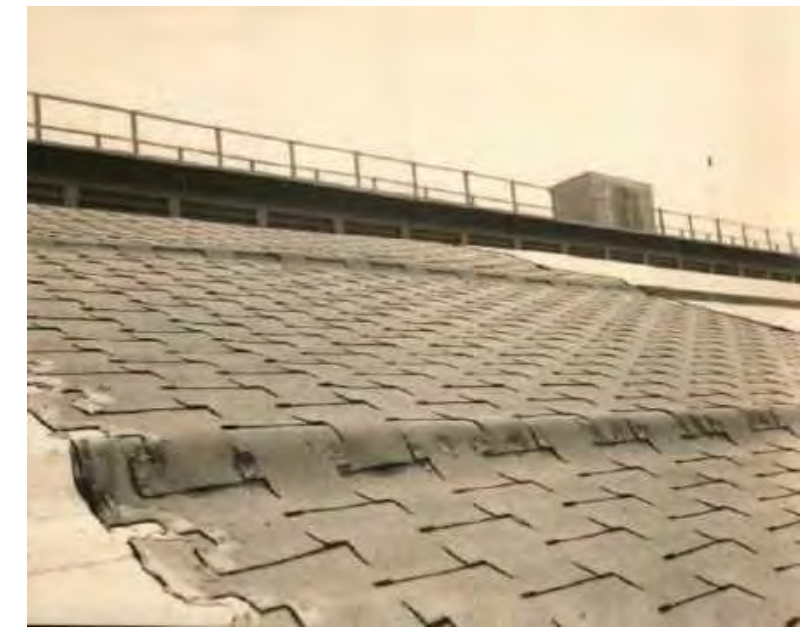
Asphalt shingles documented in 1954
-Seabees Historic Photos

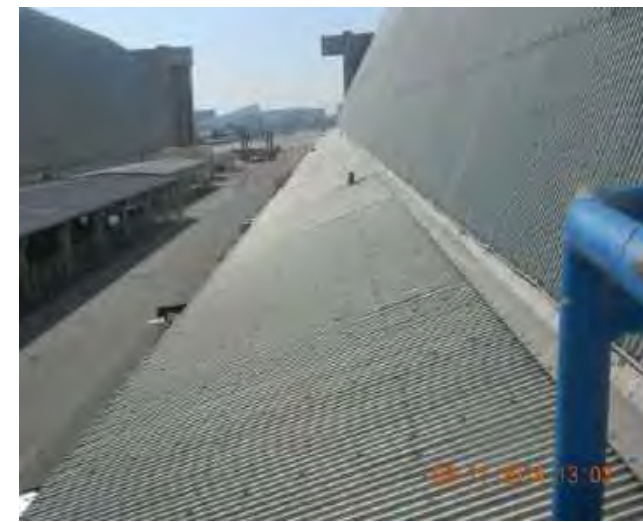
Current aluminum roofing
