MFA Hangar 3 Hazard
Remediation Section 106
Technical Report

SHPO# NASA_2019_1216_001

Moffett Federal Airfield,
Santa Clara County, California

May 11, 2020

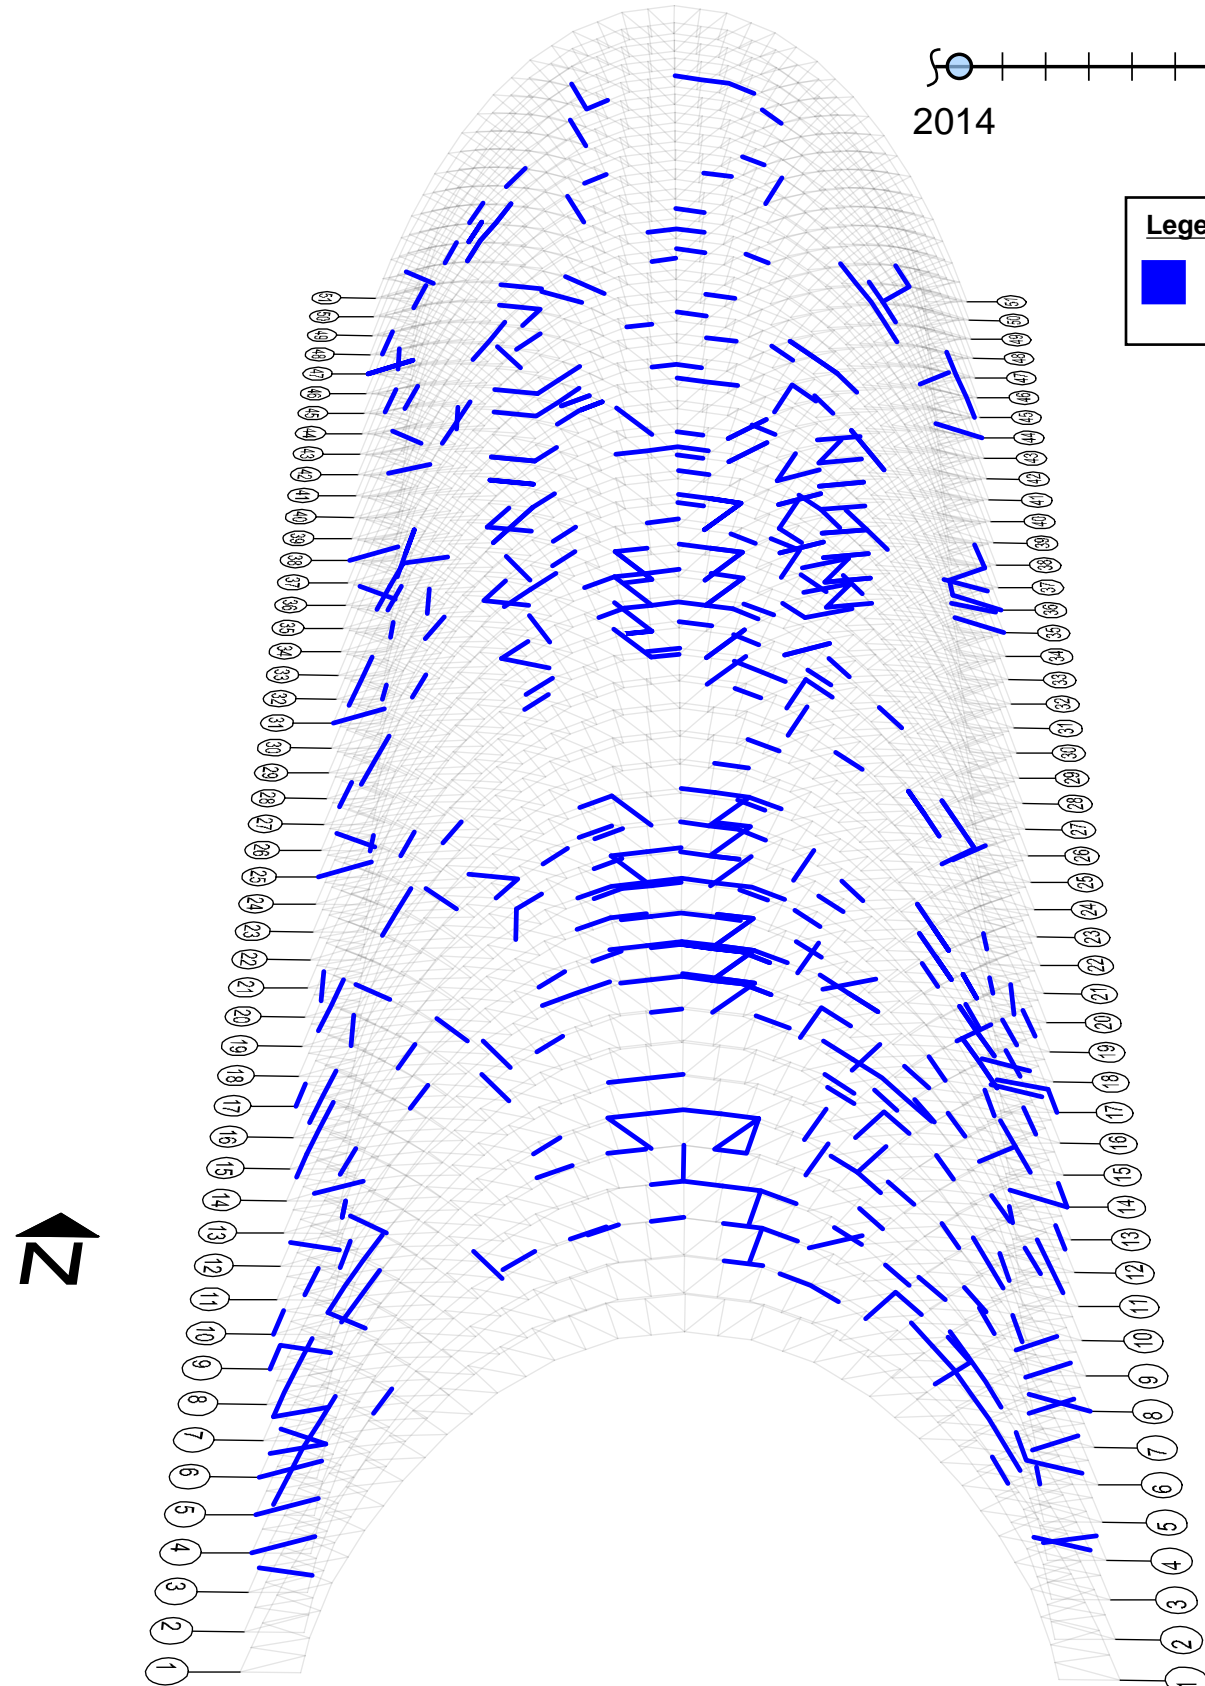
Documented existing minor repairs

- Standard repairs for Navy maintenance included steel clamps and stitch bolts to fix minor splits "Maintenance Procedure for Timber Trussed Structures" Department of Navy Bureau of Yards and Docks, 1944
- Repairs occurred periodically throughout the service life of the hangars
- Navy records indicate that Timber Structures performed an inspection of the hangars in 1954
- The extent of these repairs is not fully documented
- Minor repairs have been documented at **541** members in H3 (many still undocumented)

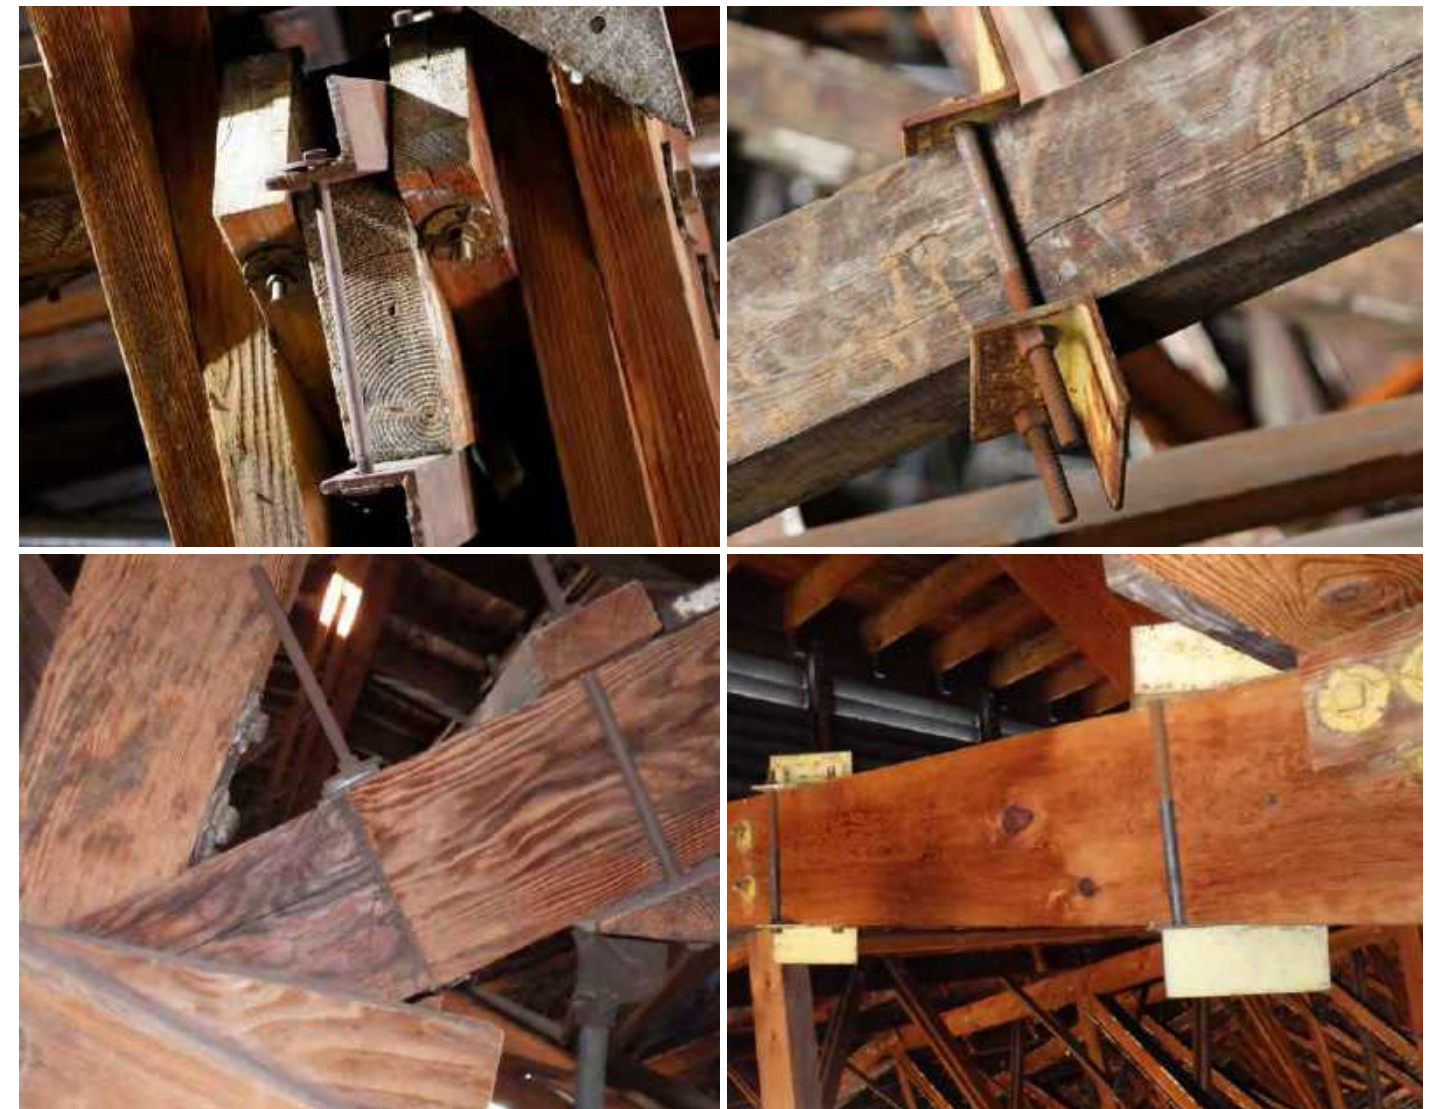
Minor repairs made during Hangar 3 service life

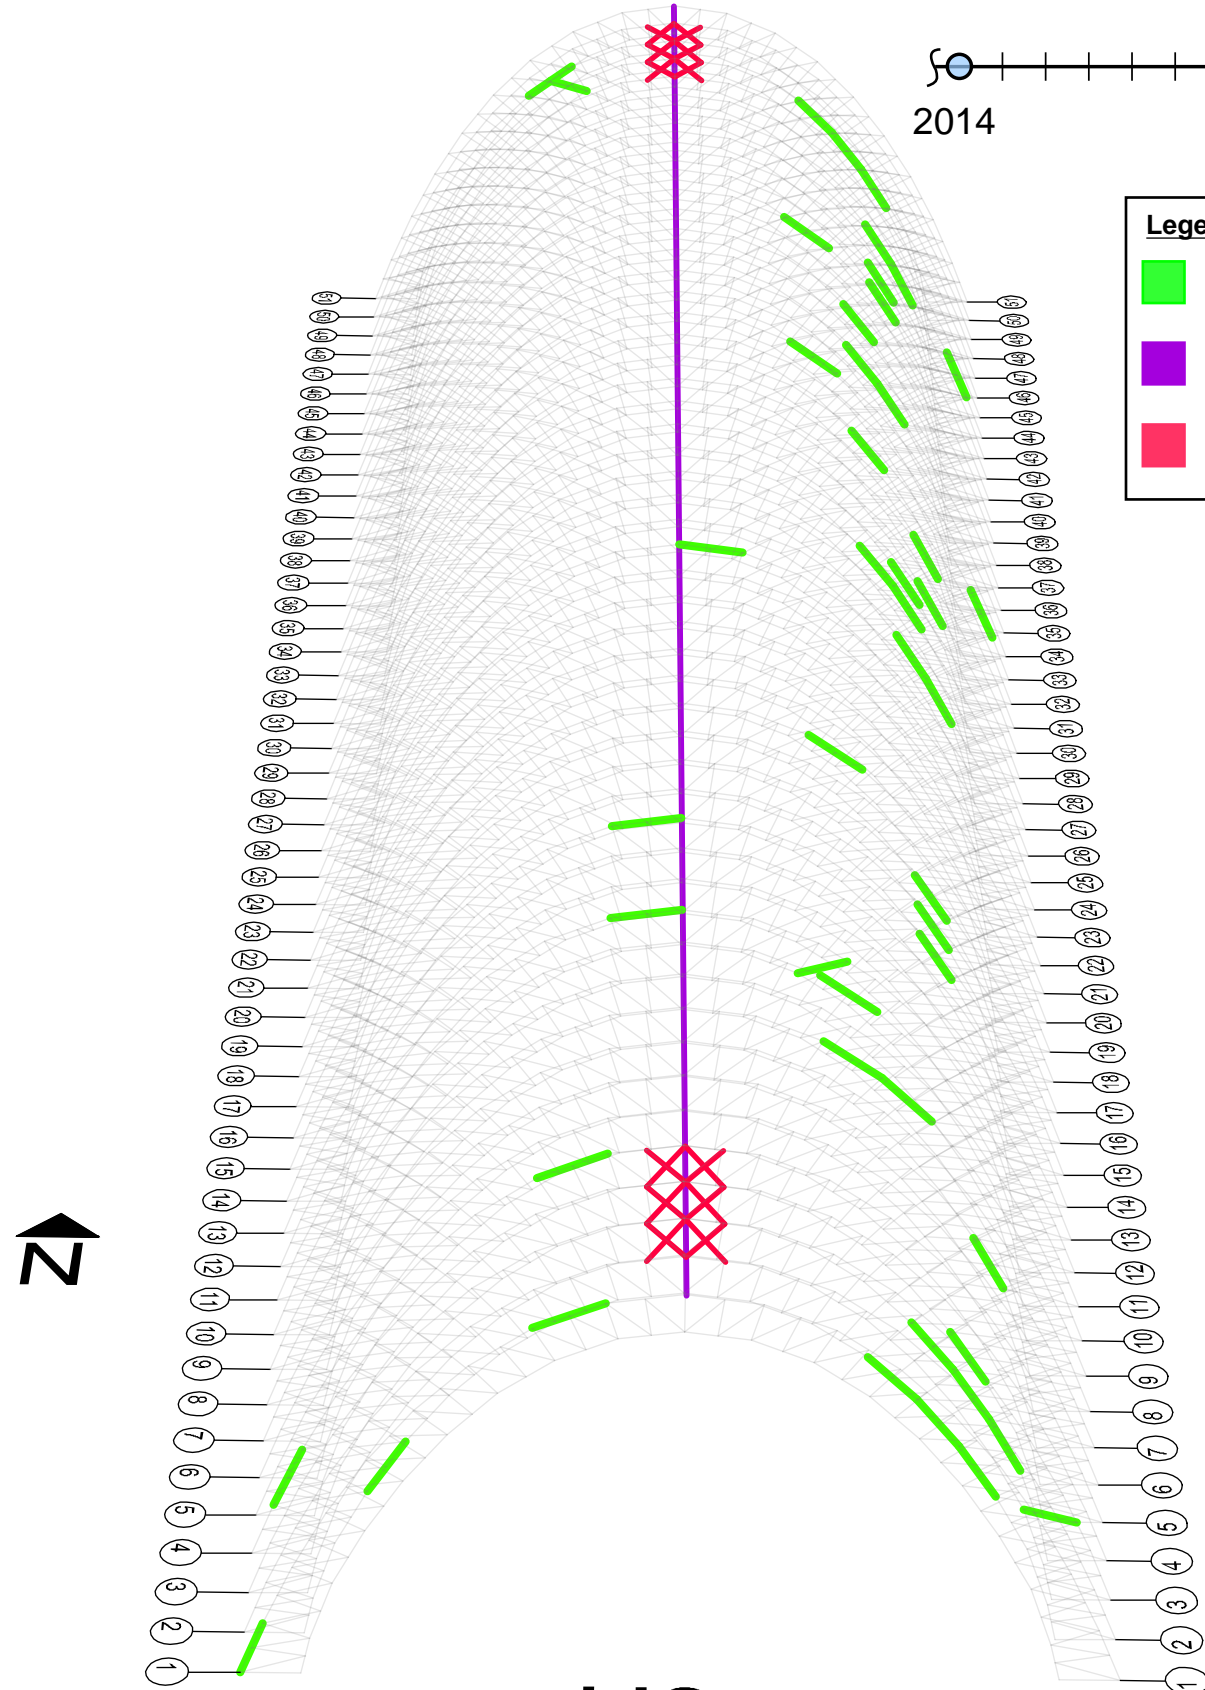
- █ 1981 Glulam Repairs
- █ Node 18 Struts
- █ Rod Cross-Braces

- Major glulam repairs were made in 1981 to correct buckling observed in truss chords
- Glulam strongback members were installed to re-align chords, but load path remained in the original members
- Major repairs made to **49** members
- Struts added at each arch at node 18 to brace top of truss, with rod cross-bracing added at the north and south ends of the hangar
- Minor repairs were also made with clamps and stitch bolts. Many 1x6 purlin ties were replaced with steel rod ties

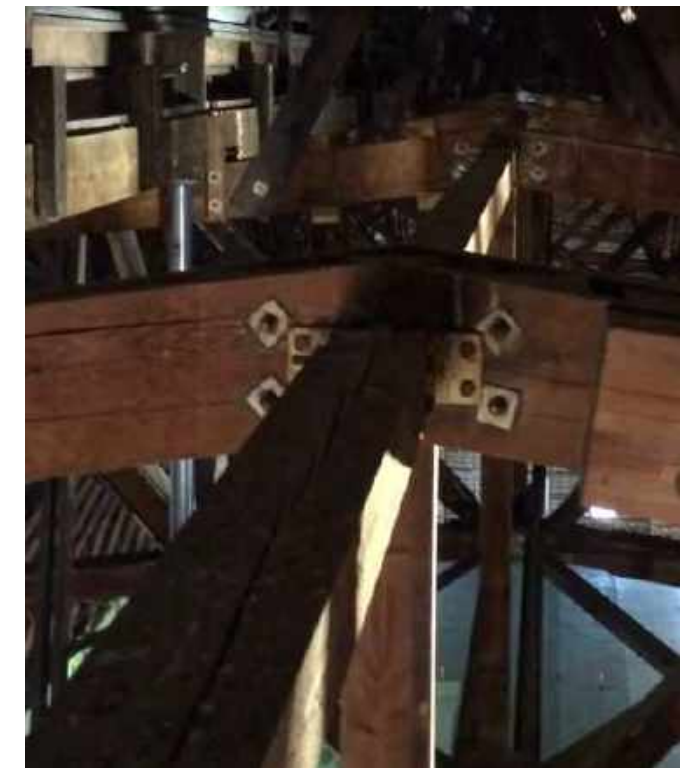
Node 18 struts

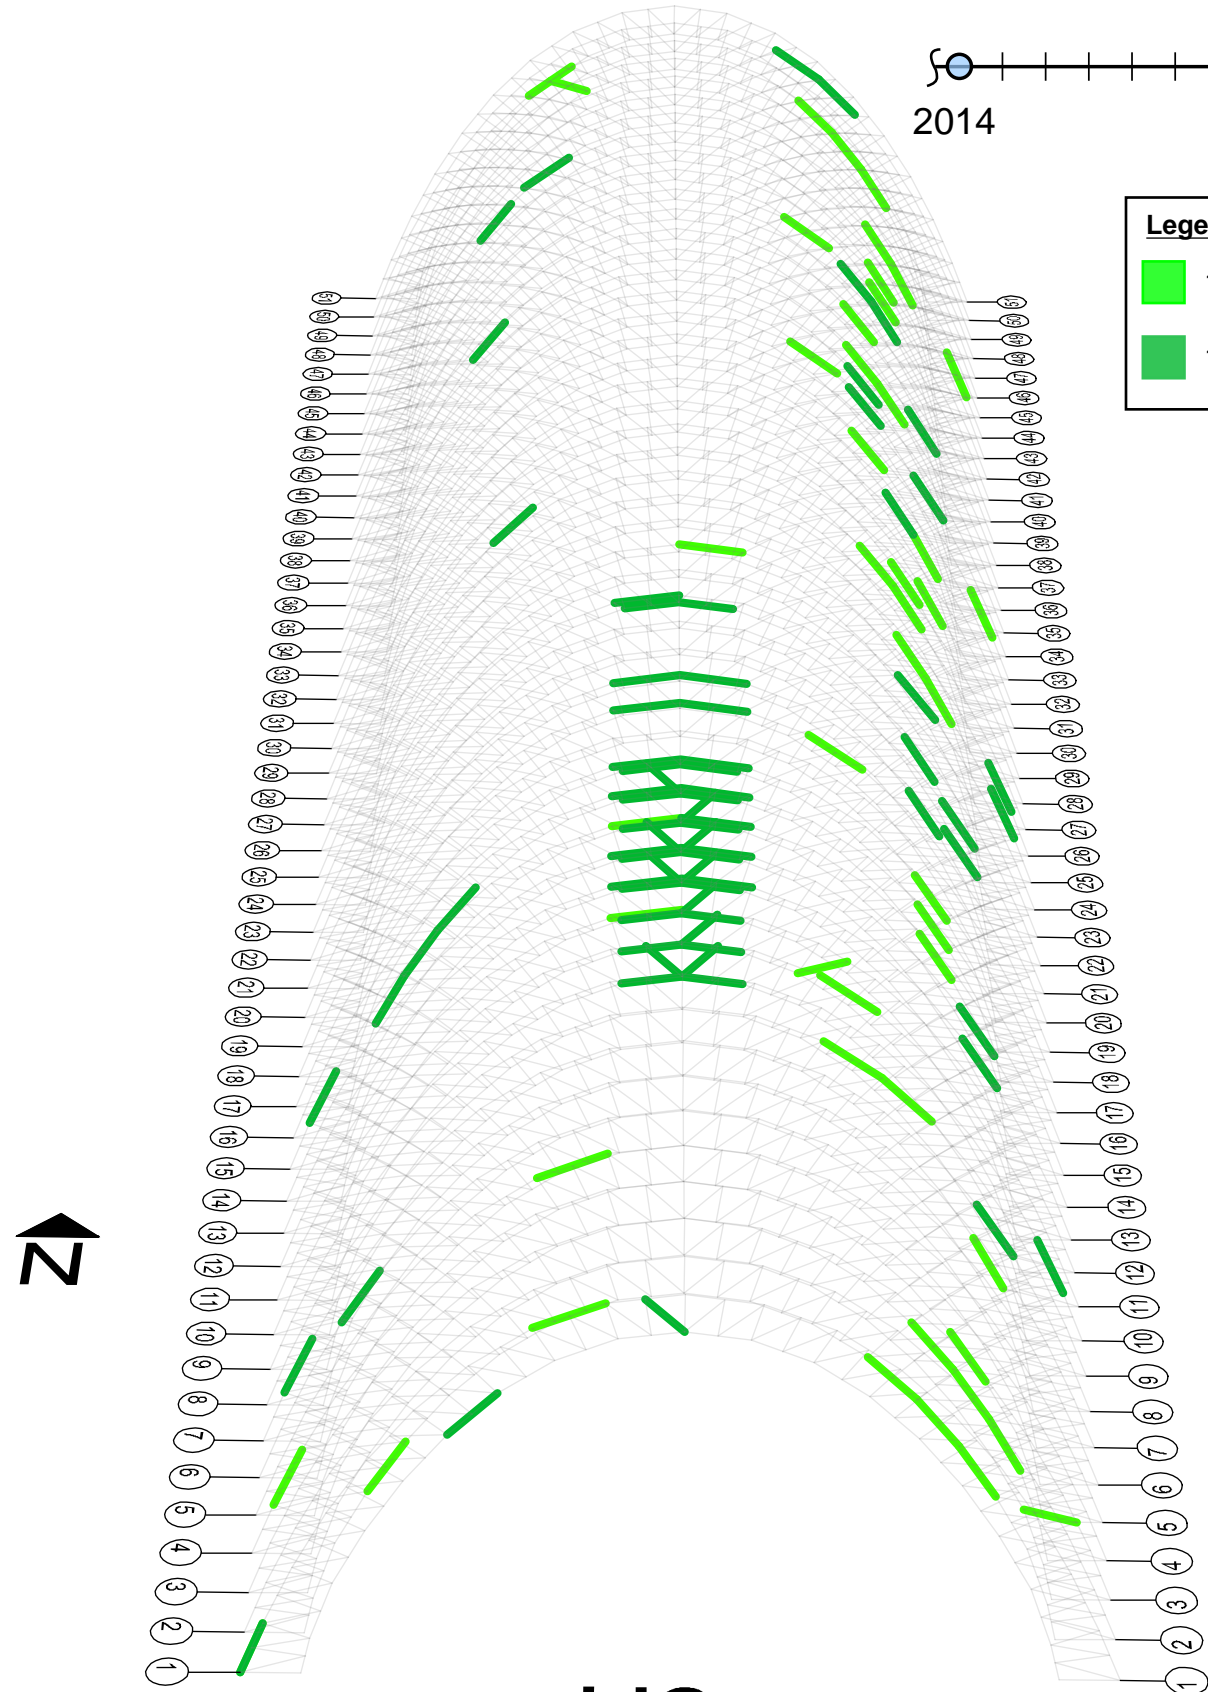
H3

- 1981 Glulam Repairs
- 1993 Glulam Repairs

- Continued deterioration of Hangar 3 necessitated further glulam repairs in 1993
- Repairs consisted of glulam strongbacks for buckling, and multi-chord glulam sistered members
- Many of these repairs were made in the critical zone where the most severe deflections and damage were later found
- Major repairs made to **75** members
- Sistering repairs also made to roof support purlins and minor clamp repairs were again performed on arch trusses

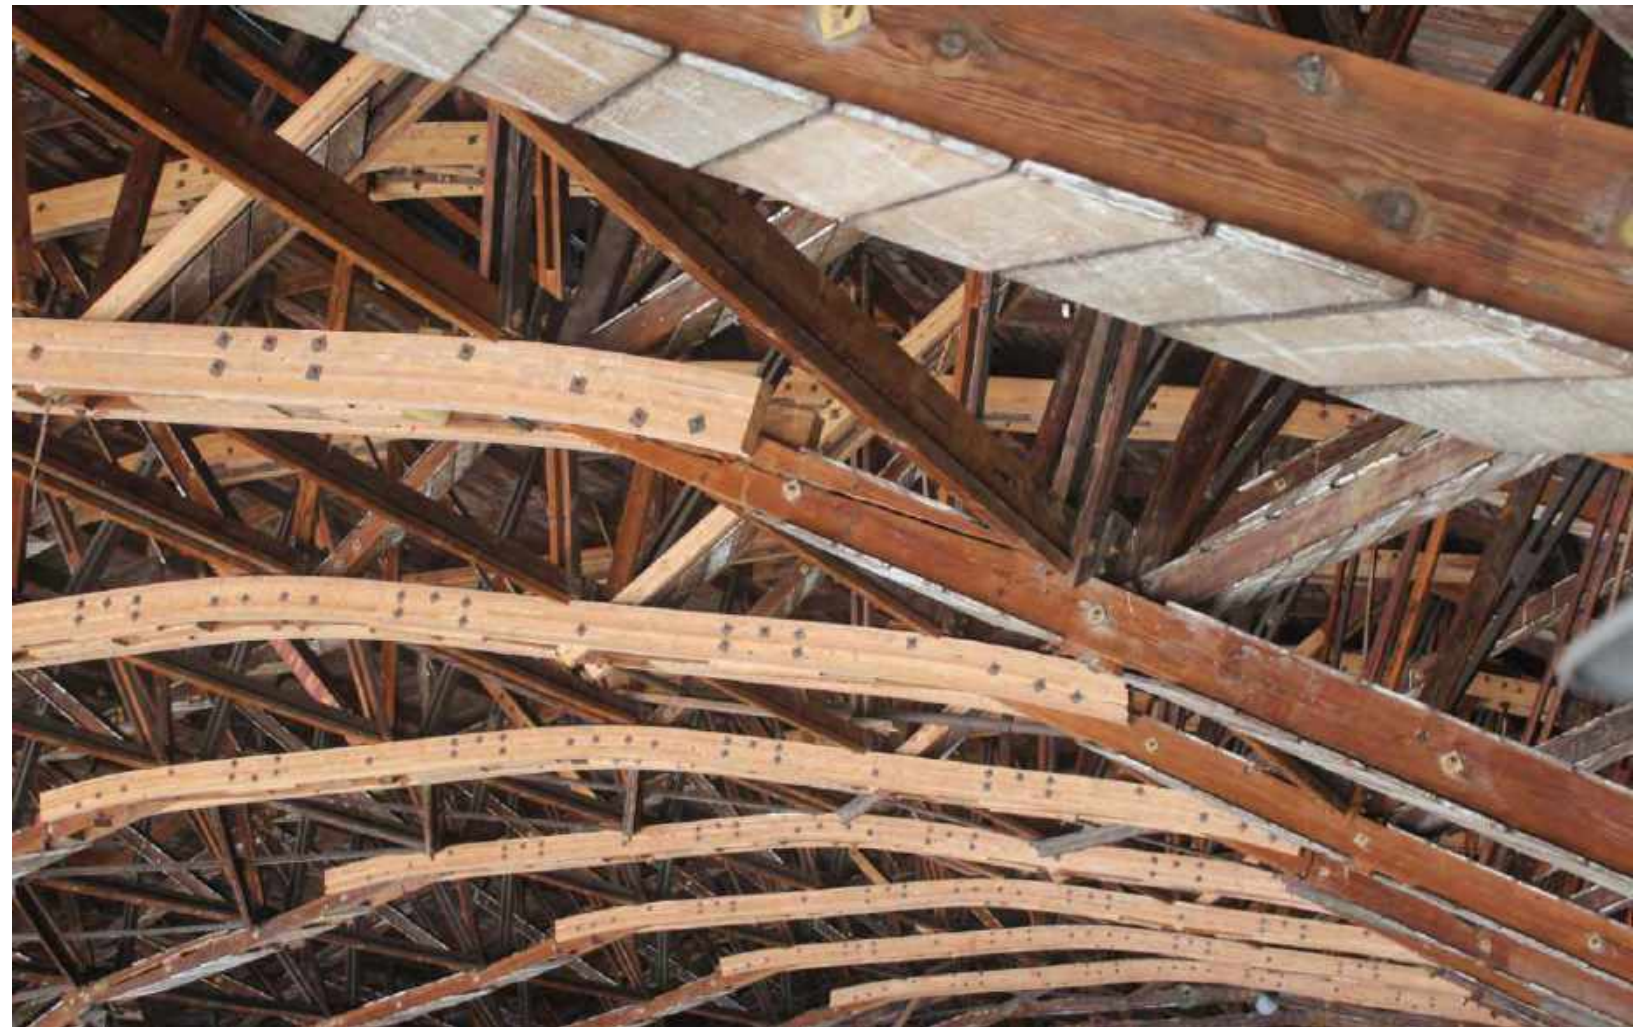
1993 glulam sister repairs to chord members in critical zone

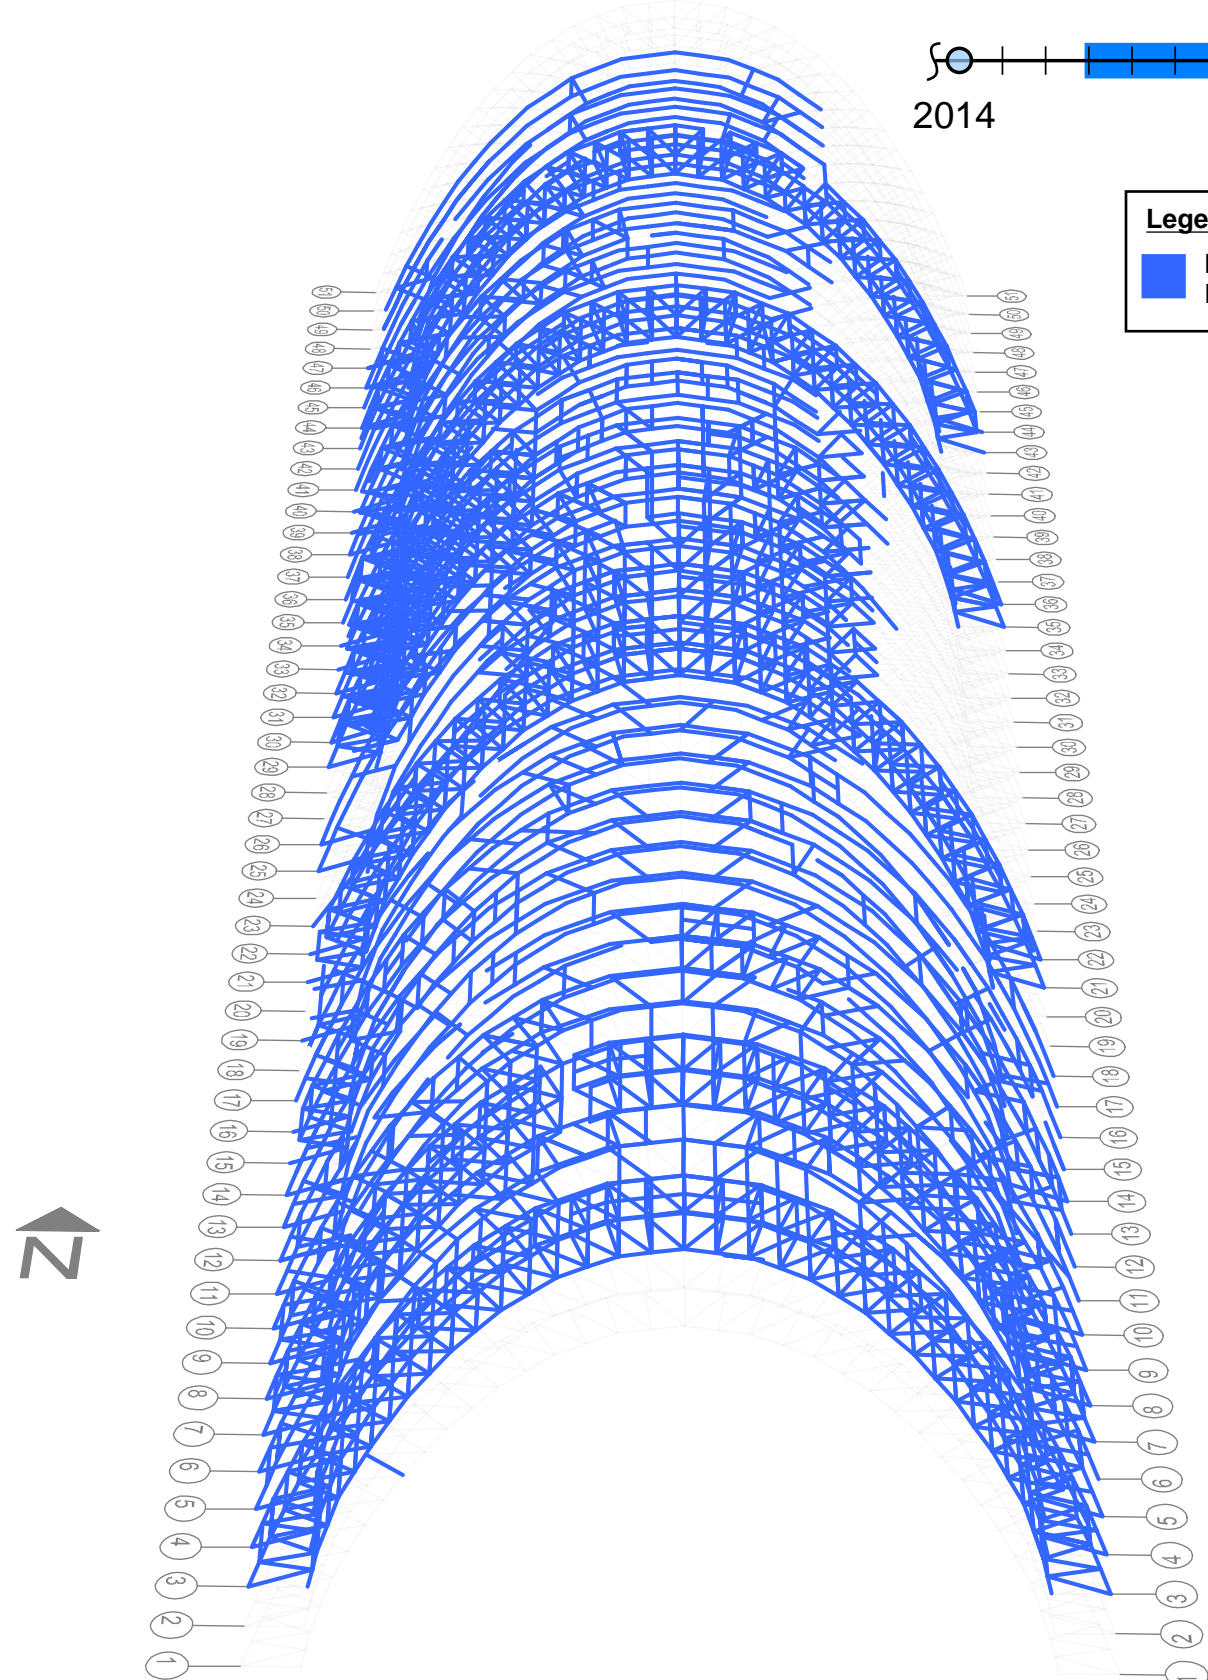
Legend
 Members surveyed in Due Diligence Investigations

- Data collected in the Due Diligence Investigations phase of the project included visual observations of many (but not all) of the truss members
- Observations were made regarding wood grading, existing condition, and previous repairs
- Data was logged for **5663** members in H3 through TPAS® (Tablet PC Annotation System) provided by Vertical Access
- H3 contains over **20,000** total members, including **5559** main arch members
- Results summarized in Page & Turnbull Due Diligence Investigations Findings Report (DDIF)

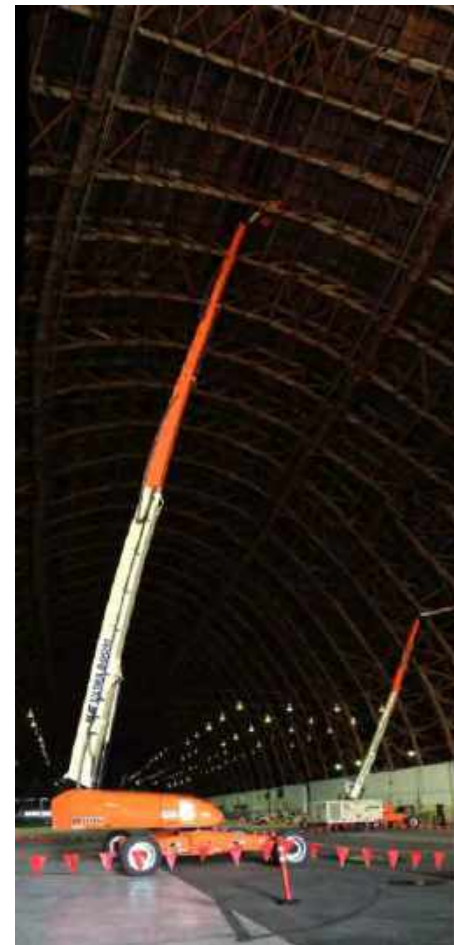
Boom lift used for visual observations

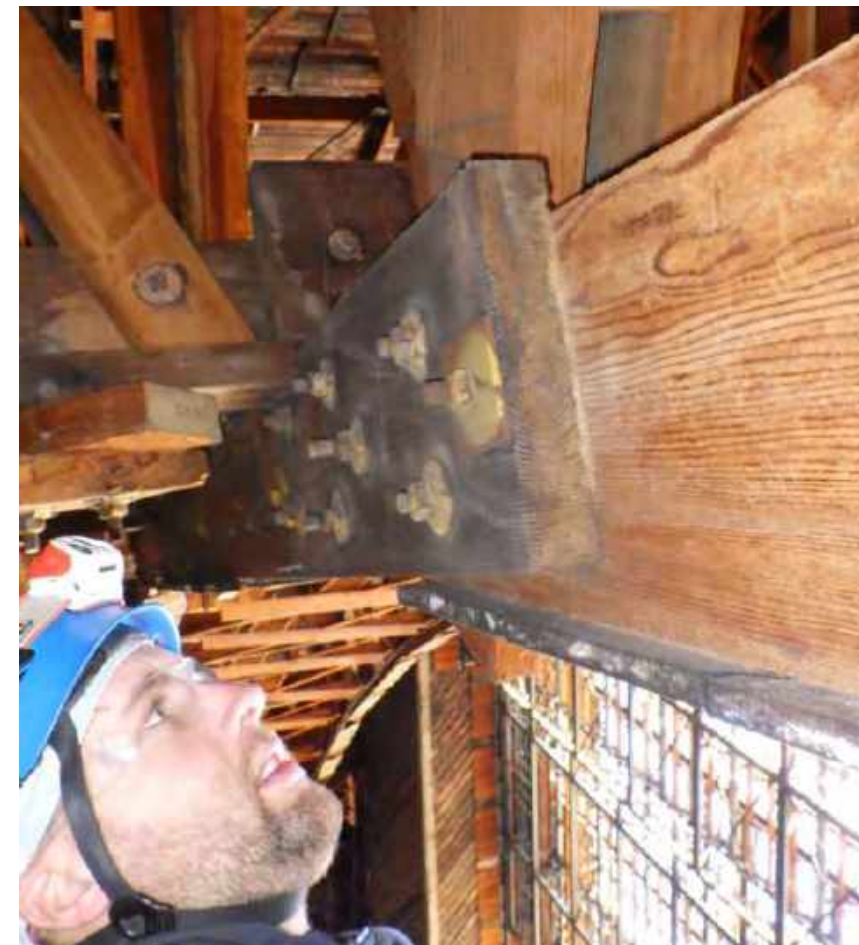
Visual observation of a lower chord member

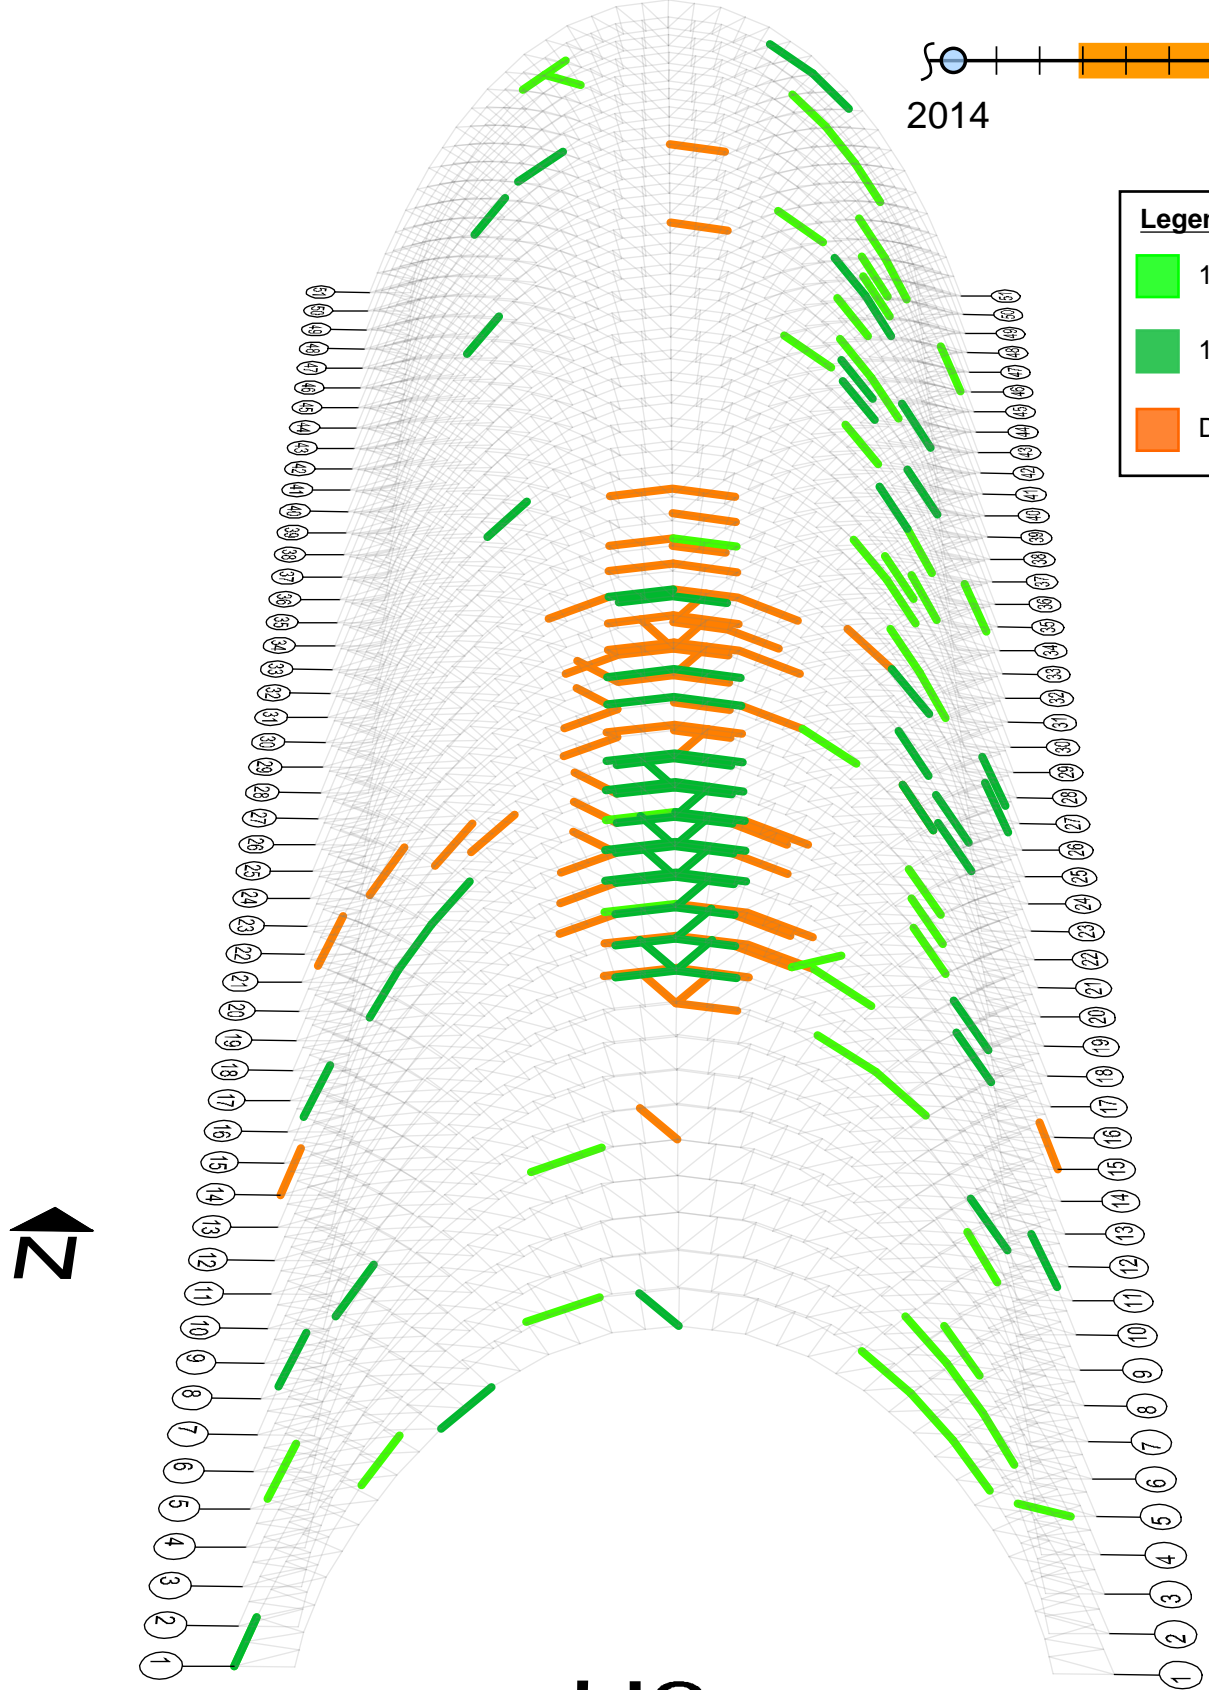
H3

- █ 1981 Glulam Repairs
- █ 1993 Glulam Repairs
- █ DDIF Repair Scope

- TPAS® data was reviewed and damaged members were identified for repair
- **68** members were found to be damaged and in need of major repairs

Example detail for removal and replacement of damaged chords found in TPAS®

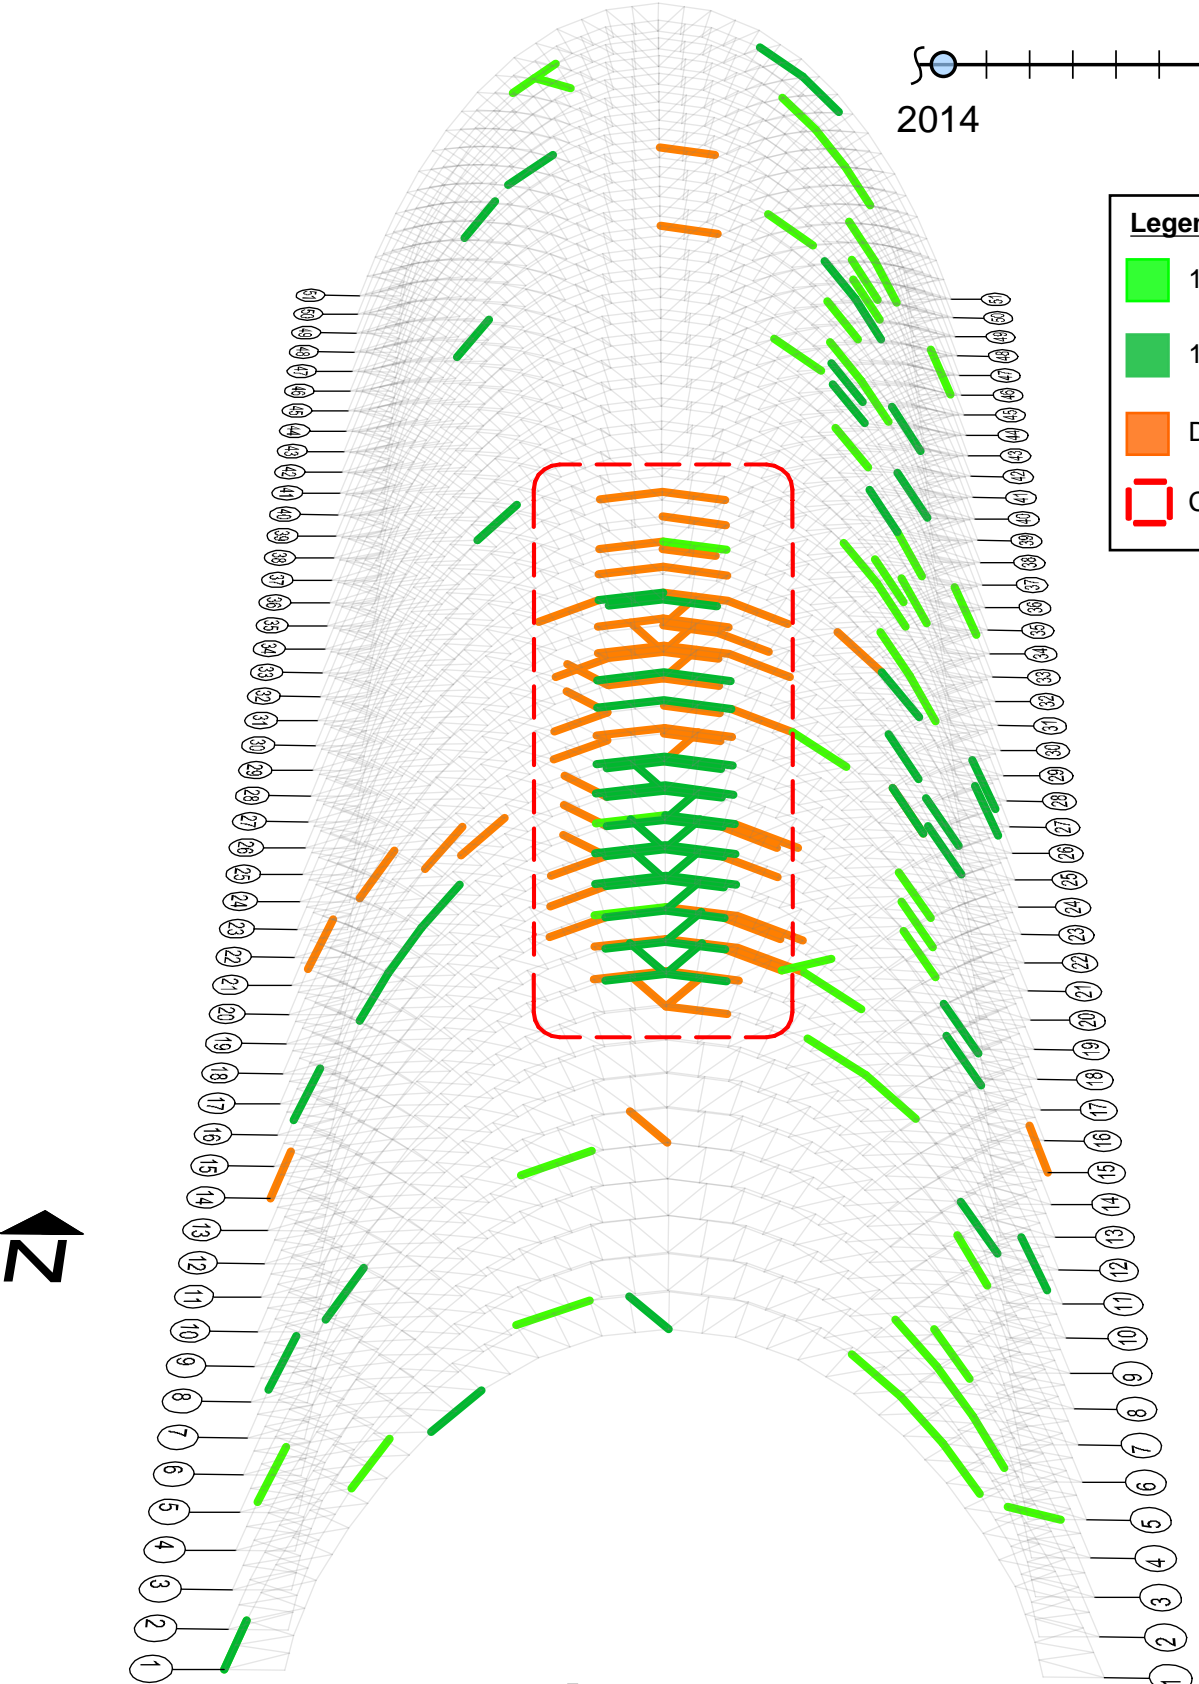
- █ 1981 Glulam Repairs
- █ 1993 Glulam Repairs
- █ DDIF Repair Scope
- Critical damage zone

- During a site visit on June 24, 2015 KPFF observed damage progression in arch trusses
- On July 2, 2015 KPFF issued an Emergency Truss Repairs permit drawing set
- KPFF, Power Engineering Construction, Turner, and Page & Turnbull coordinated work to implement shoring and emergency truss repairs
- Permit for emergency repairs was received from NASA on August 19, 2015.

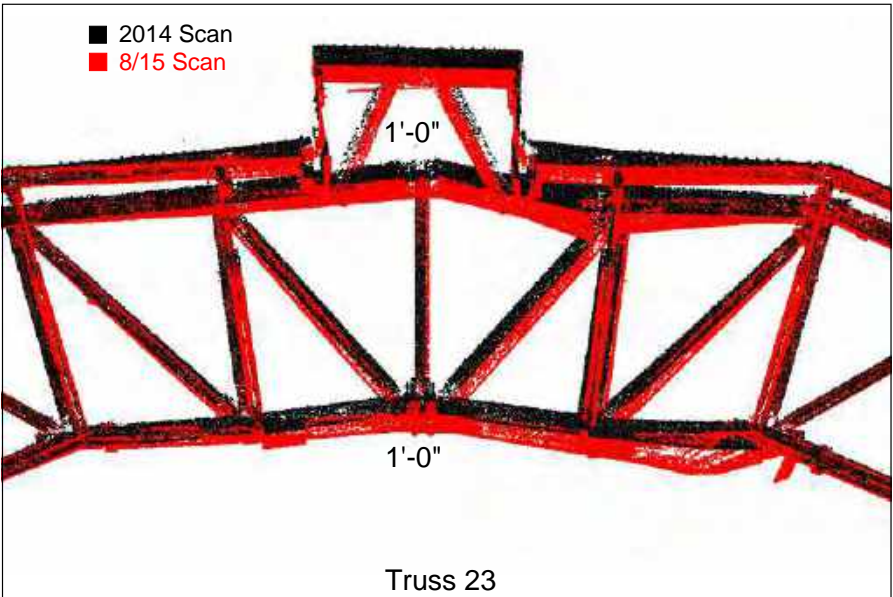
Point cloud visualization of damage progression

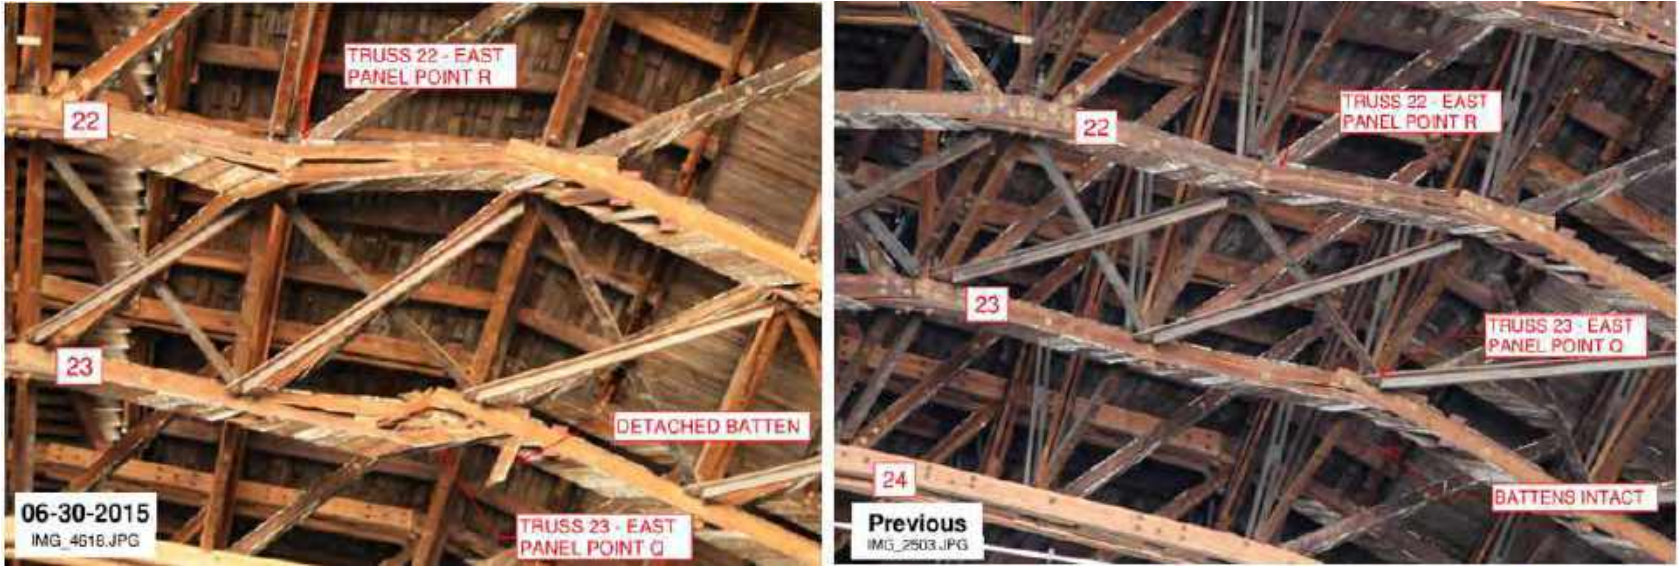
Photos of damage progression

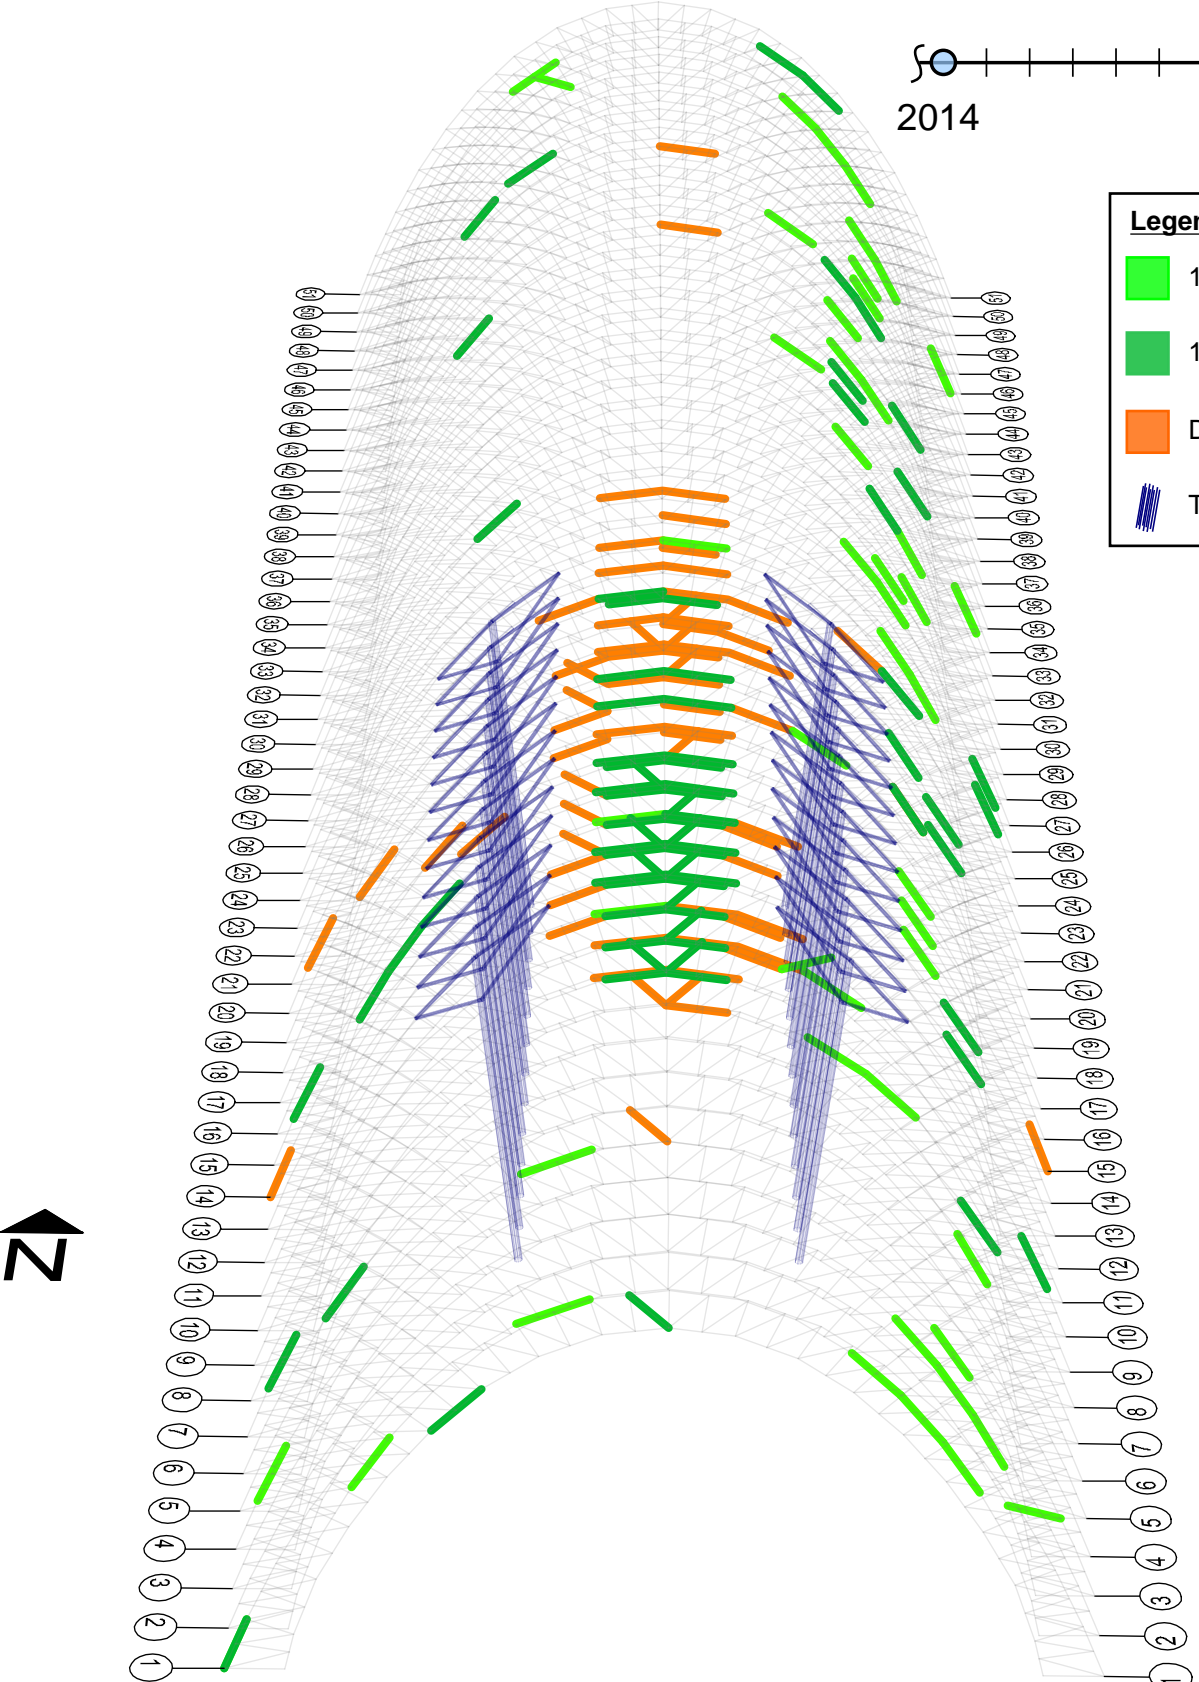
H3

- █ 1981 Glulam Repairs
- █ 1993 Glulam Repairs
- █ DDIF Repair Scope
- █ Temporary Shoring

- Evidence of severe damage and progressive collapse of Hangar 3 necessitated a shoring and emergency repair program
- As part of the contractor's means and methods of performing repairs, 36"Ø steel pipe shores were placed between trusses 9-26
- Pipe shores were designed to provide secondary stability in the event of progressive roof collapse during repair procedures
- Steel exoskeletons with jacks would then be placed at top to jack the roof and rebuild the critical zone

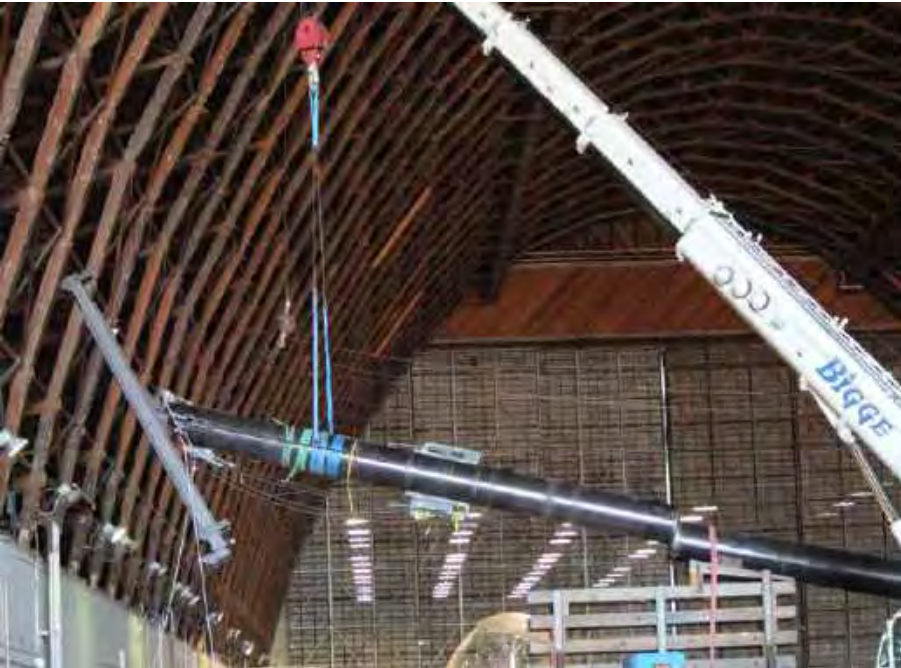
Hoisting of temporary shore segment

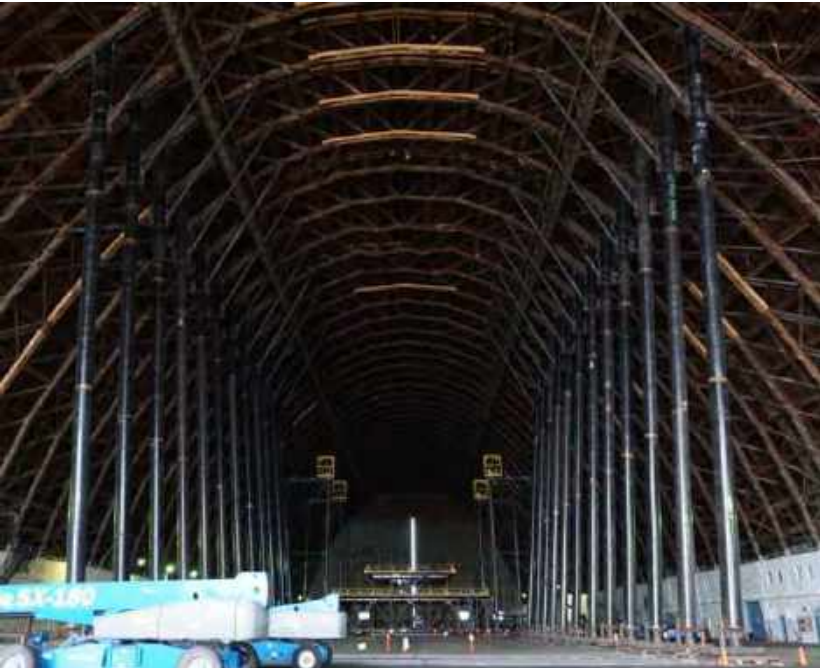
Temporary shores after installation
