MFA Hangar 3 Hazard
Remediation Section 106
Technical Report

SHPO# NASA_2019_1216_001

Moffett Federal Airfield,
Santa Clara County, California

May 11, 2020

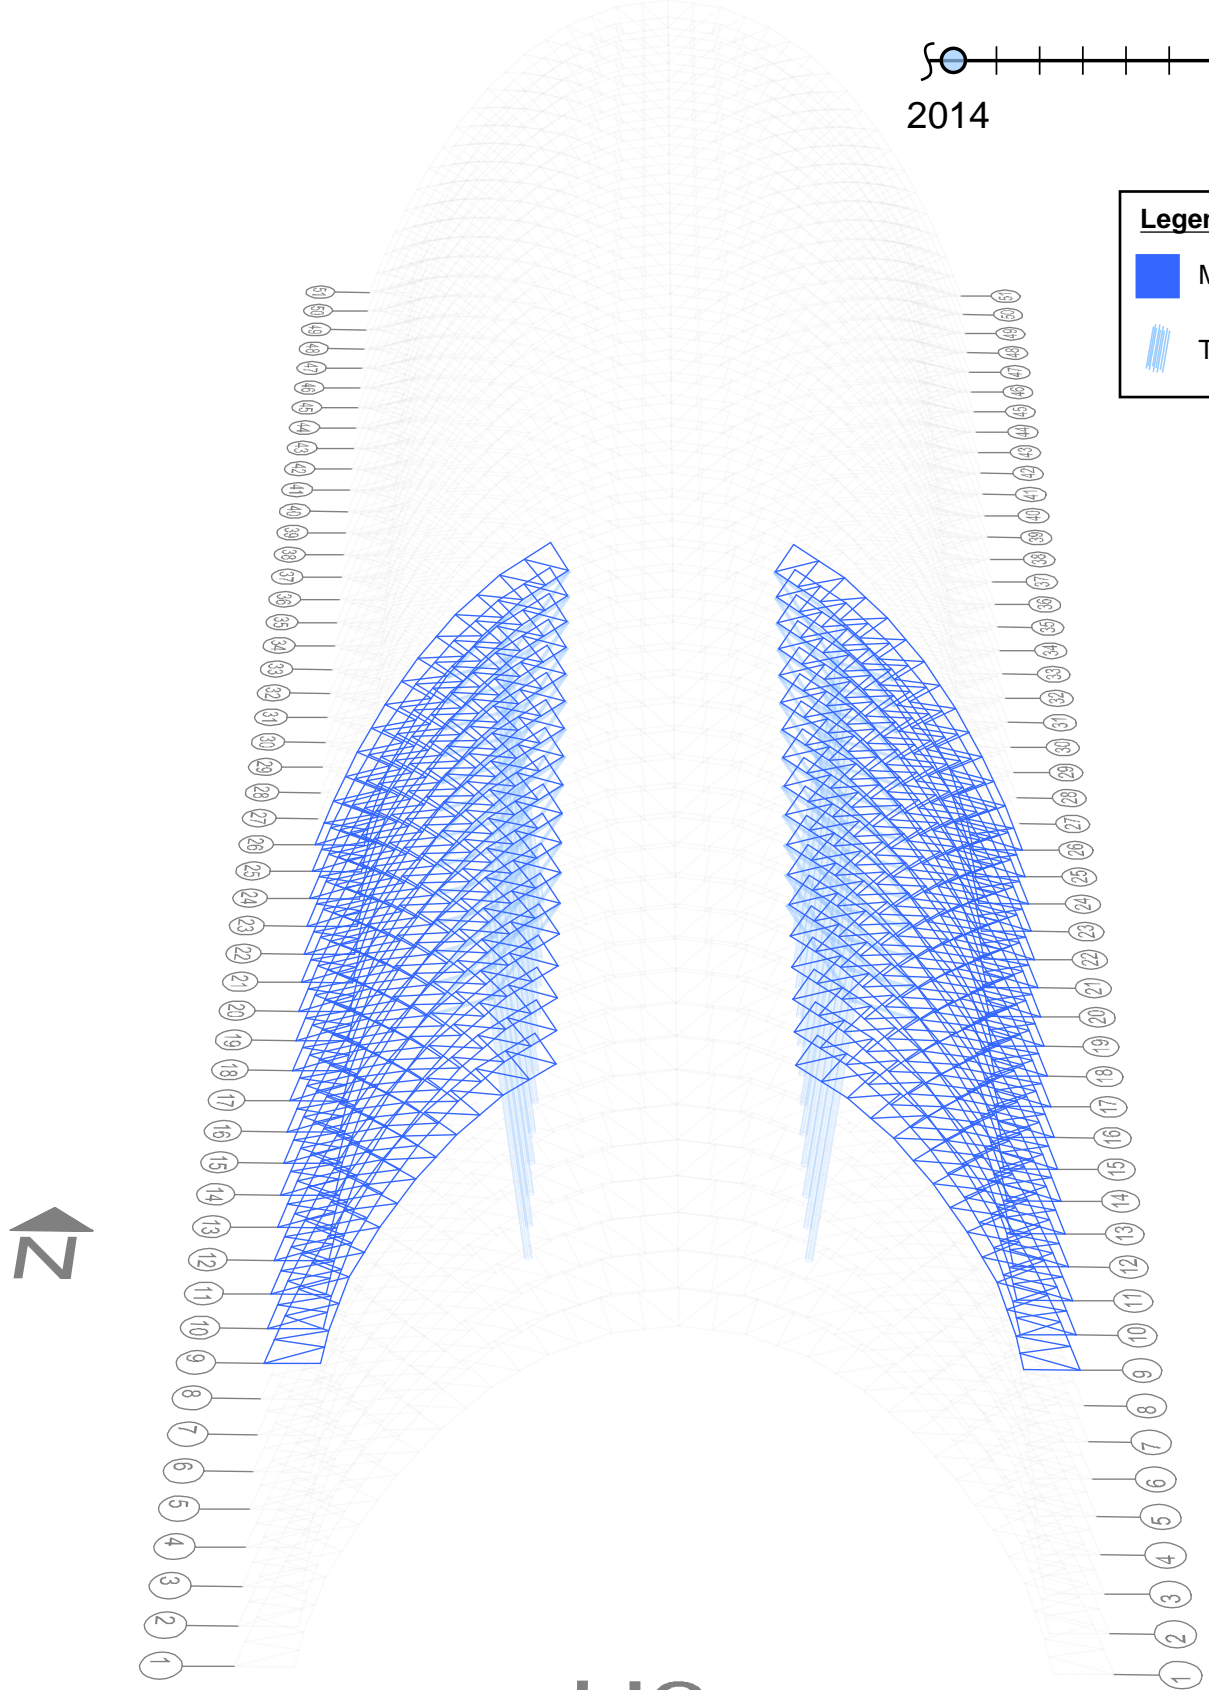
- Members surveyed below exoskeletons
- Temporary shoring

- Before the exoskeletons could be placed, the condition of the trusses below had to be verified to ensure they could take the additional weight
- Any damage of main arch members needed to be repaired prior to exoskeleton installation
- KPFF conducted a survey of main arch members between Trusses 9-26 below panel point O and 14
- **1548** main arch chords and webs were surveyed for damage

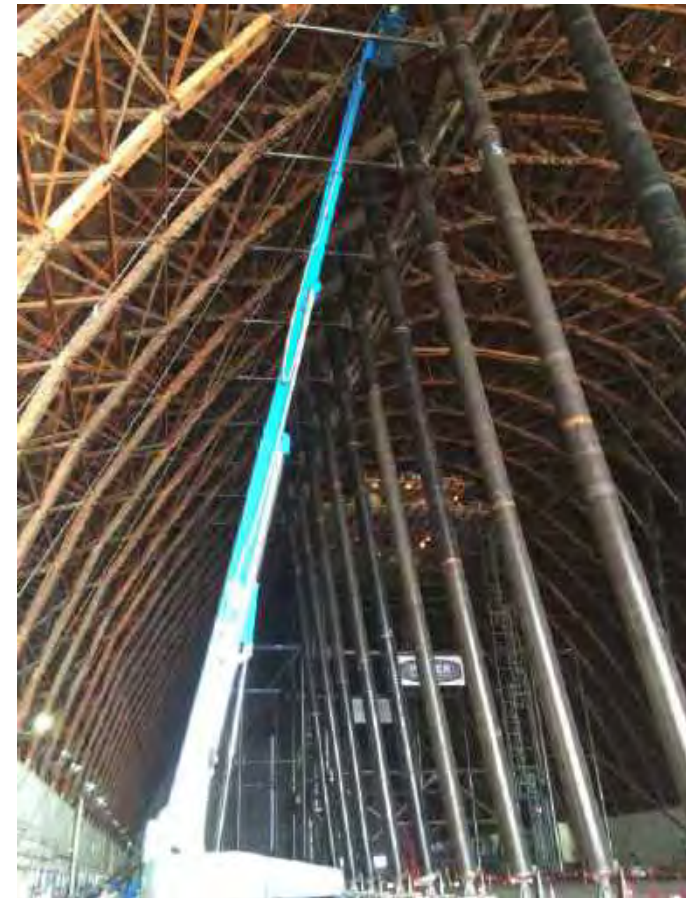
Boom lift used for visual observations

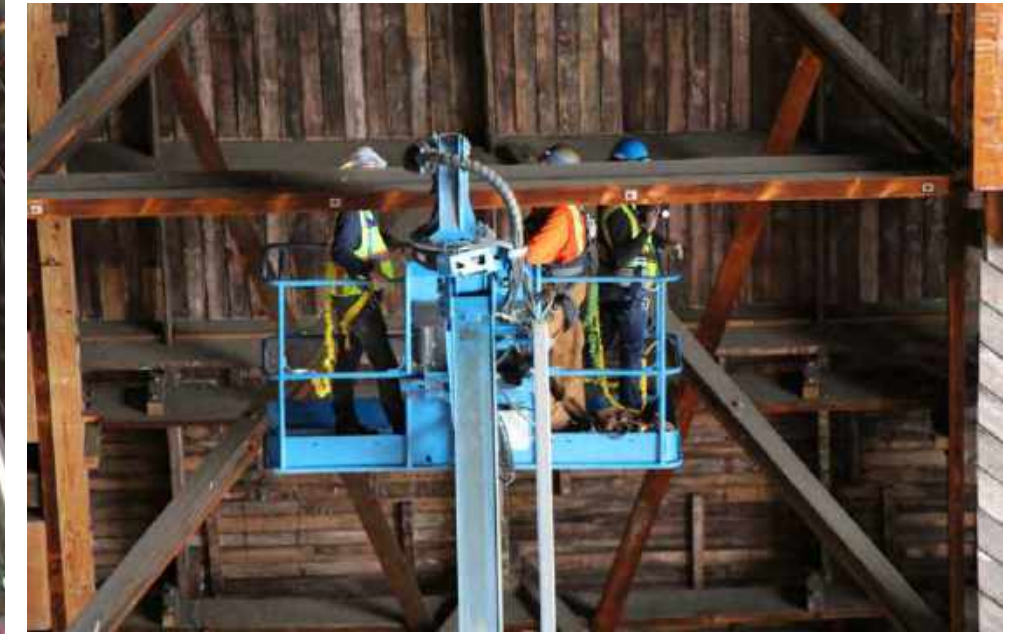
KPFF condition assessment crew

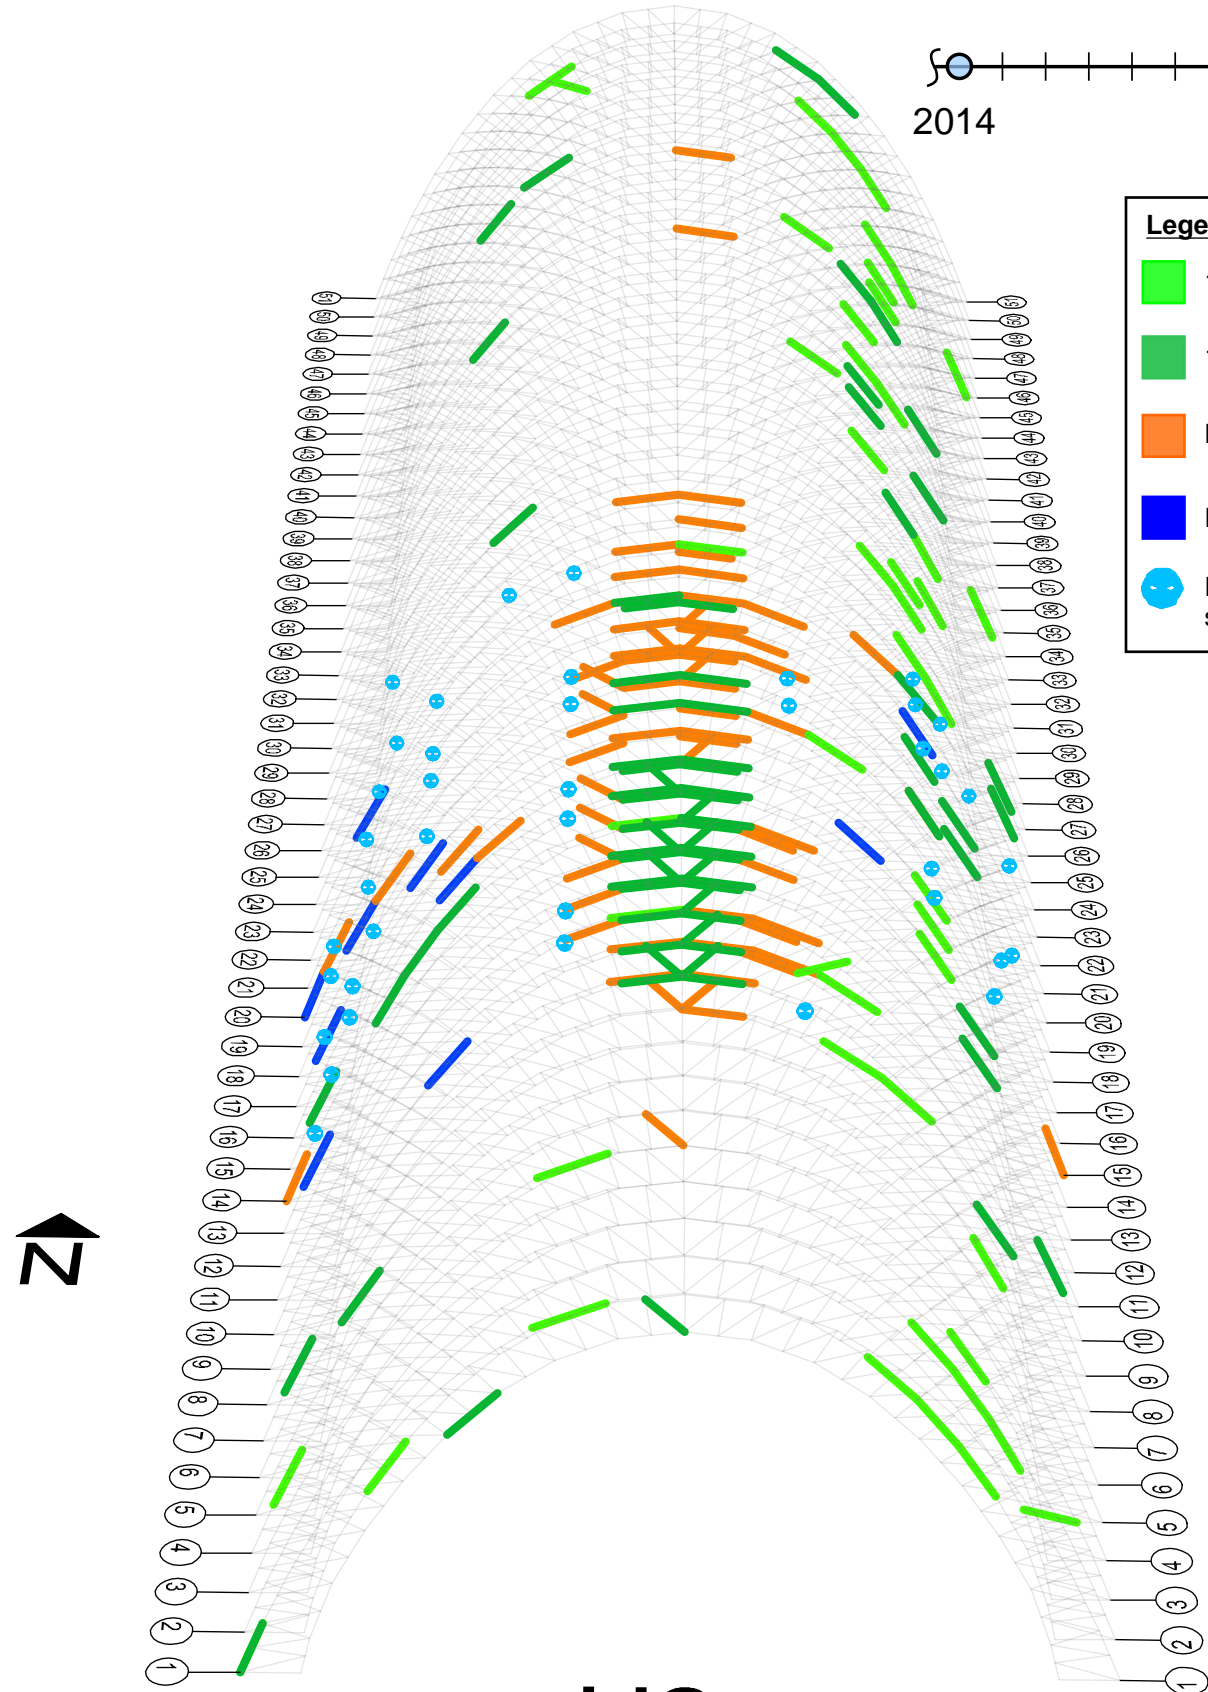
- █ 1981 Glulam Repairs
- █ 1993 Glulam Repairs
- █ DDIF Repair Scope
- █ Pre-jacking sister repair
- Pre-jacking connection strengthening bracket

- The KPFF survey discovered chord damage which was either not observed or not present during the due diligence investigations
- The survey uncovered extensive deficiencies within the web member connections, including many plug pullout failures
- **10** additional arch members received glulam sistering repairs
- **39** chord connections received connection strengthening brackets

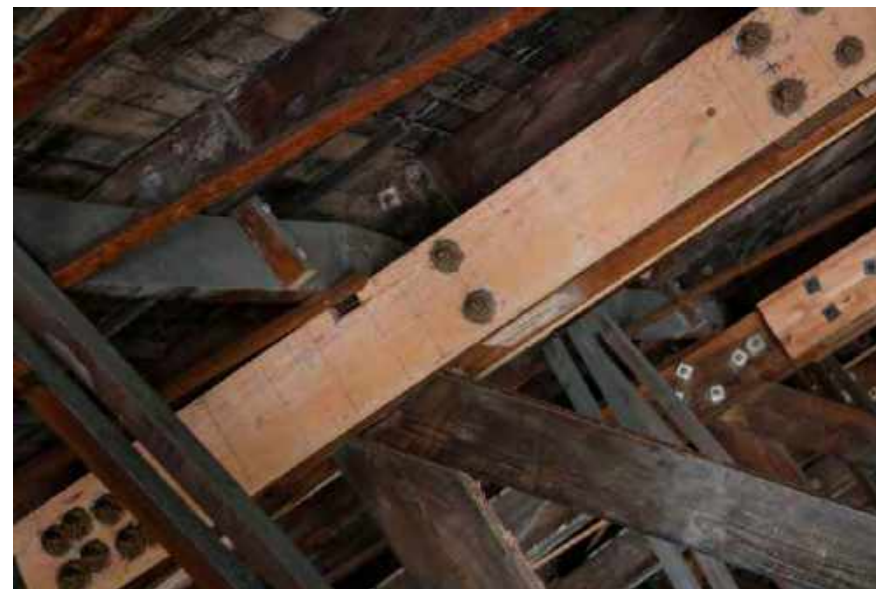
Chord sister repair installed prior to exoskeletons

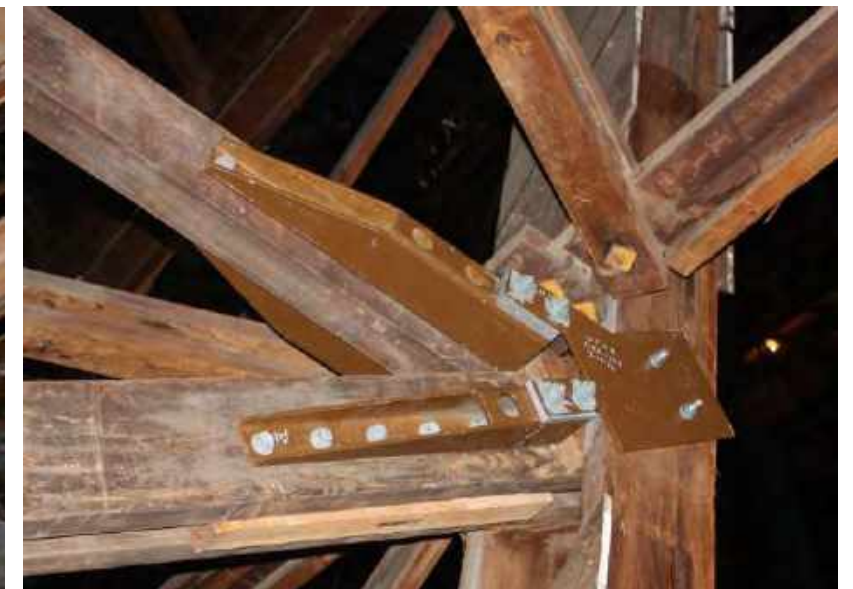
Typical connection strengthening bracket

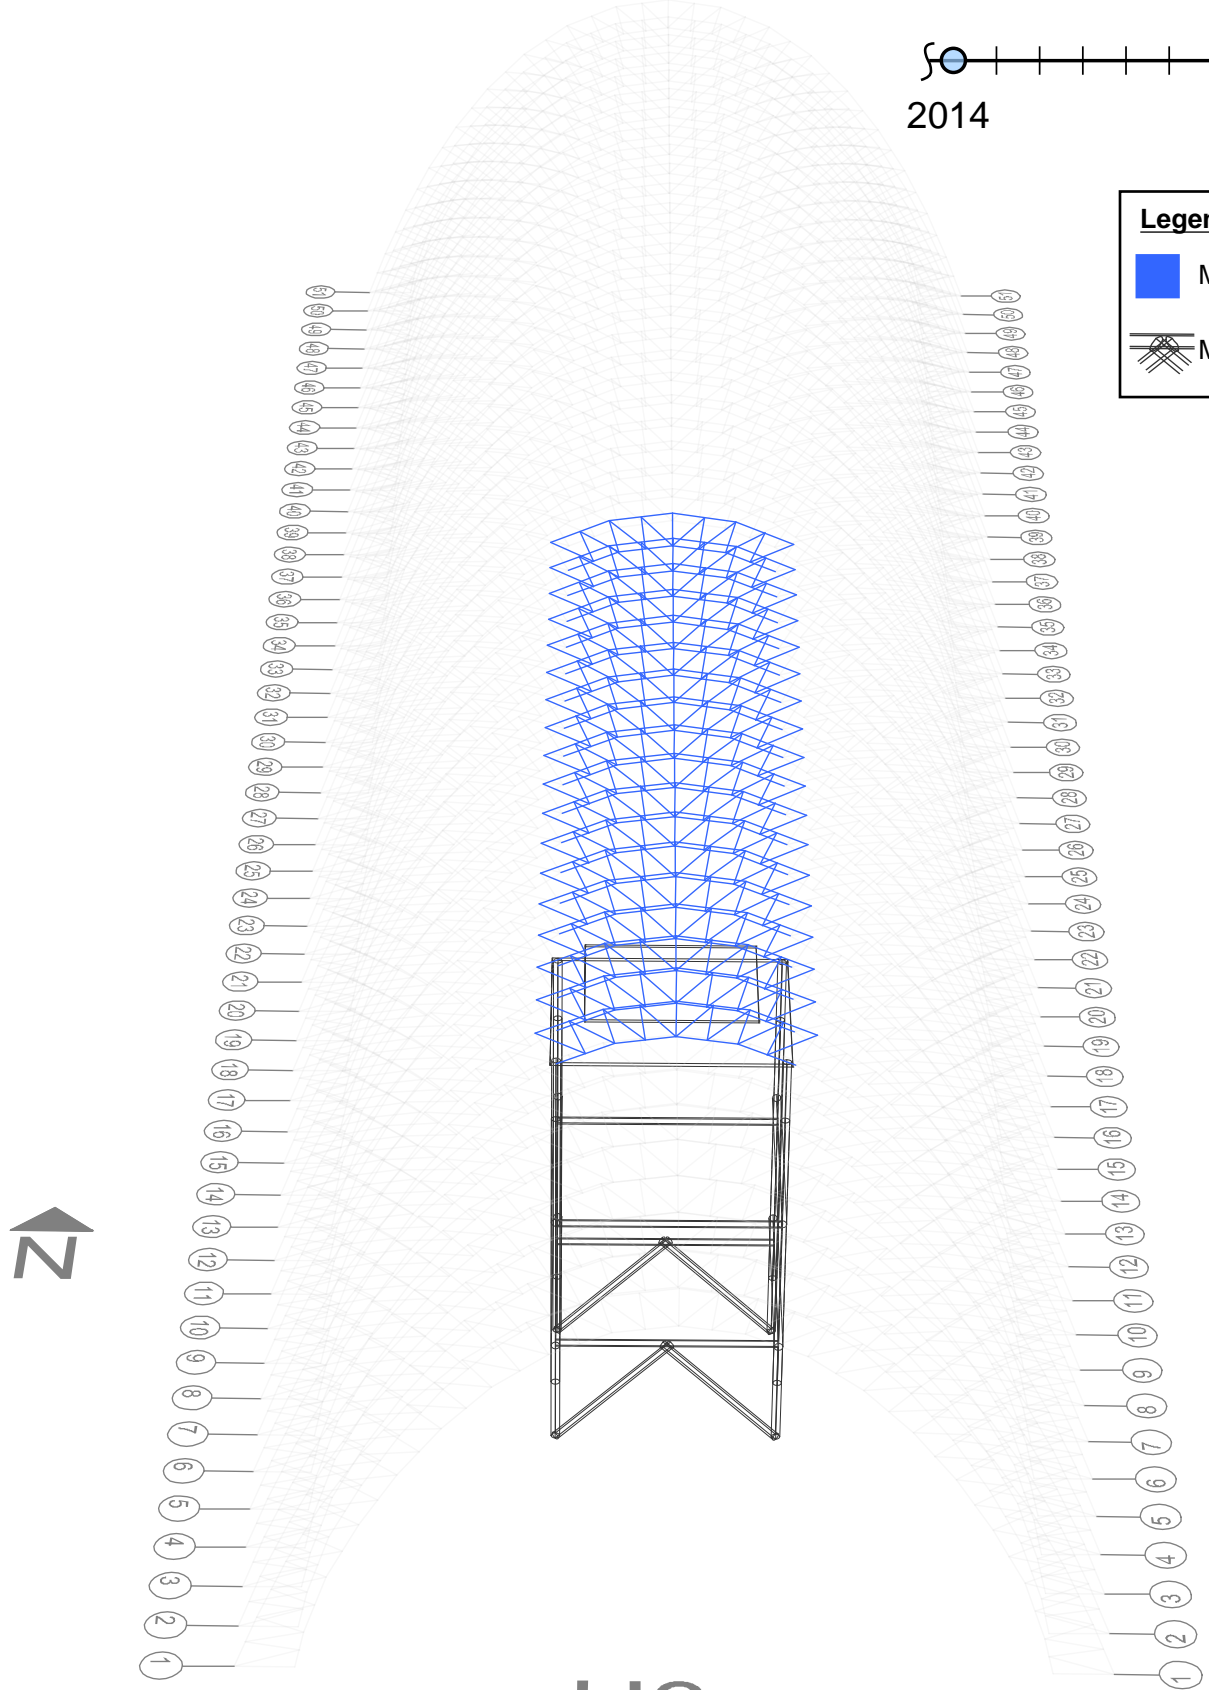
H3

- Members surveyed from tower
- Movable access tower

- The movable access tower provided clearance for KPFF to make additional observations in the zones above the temporary shores
- Chord and web members were observed after each tower move before the exoskeletons were installed
- Additional damage observed in this zone was planned to be repaired after roof jacking

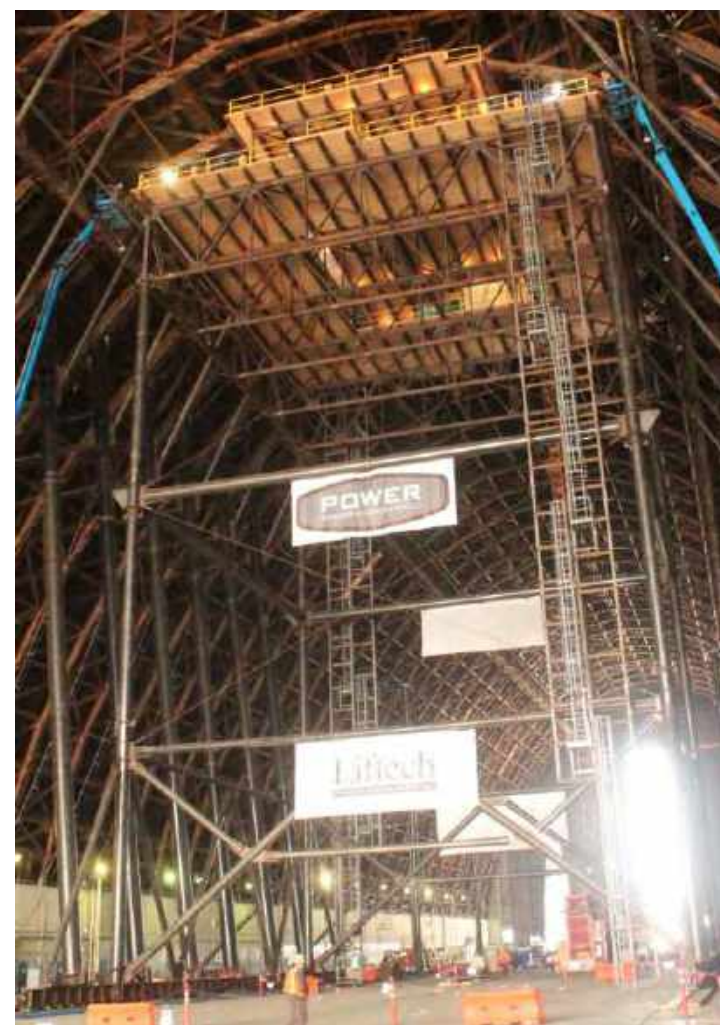
Movable access tower

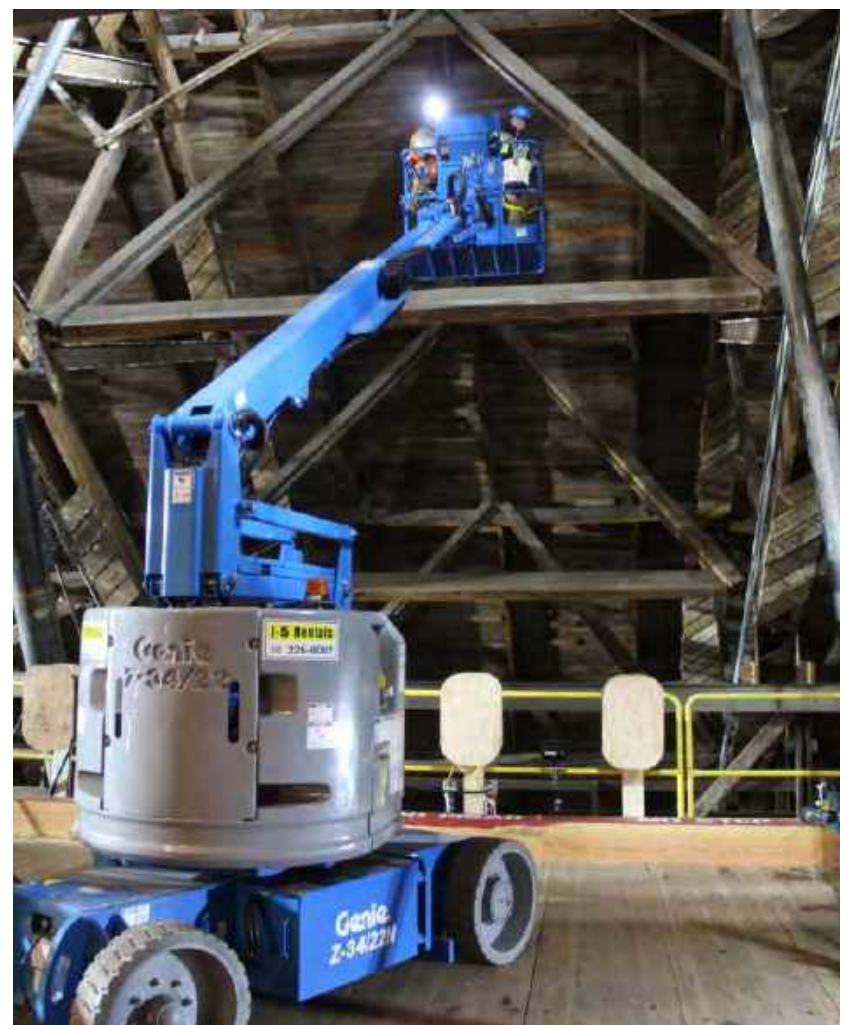
Truss observations from a boom lift on top of access tower

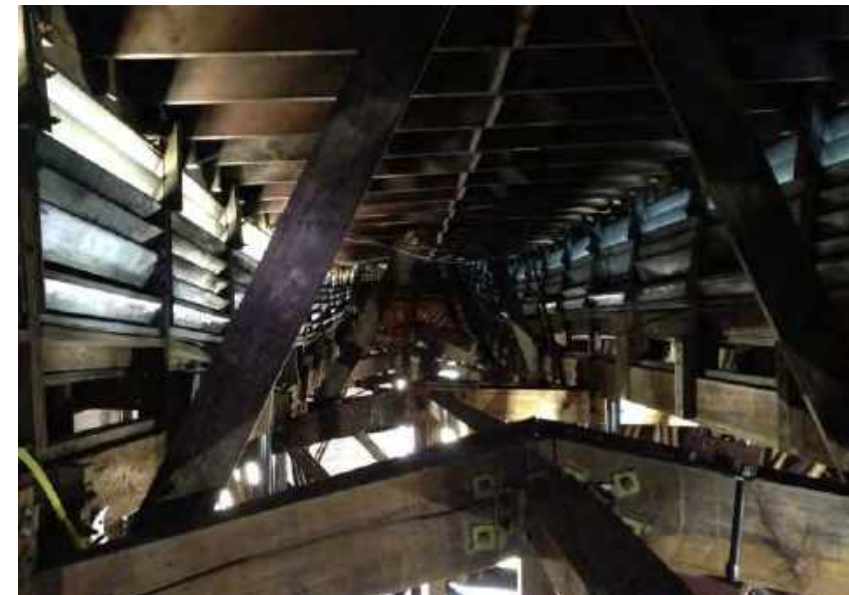
- **50** additional members were identified as severely damaged and scheduled to be removed and replaced after roof jacking
- Before jacking and repairs were made, decision was made to defer further construction activities

Roof monitor deflection in critical zone

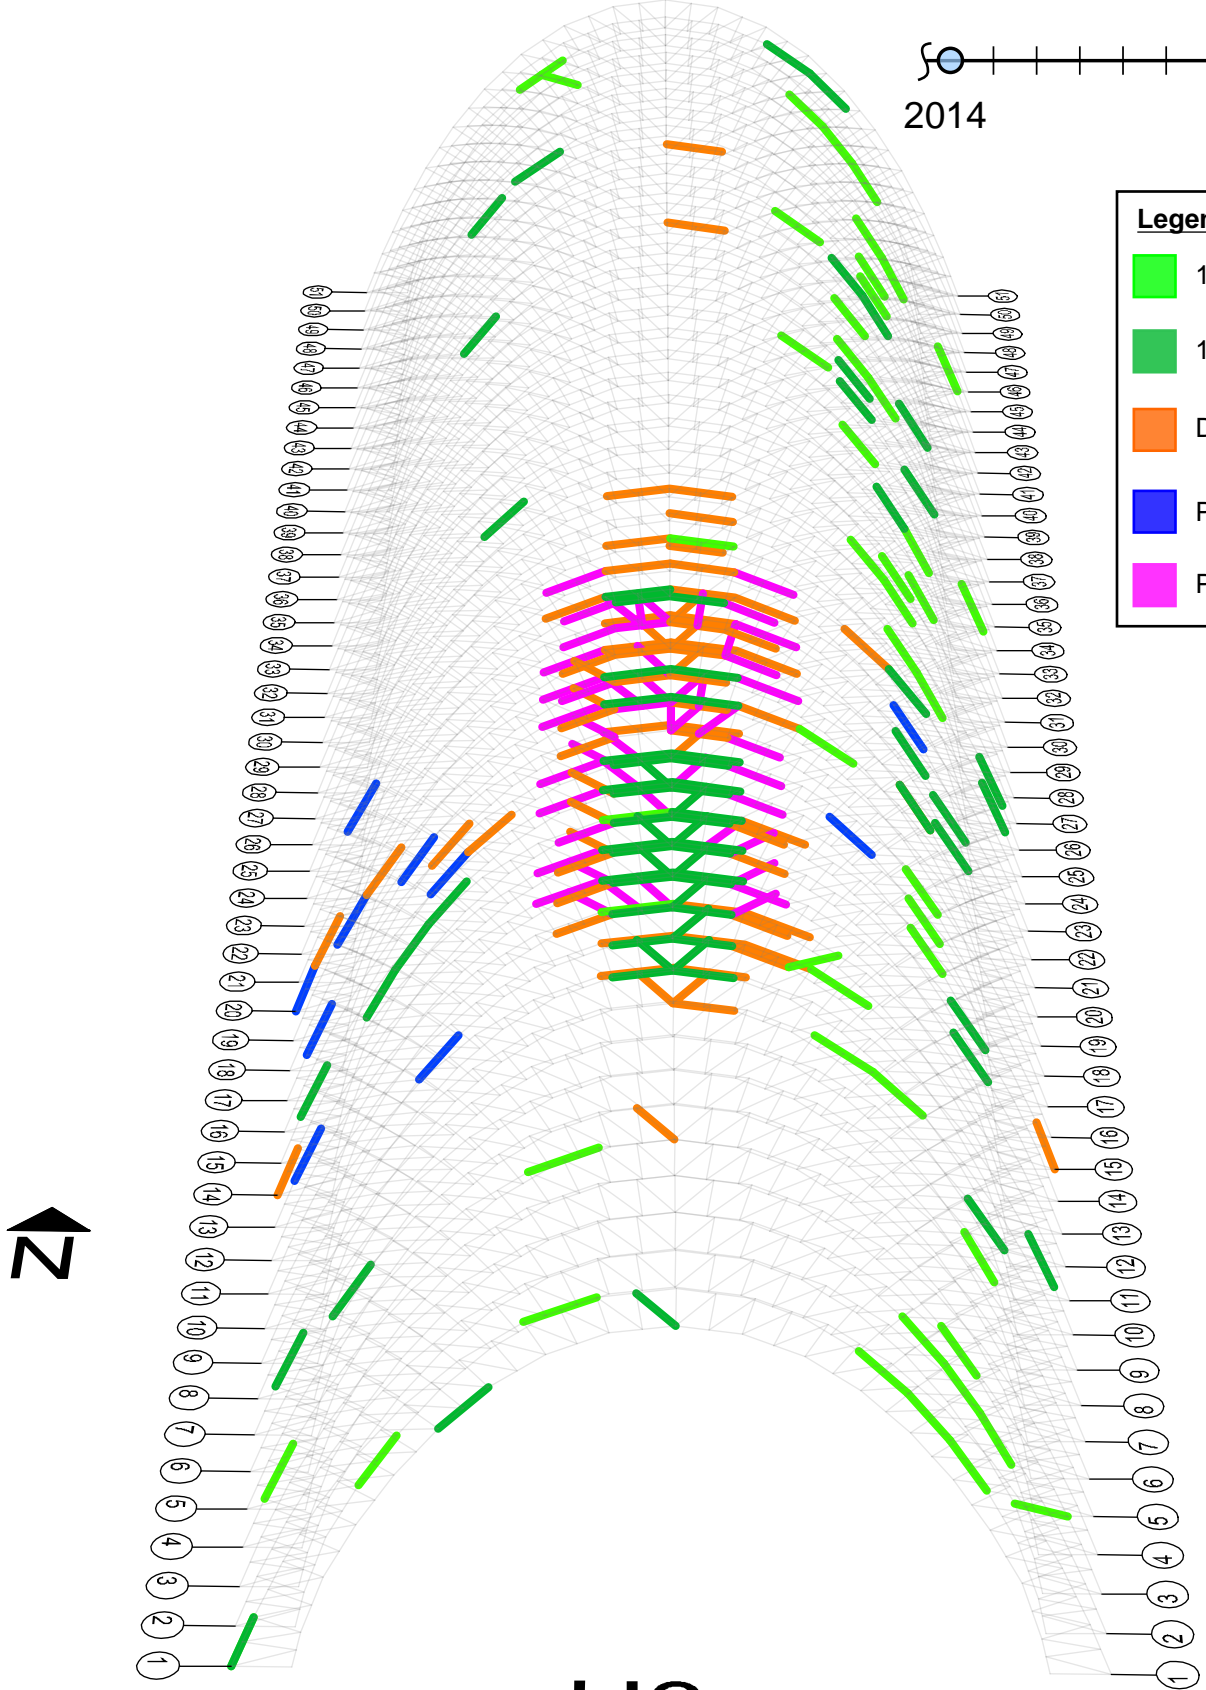
H3

- █ 1981 Glulam Repairs
- █ 1993 Glulam Repairs
- █ DDIF Repair Scope
- █ Pre-jacking repair scope
- █ Post-jacking repair scope

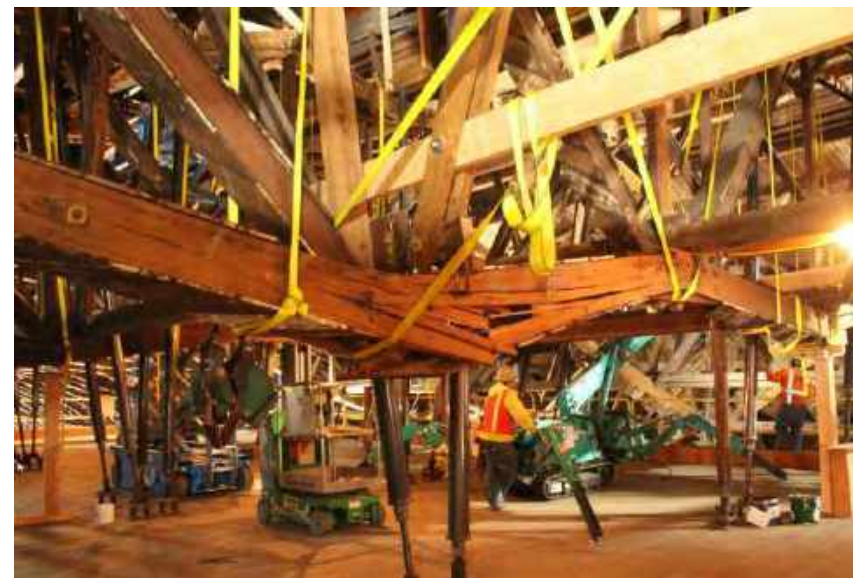
Temporary strapping on chord marked for removal and replacement

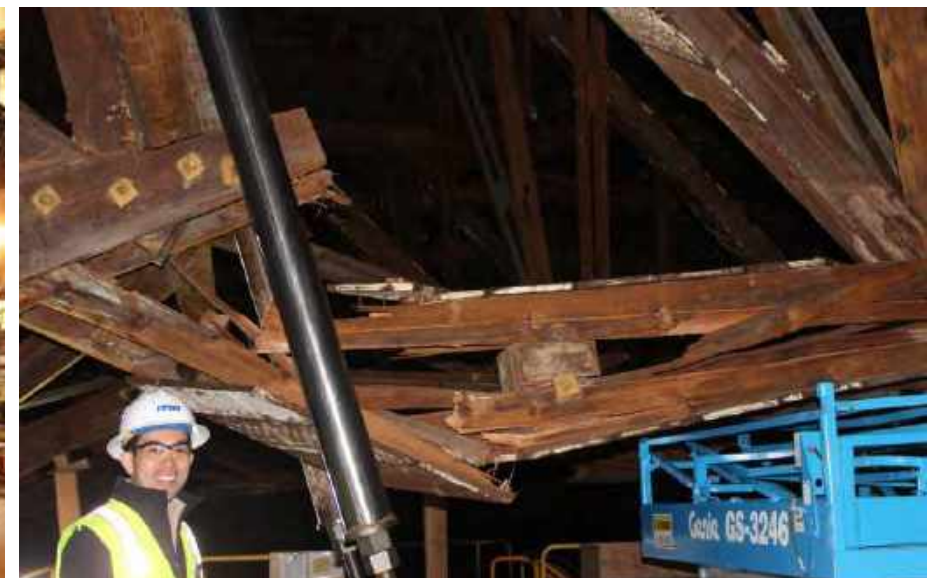
Damaged chord member viewed from access tower

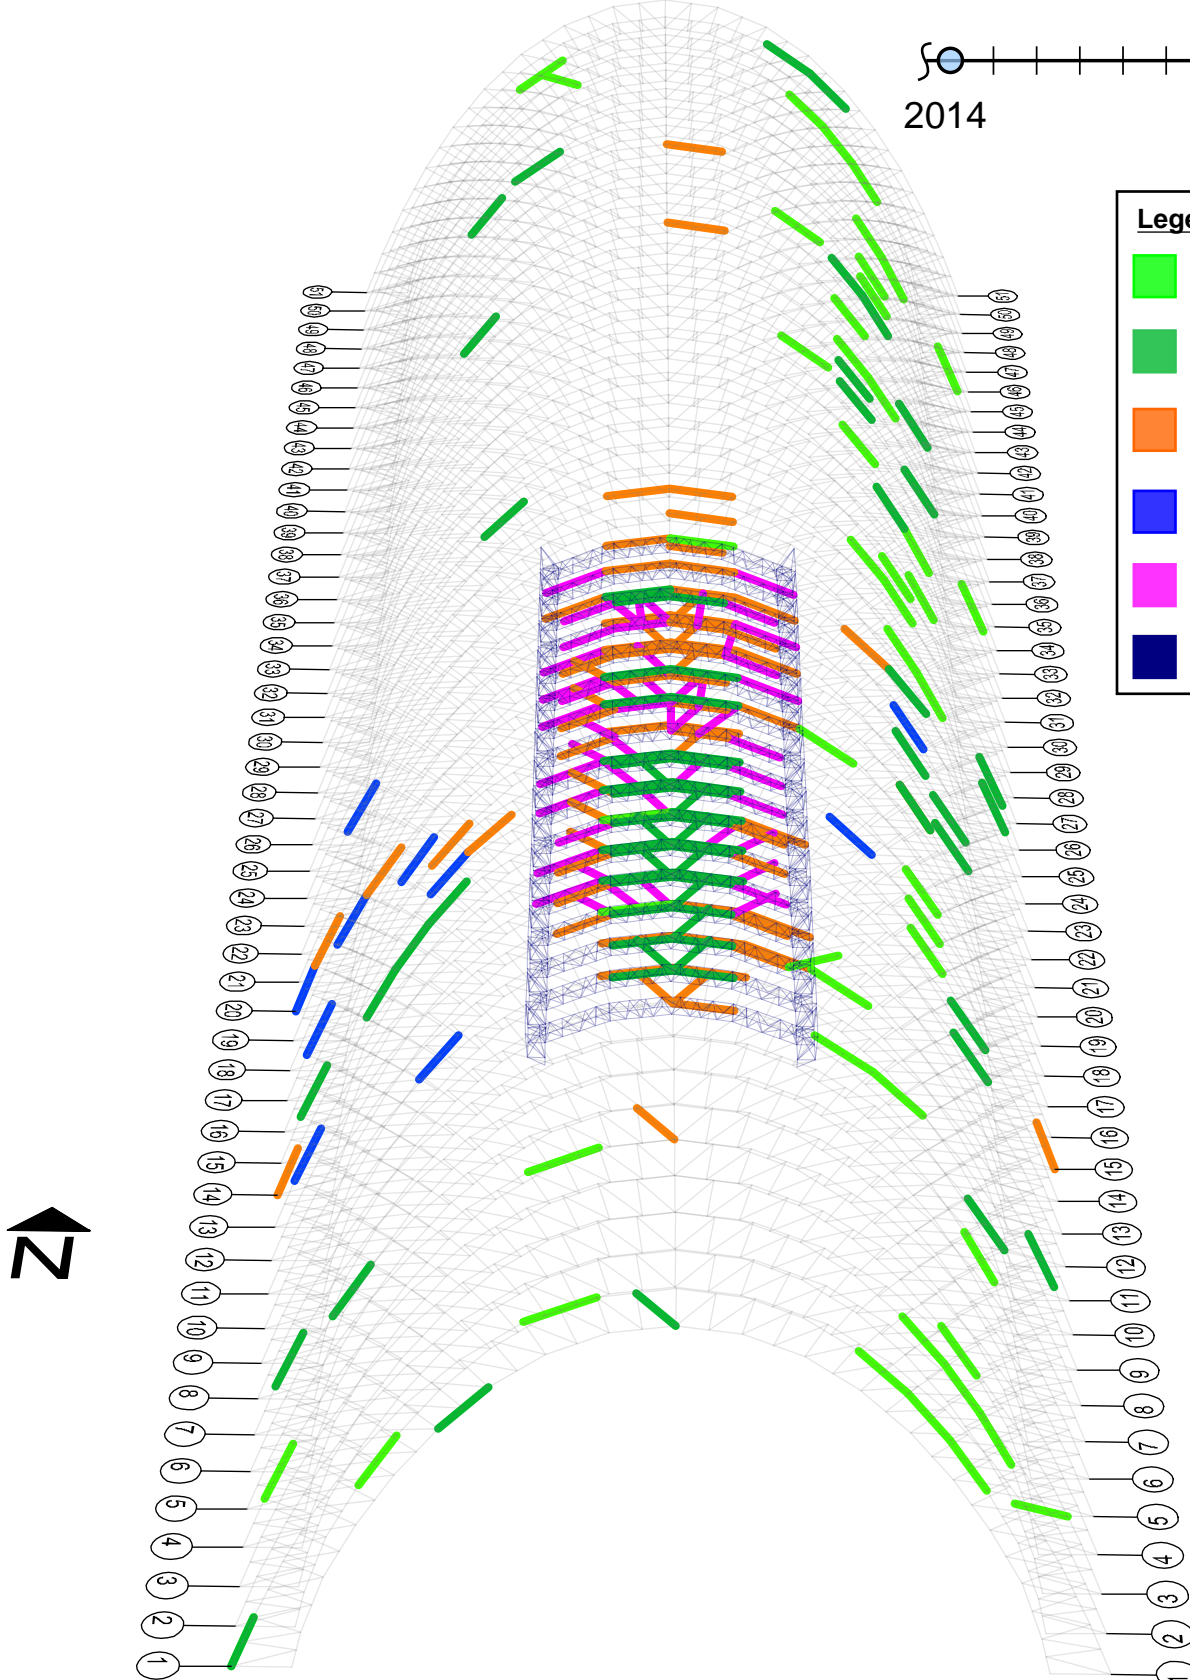
Legend	
█	1981 Glulam Repairs
█	1993 Glulam Repairs
█	DDIF Repair Scope
█	Pre-jacking repair scope
█	Post-jacking repair scope
█	Exoskeletons

- Steel exoskeletons were installed at Trusses 9-26 after observations were made.

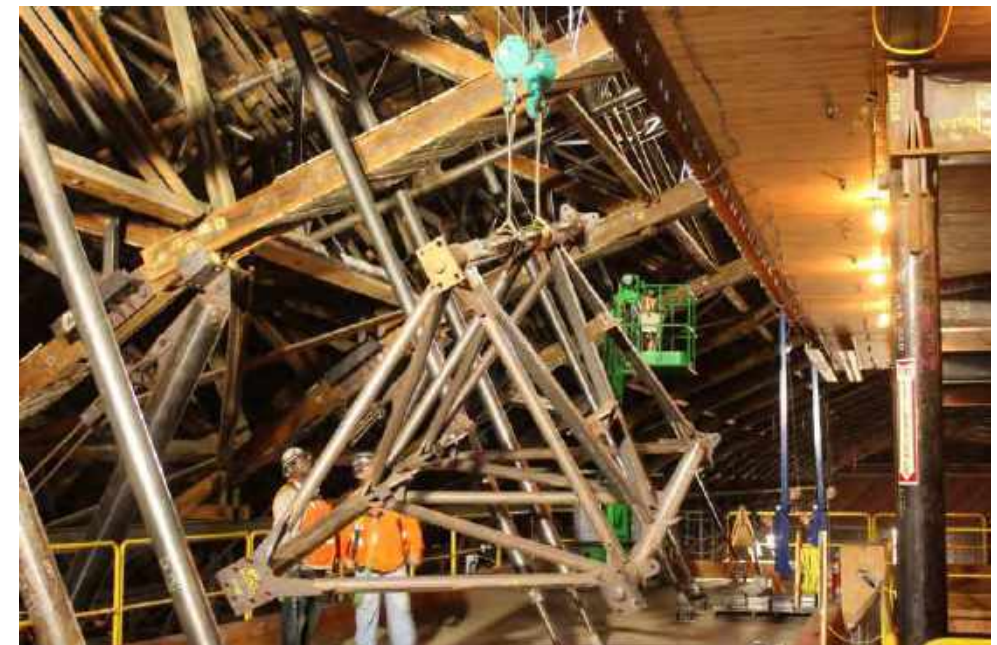
Hoisting exoskeleton segment into place

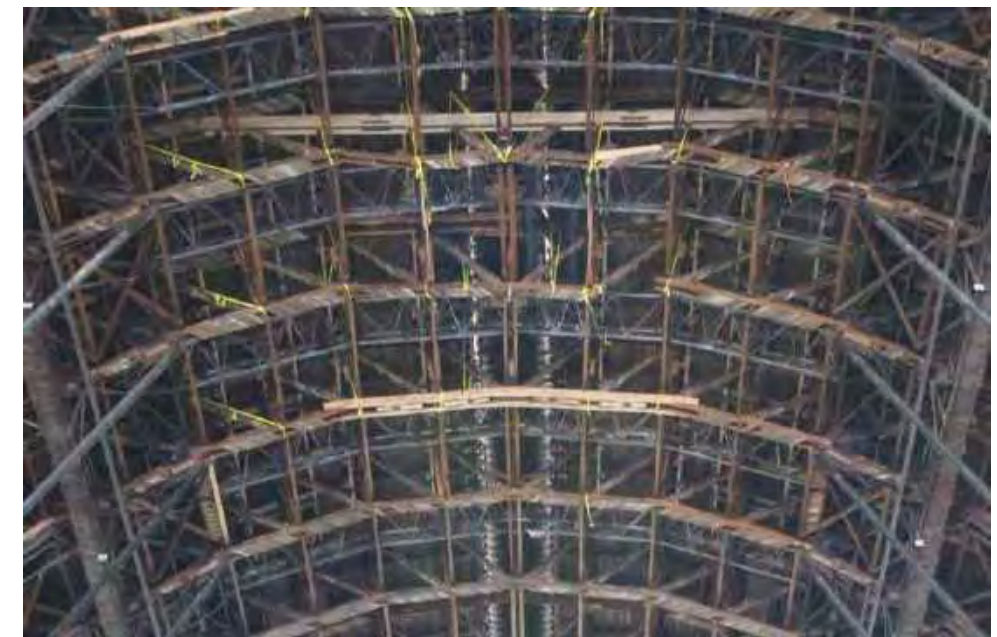
Installed exoskeletons

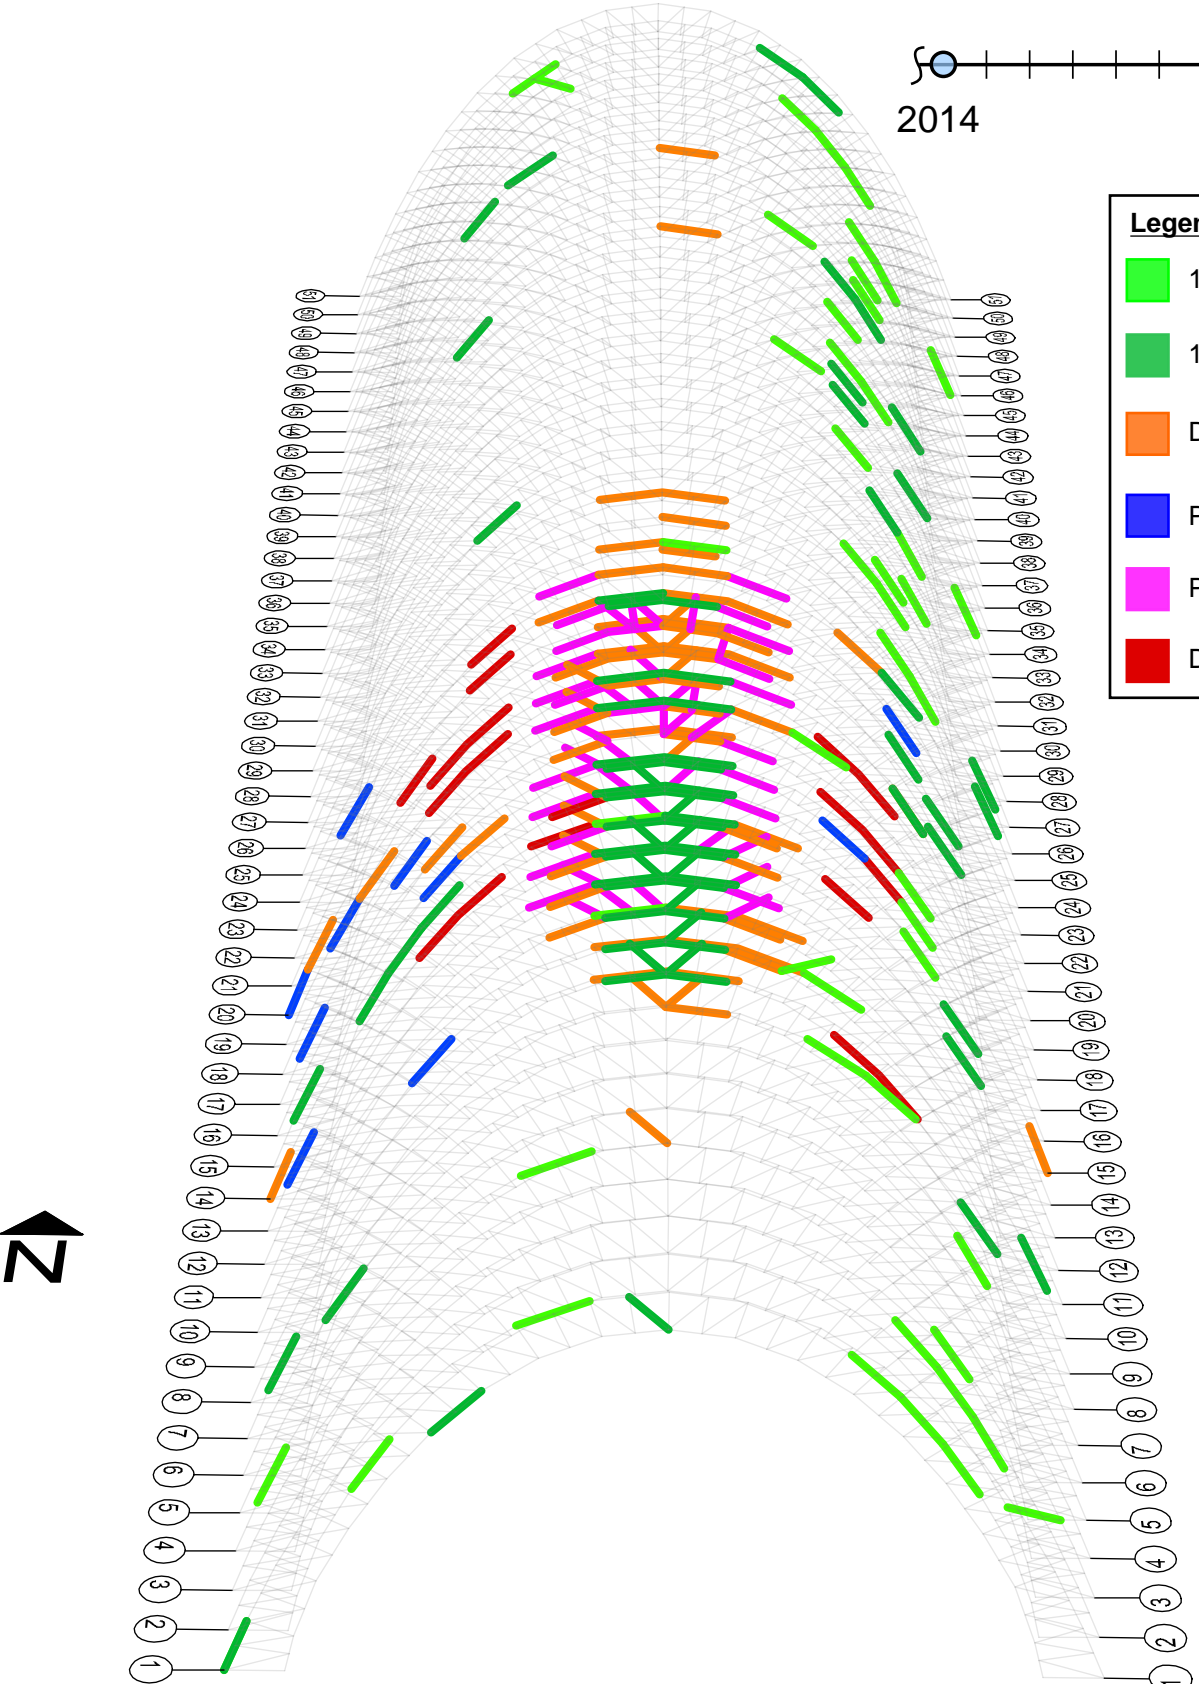
- █ 1981 Glulam Repairs
- █ 1993 Glulam Repairs
- █ DDIF Repair Scope
- █ Pre-jacking repair scope
- █ Post-jacking repair scope
- █ Damage progression

- Months after installation of exoskeletons, major splits were observed in chord members which had previously been observed and cleared.
- Major damage was observed on **19** chords, most between panel points I to M.
- Sistering repairs installed on most severe cases
- Due to the concentration of new damage at the lower chord members at panel points I to M, preemptive measures were taken to help reduce the progression of damage.
- Preemptive measures included fully-threaded screws at connections, and steel clamps.

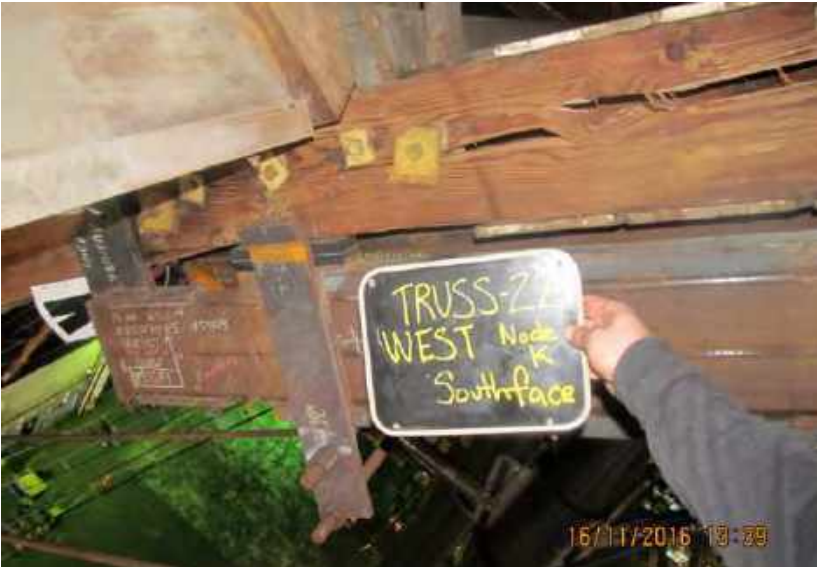
Chord damage at node K after exoskeleton install

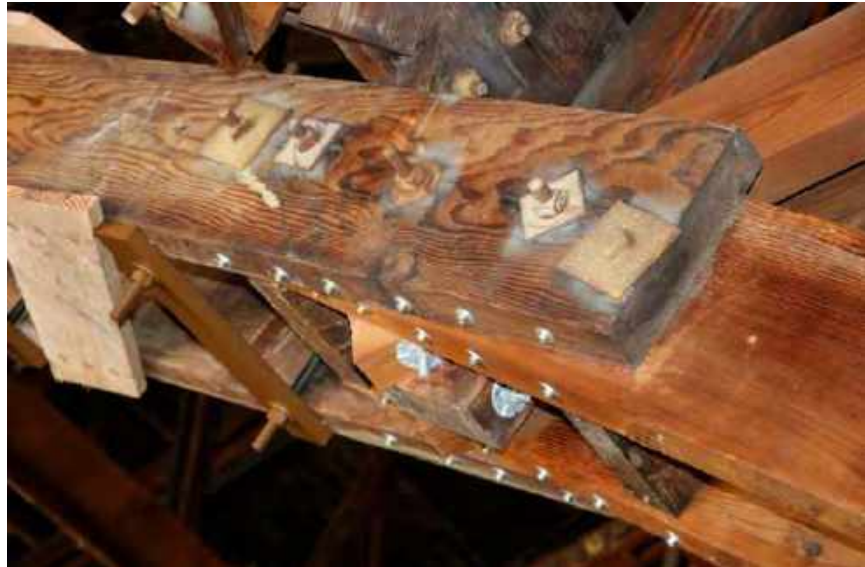
Preemptive screw and clamp strengthening on undamaged chord at node K

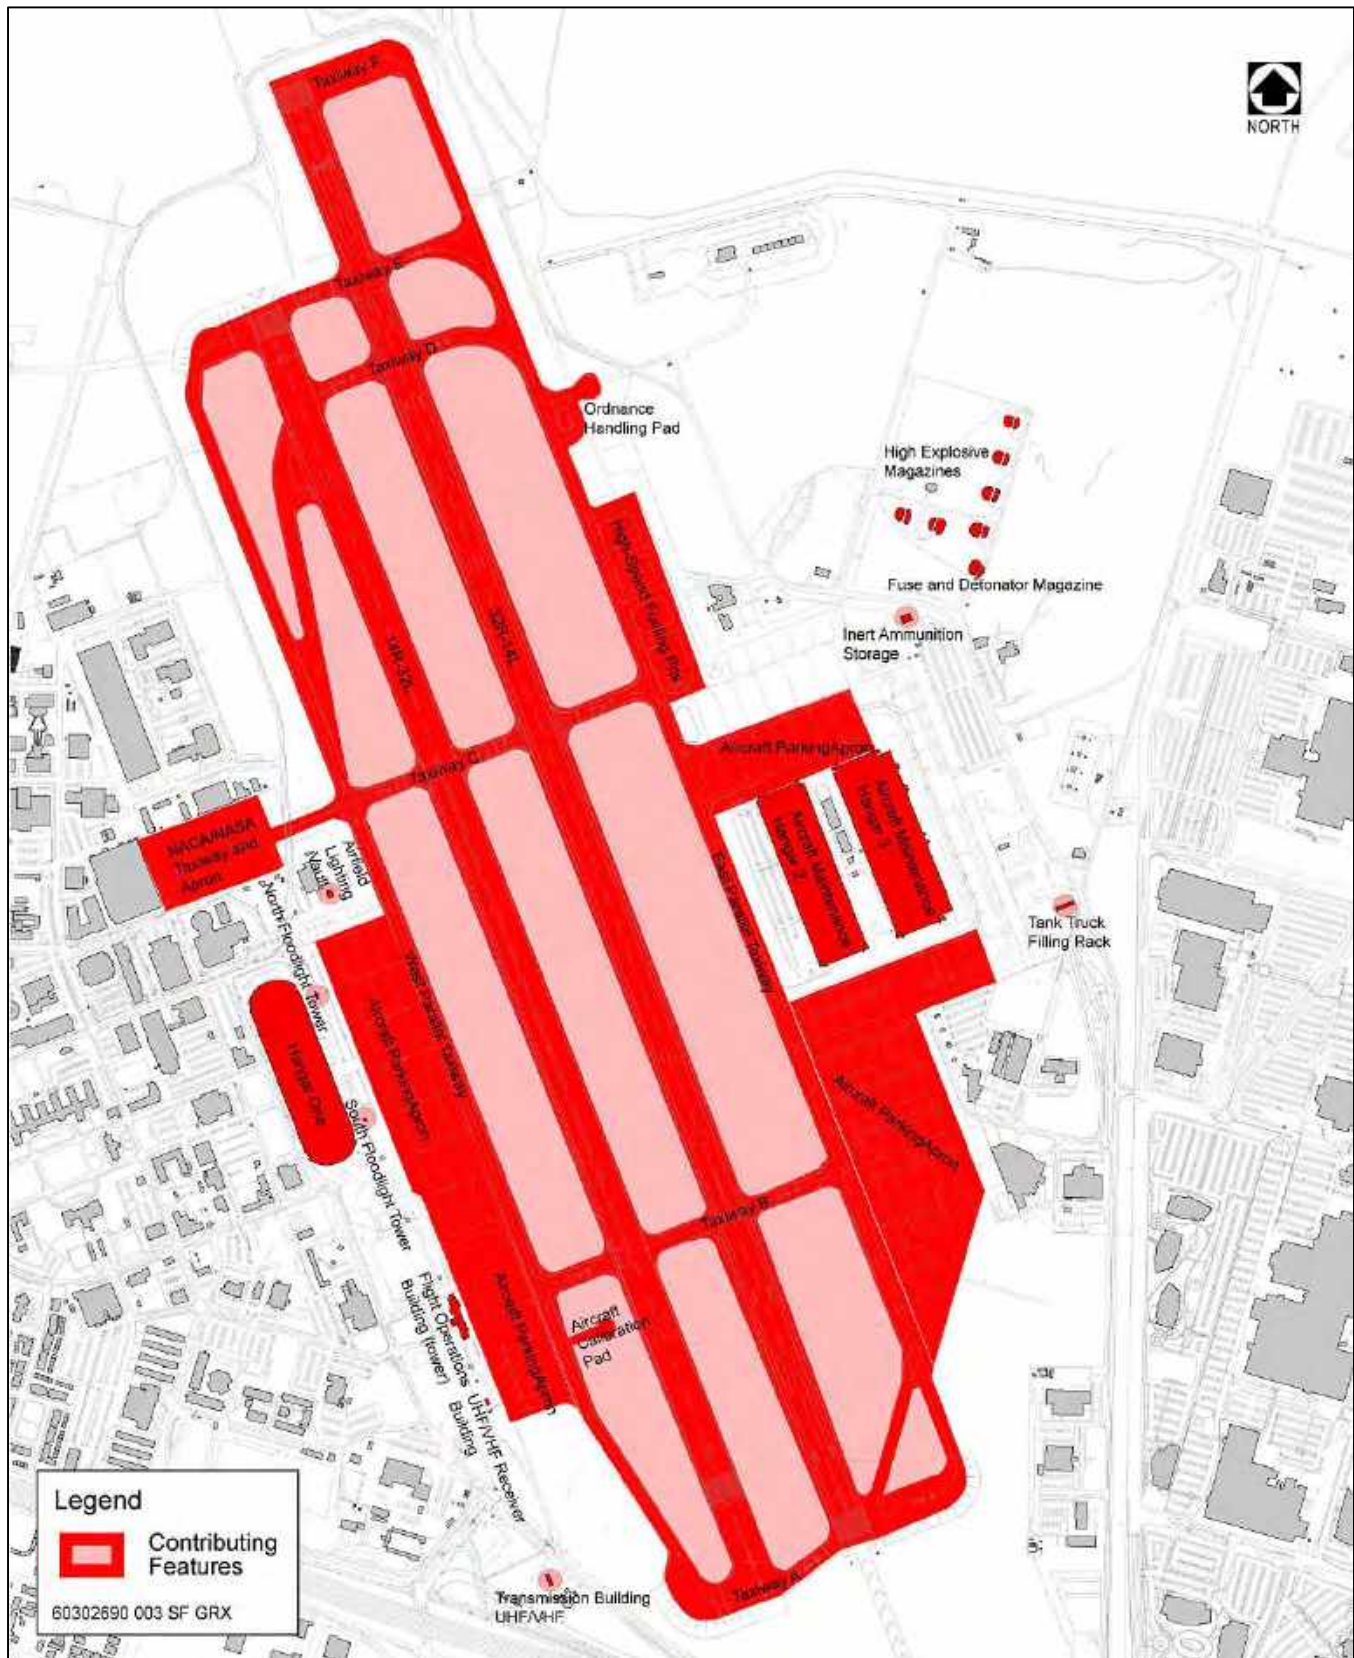
Figure 2. Preliminary Map of Contributing Airfield Features

Character-defining features of the Airfield are as follows (Figure 2, "Airfield Contributing Features"):

- Flat topography.
- Broad, open views across aviation areas.
- Long views to the salt ponds and San Francisco Bay.
- The expansive, linear system of aviation circulation, dominated by the two parallel concrete-paved runways and their associated taxiways. Associated contributing structures include Runway 14R-32L, Instrument Runway 32R-14L, west and east parallel taxiways, and the aircraft compass calibration pad.
