MFA Hangar 3 Hazard
Remediation Section 106
Technical Report

SHPO# NASA_2019_1216_001

Moffett Federal Airfield,
Santa Clara County, California

May 11, 2020

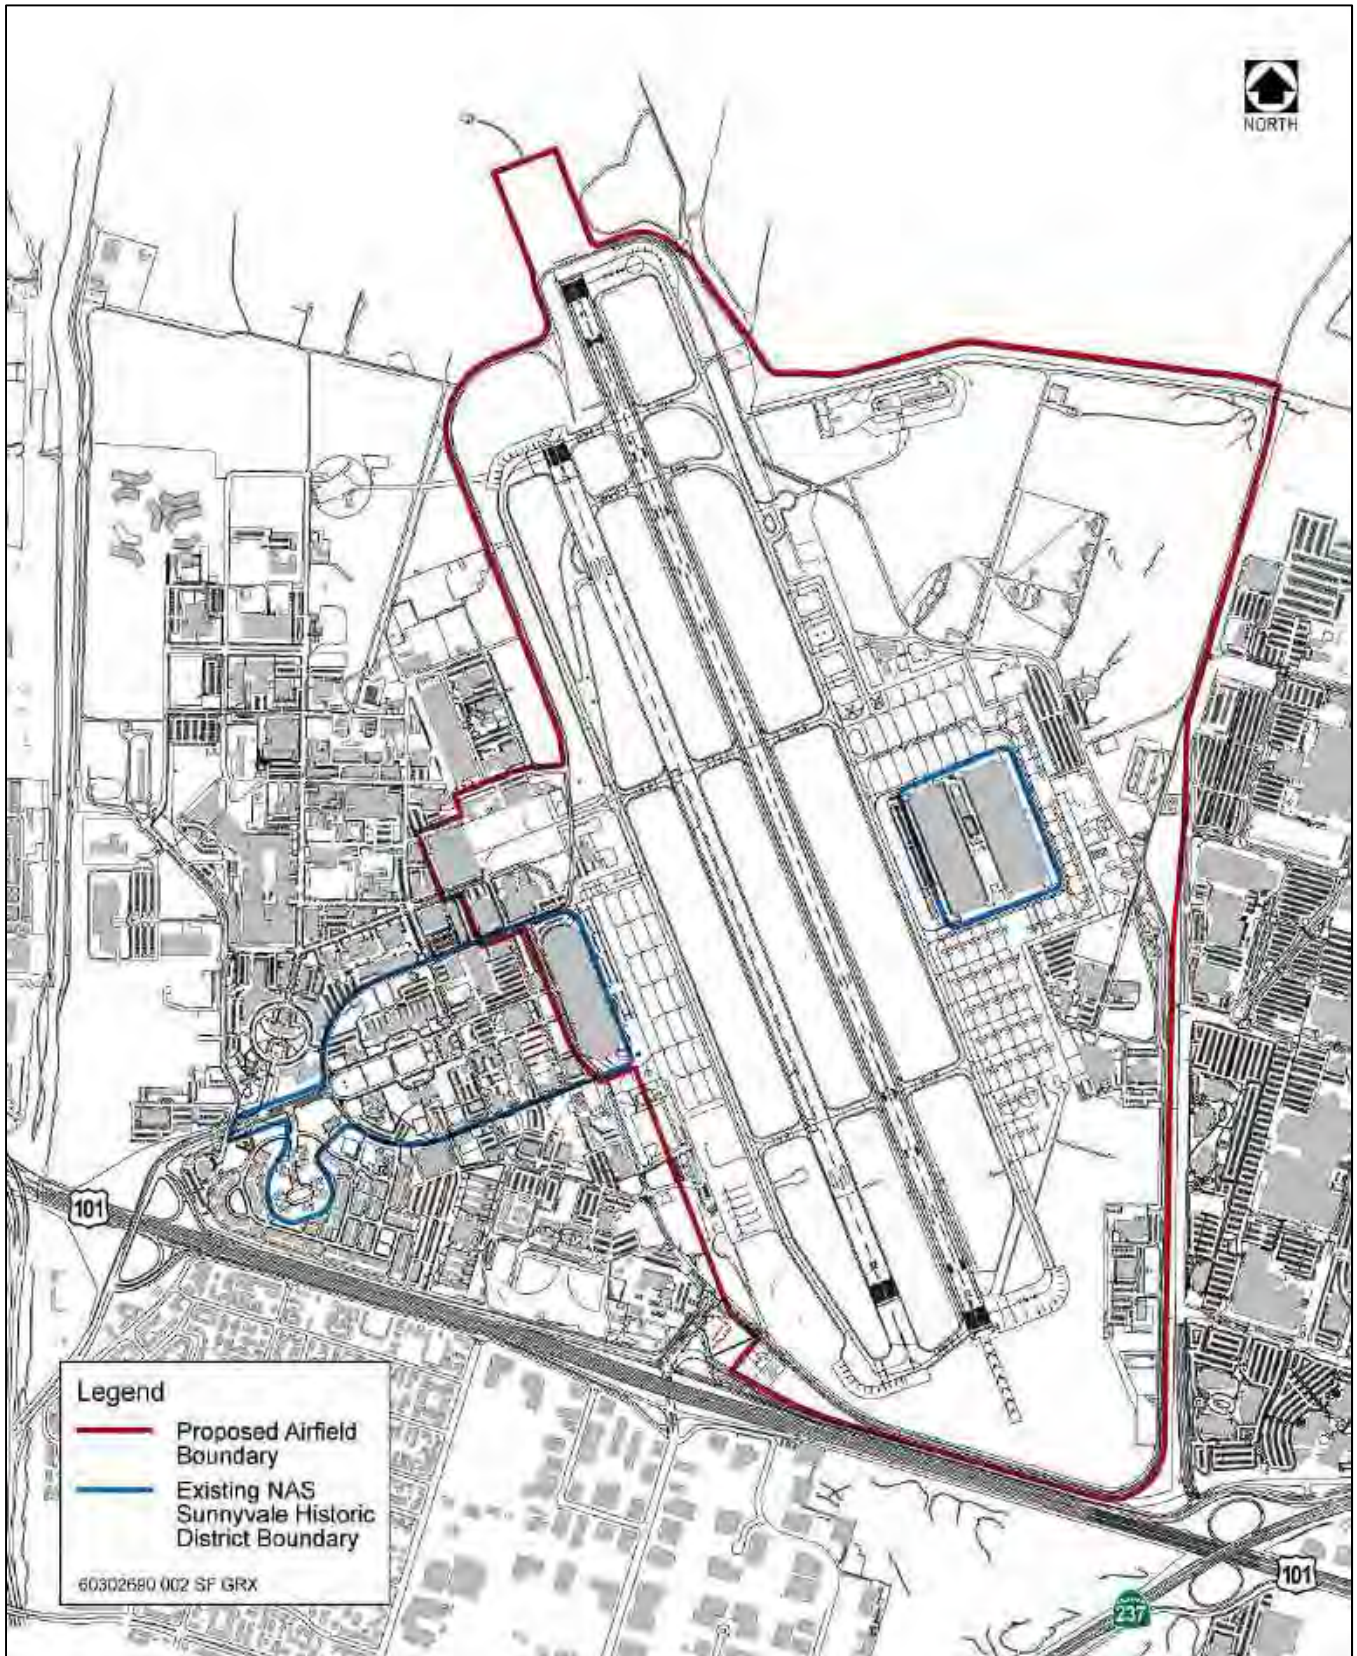
Figure 3. Proposed Revised Boundary, NAS Sunnyvale Historic District

This study recommends that the Airfield and its contributing features are eligible for listing as an extension of the NAS Sunnyvale Historic District, which is already listed in the NRHP. Thus, the discussion of the boundary necessarily suggests the need to expand the boundary of the NAS Sunnyvale Historic District to encompass the Airfield (see Figure 3, “Proposed Revised Boundary, NAS Sunnyvale Historic District”).

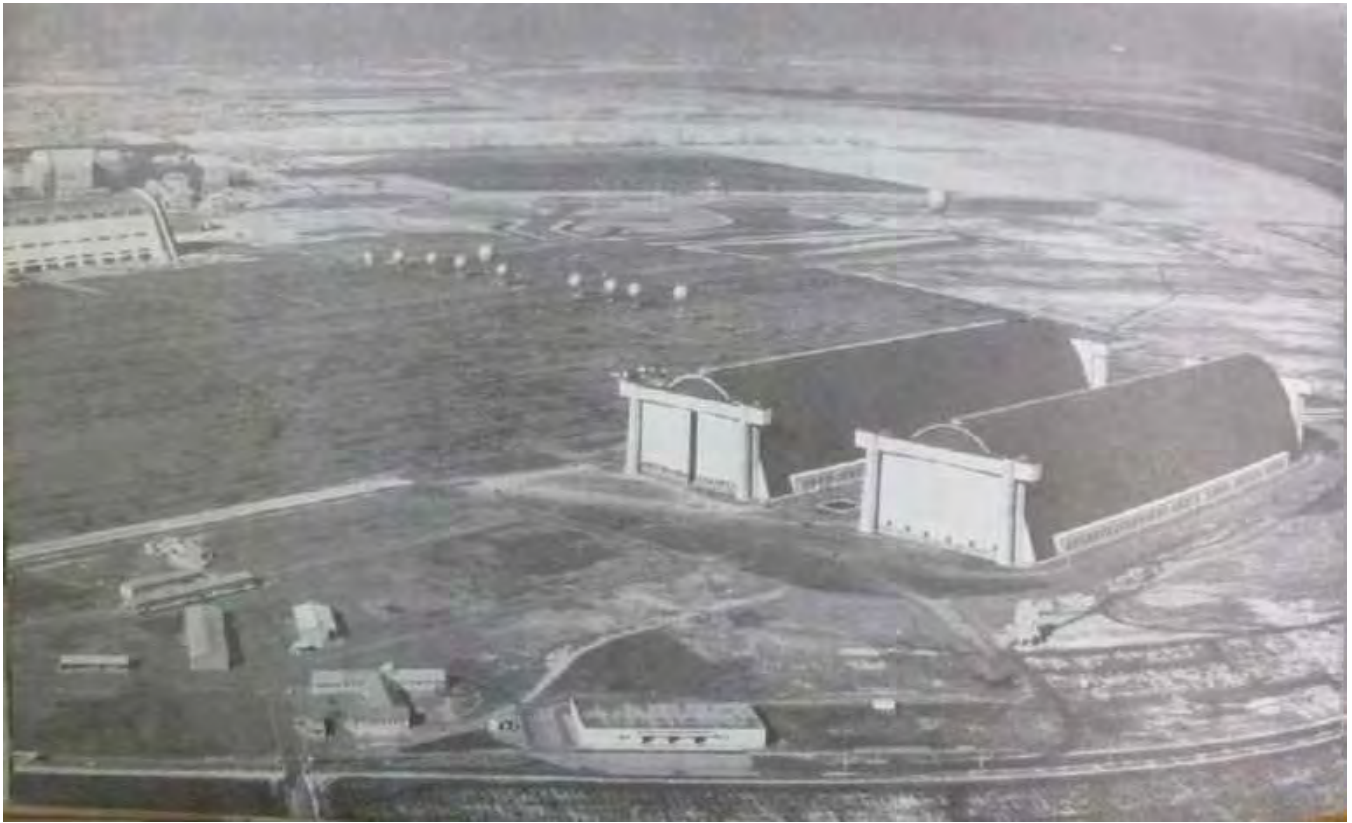
Aerial photograph of NAS Moffett Field showing recently completed Hangars 2 and 3 at center right and future CANG area at lower left, 1944 (Source: *Moffett Field Historical Society*)

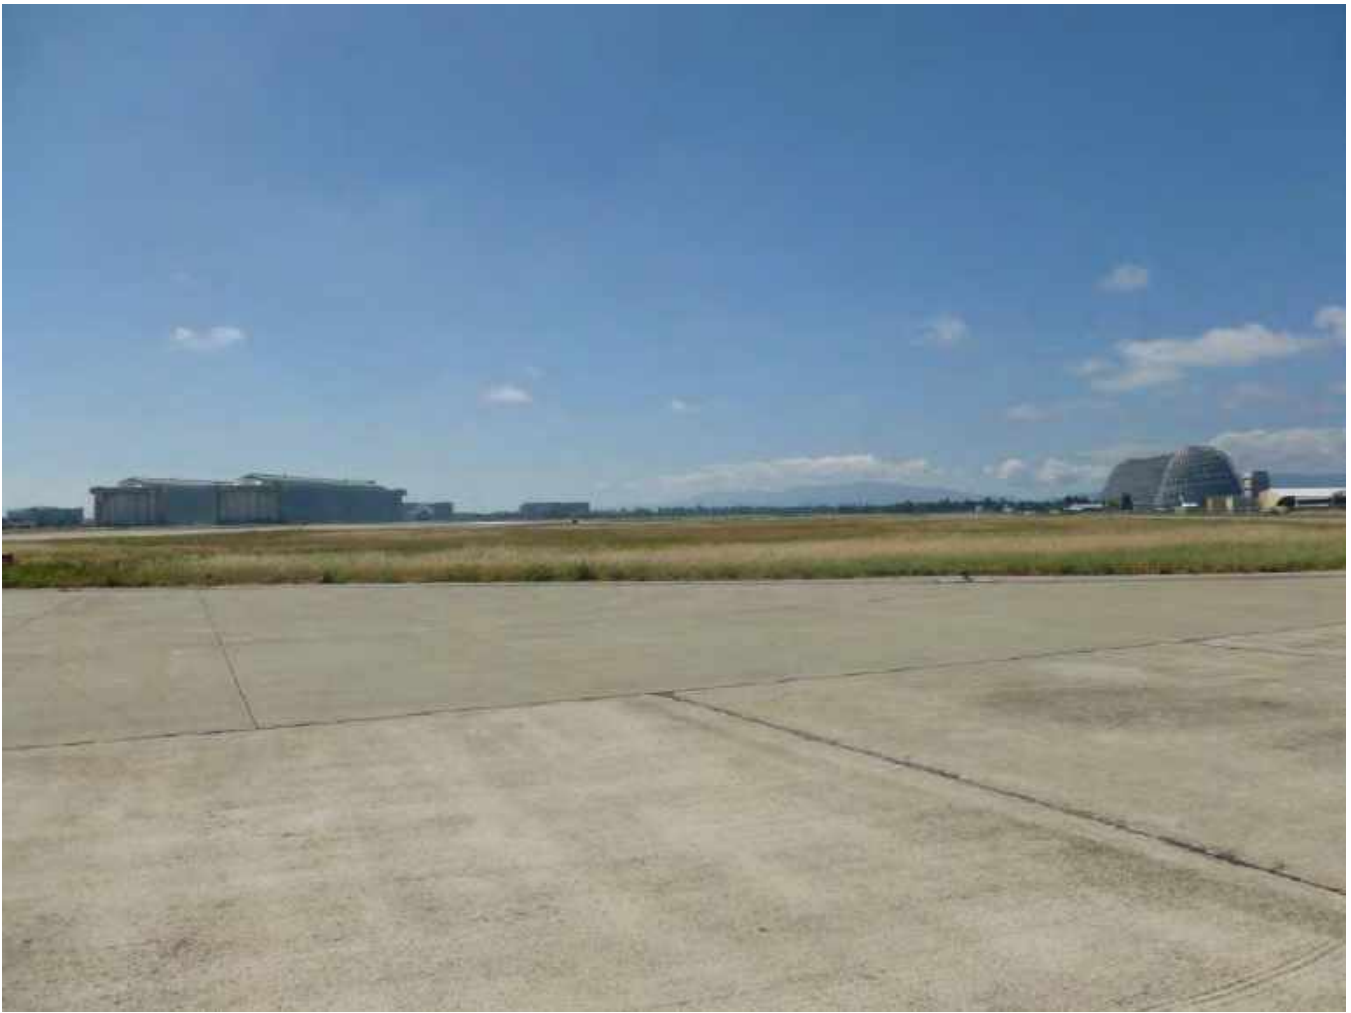
View from north end of runways looking south toward Hangars 1, 2, and 3 (Source: AECOM 2013)

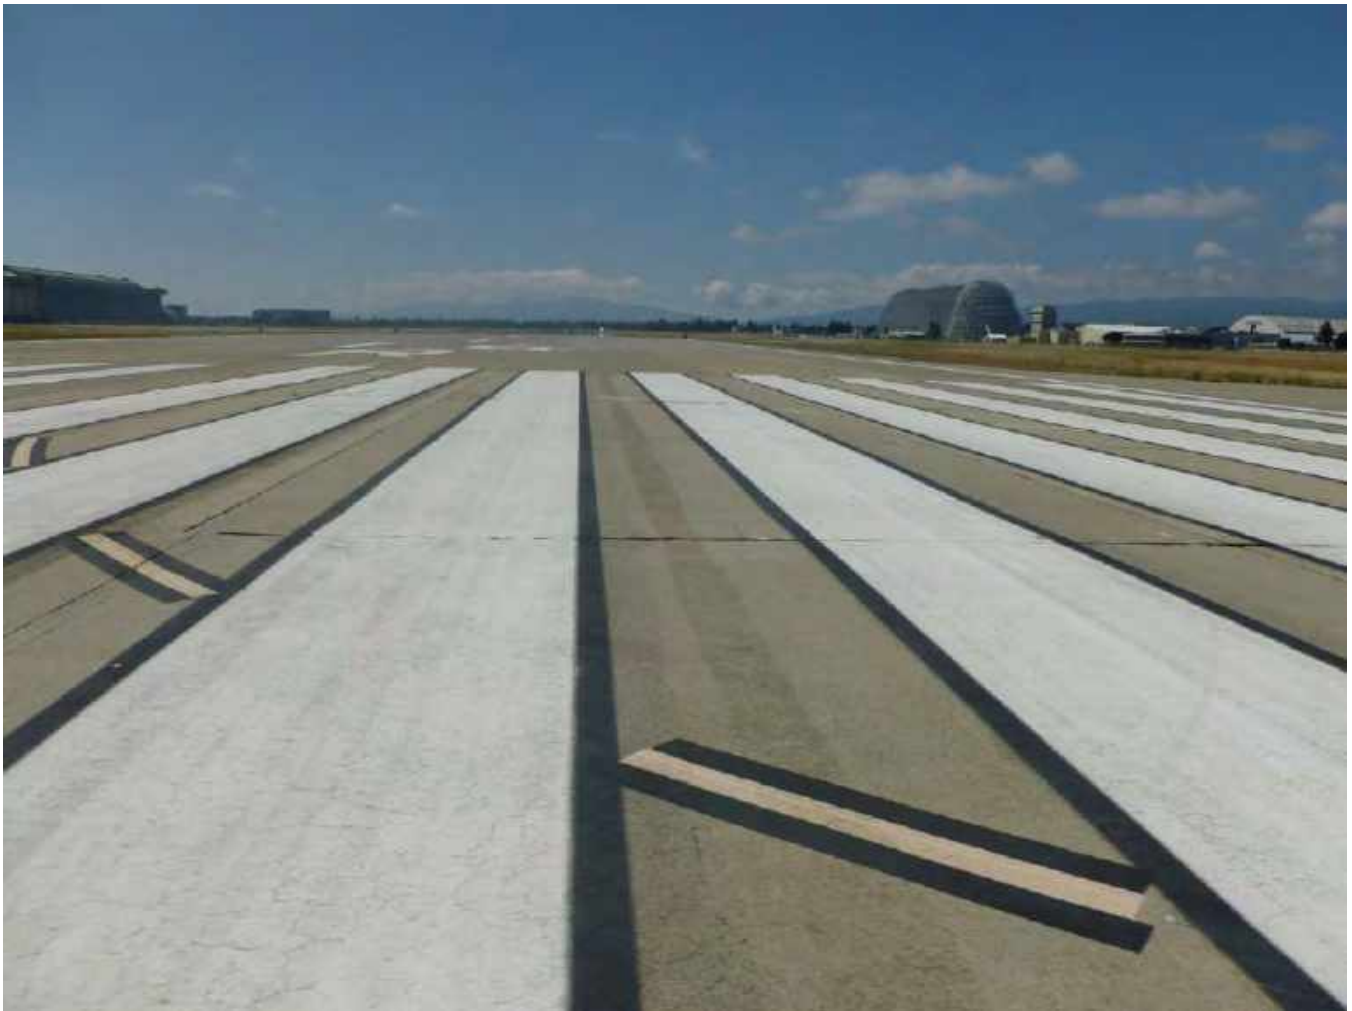
Detail view of Runway 14R-32L looking south (Source: AECOM 2013)

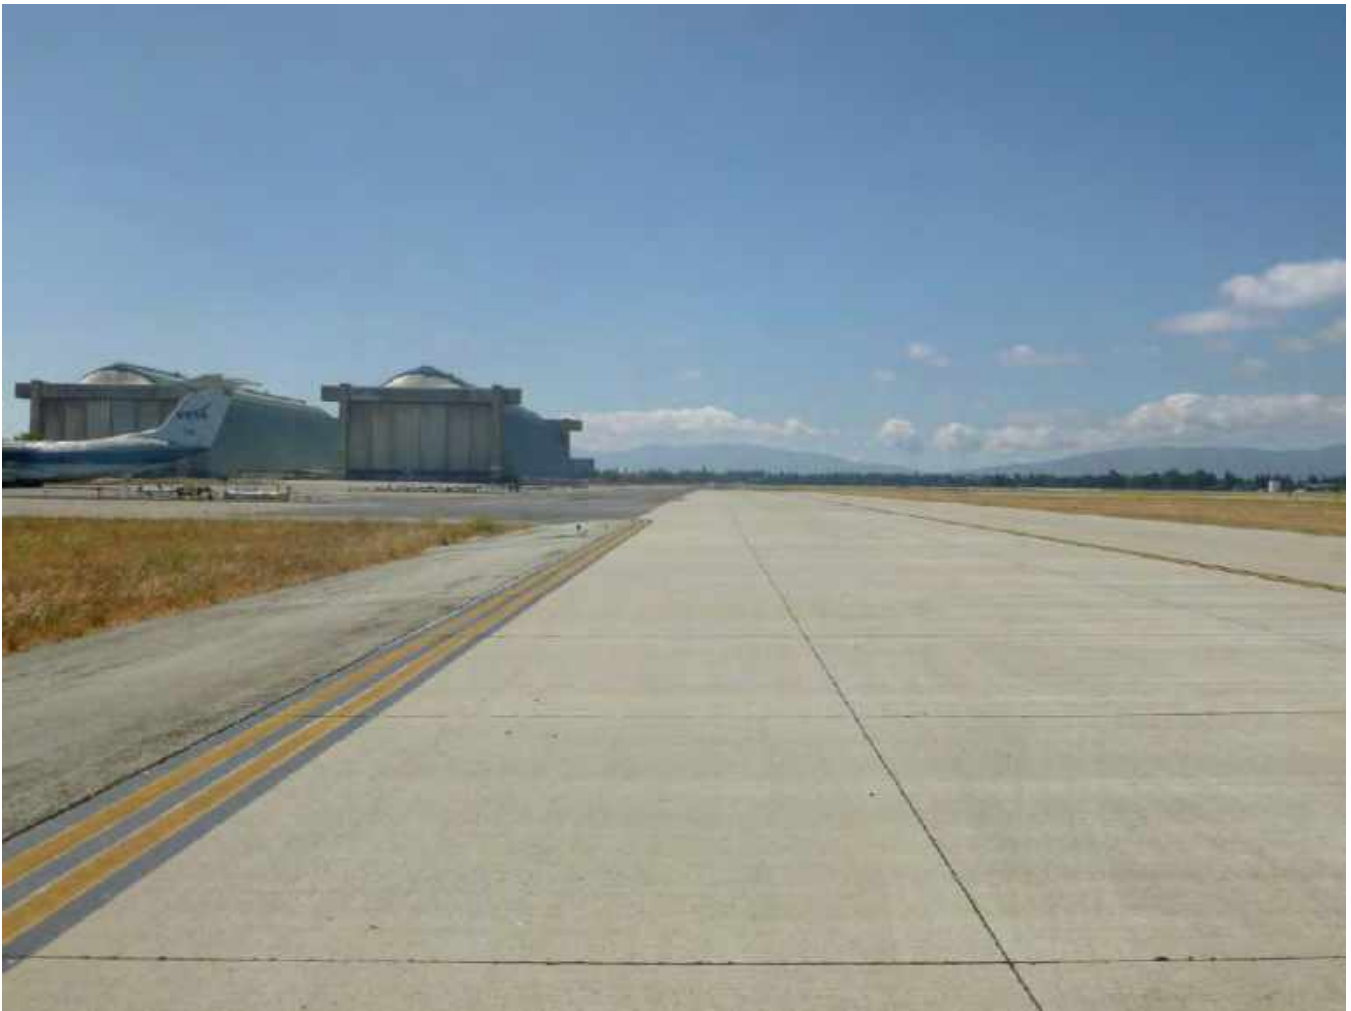
View of east parallel taxiway looking south toward Hangars 2 and 3 (Source: AECOM 2013)

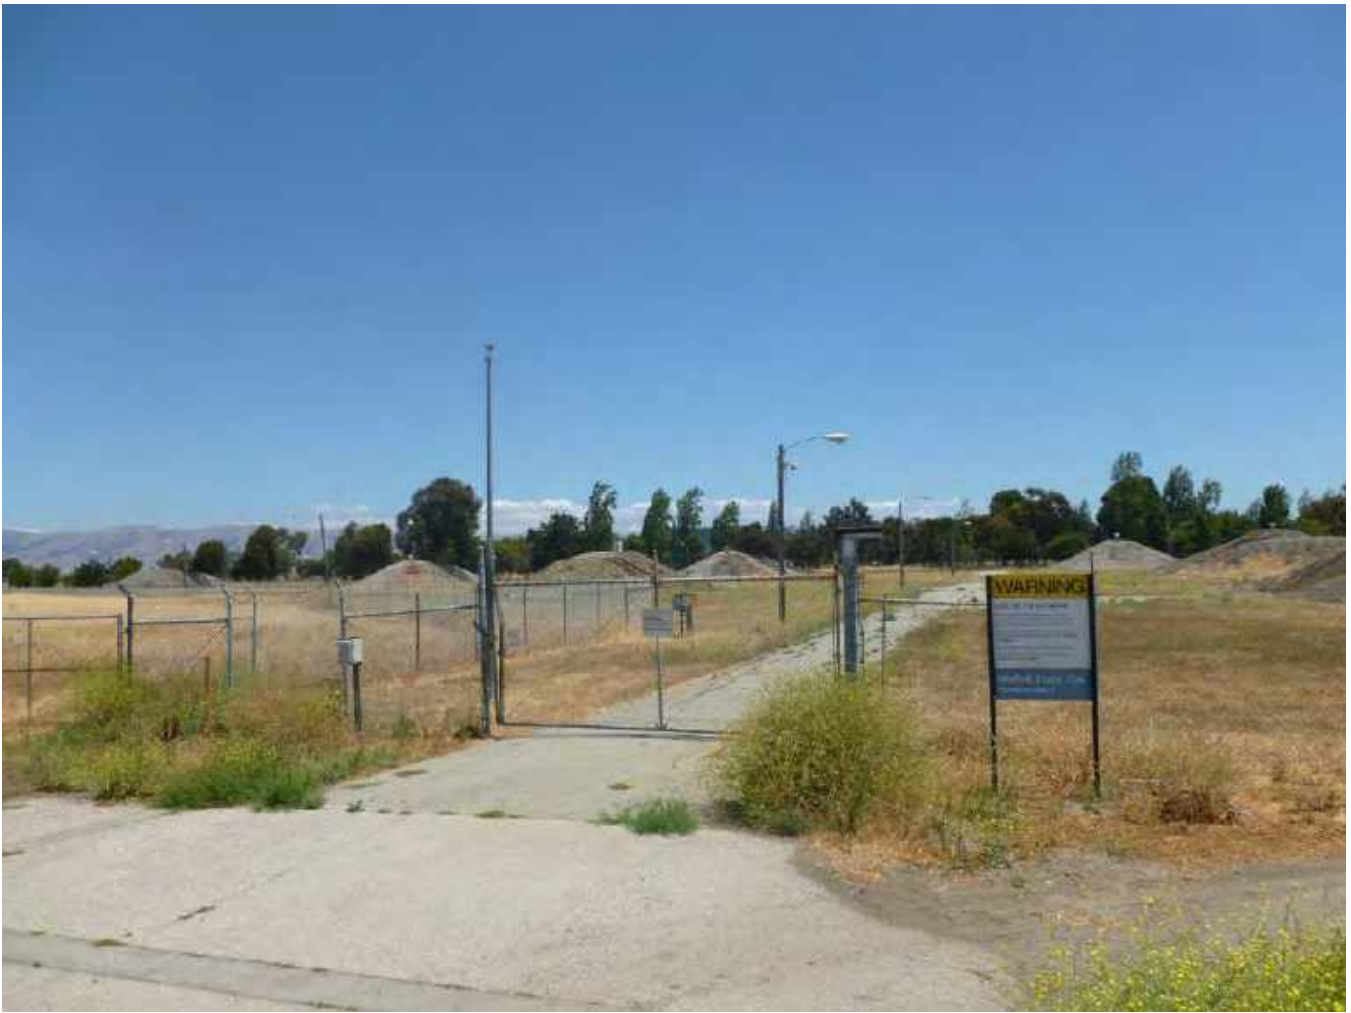
View of magazines 70-74 and surrounding safety buffer zone, looking east (Source: AECOM 2013)

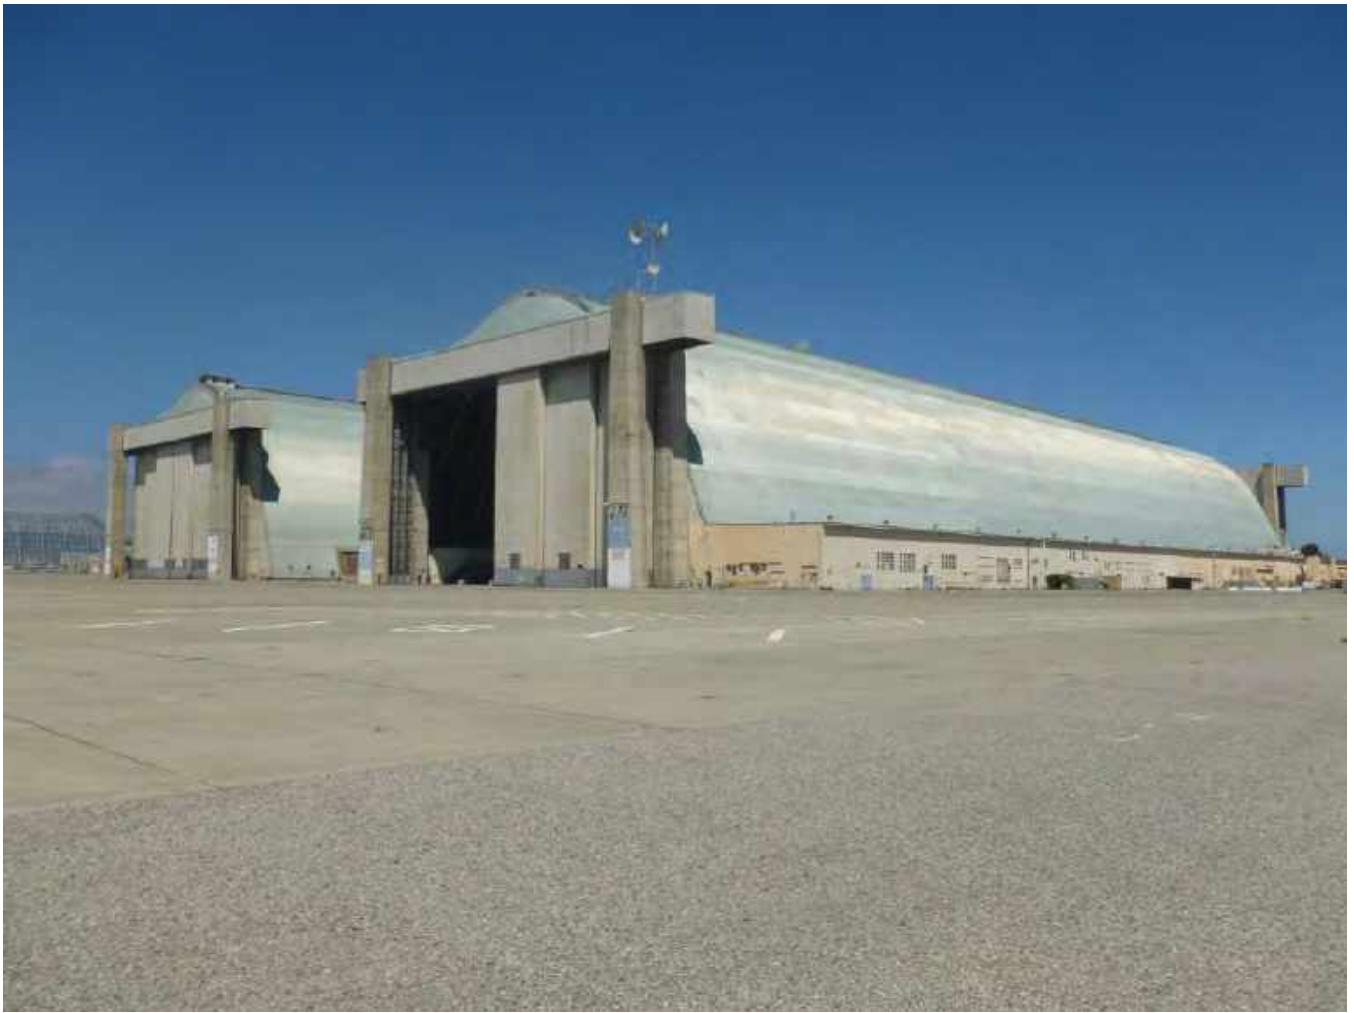
View of Hangars 2 and 3 looking northwest (*Source: AECOM 2013*)
