DRAFT Final Hangar 1 Engineering Evaluation/Cost Analysis

**Former Naval Air Station Moffett Field,
California**

**13 August 2019
EKI B20019.19**

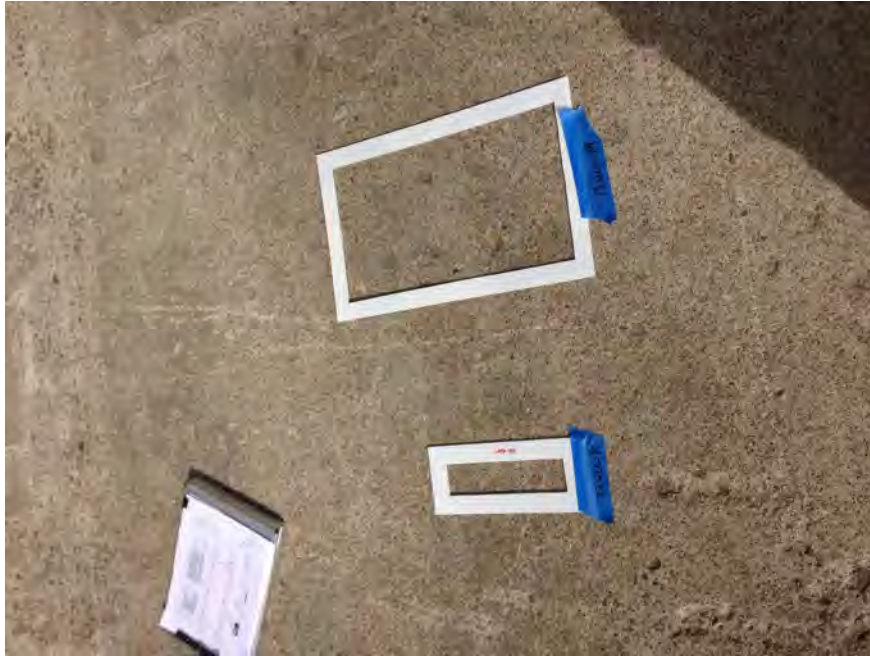
Sample Location: Ground Floor, Column Line 13, West Side
Sample Number: 13WCC
Sample System / Condition: Concrete Floor - Clean

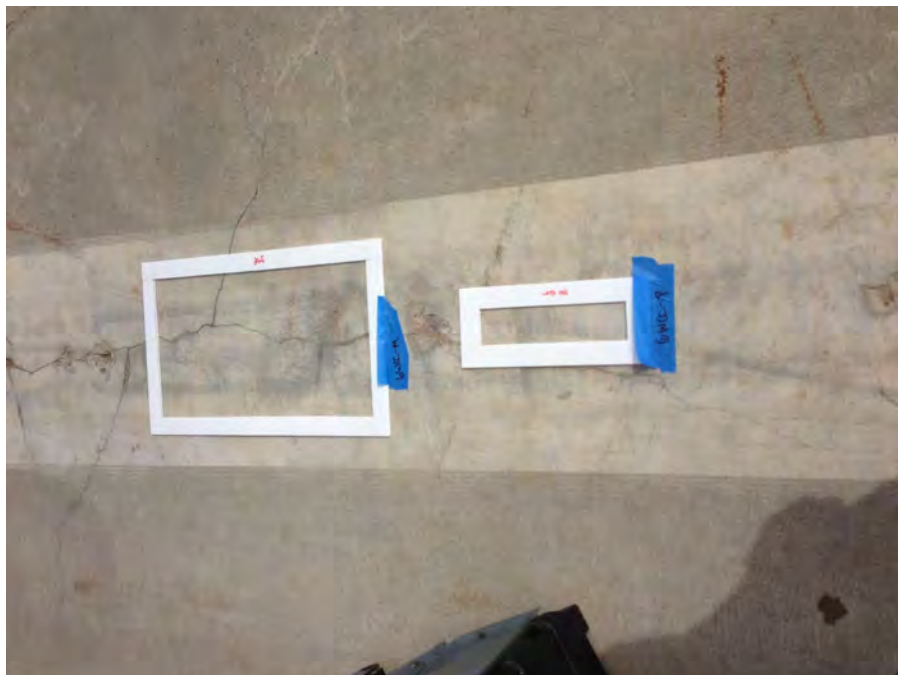
Sample Location: Ground Floor, Column Line 6, West Side
Sample Number: 6WCC
Sample System / Condition: Concrete Floor - Clean

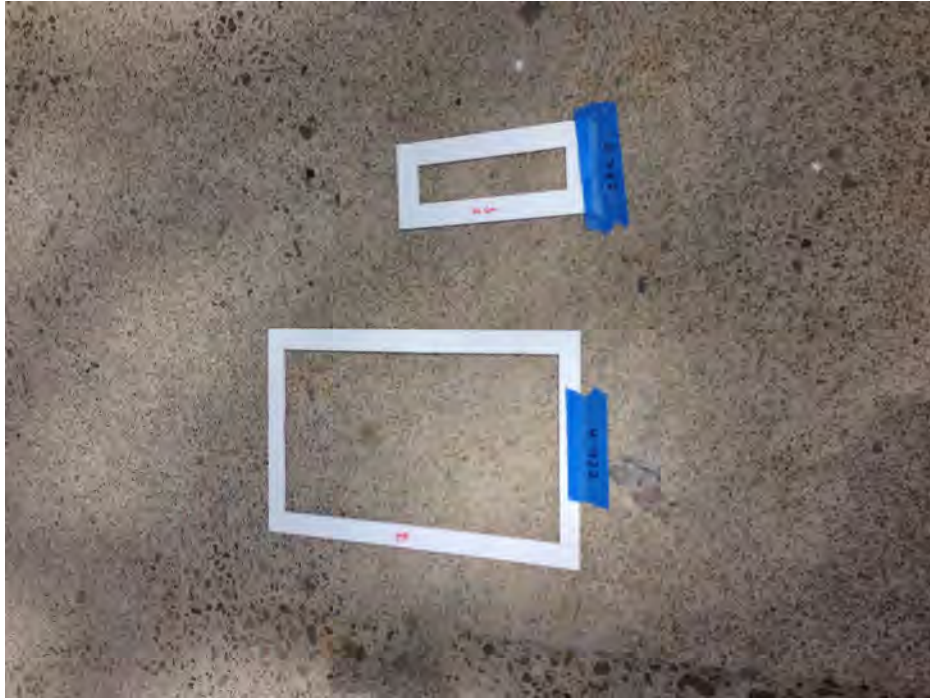
Sample Location: Ground Floor, Column Line 6, West Side
Sample Number: 2ECC
Sample System / Condition: Concrete Floor - Clean

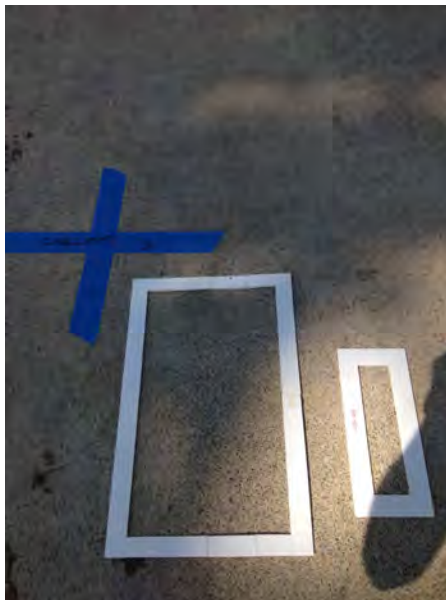
Sample Location: Ground Floor, Column Line 12.5, East Side
Sample Number: 12.5ECC0807
Sample System / Condition: Concrete Floor - Clean

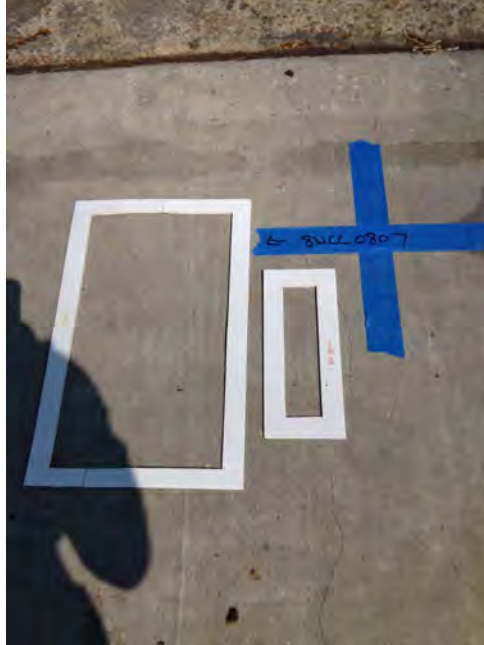
Sample Location: Ground Floor, Column Line 8, West Side
Sample Number: 8WCC0807
Sample System / Condition: Concrete Floor - Clean

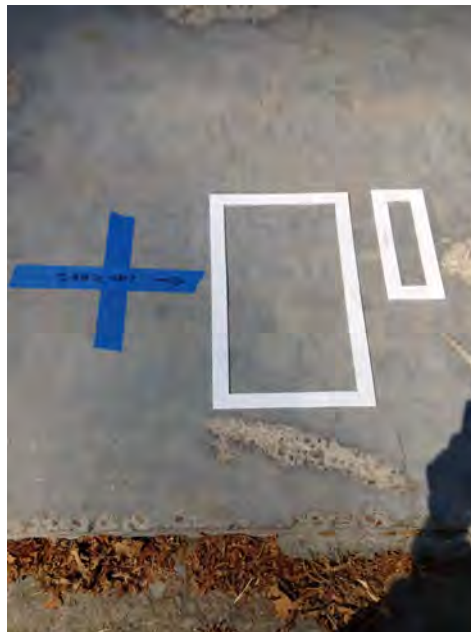
Sample Location: Ground Floor, Column Line 2.5, West Side
Sample Number: 2.5WCC0807
Sample System / Condition: Concrete Floor - Clean

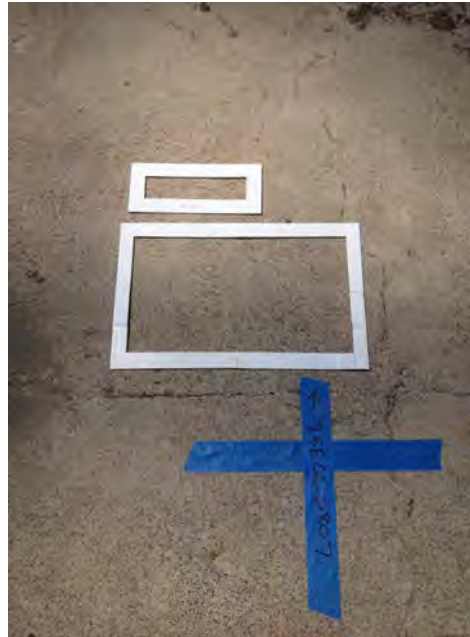
Sample Location: Ground Floor, Column Line 7.5, East Side
Sample Number: 7.5ECC0807
Sample System / Condition: Concrete Floor – Clean

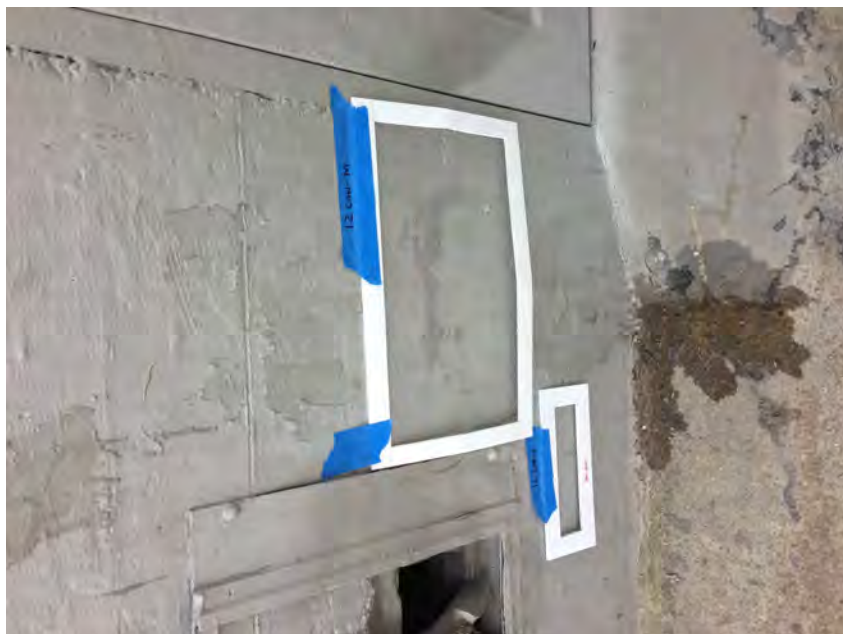
Sample Location: Ground Floor, Column Line 12, East Side
Sample Number: 12ECON – CMU Wall Ledge
Sample System / Condition: Concrete/CMU

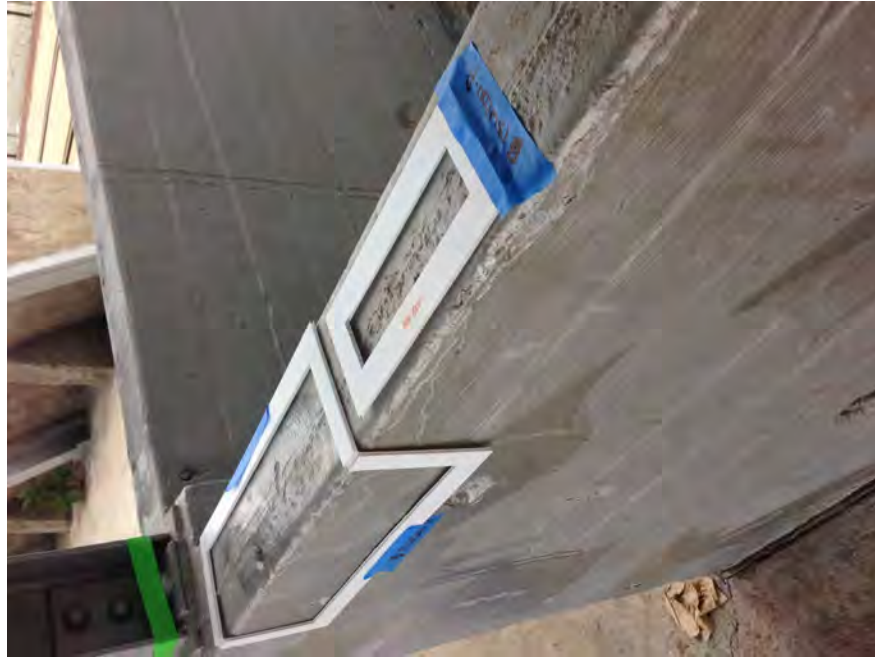
Sample Location: Ground Floor, Column Line 13, West Side
Sample Number: 13WCON - CMU Wall
Sample System / Condition: Concrete/CMU

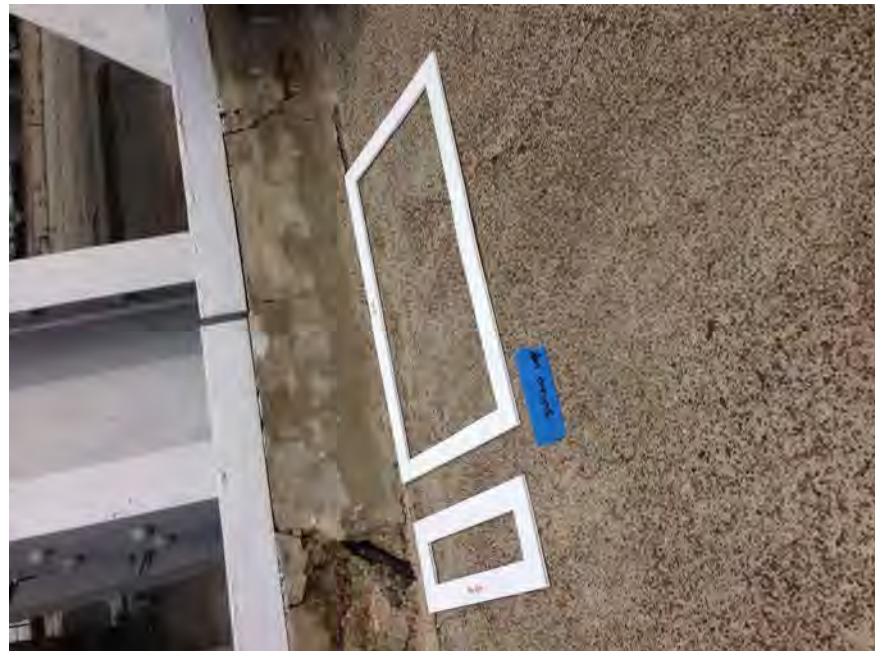
Sample Location: Ground Floor, Column Line 3, West Side
Sample Number: 3WCON - Stem Wall
Sample System / Condition: Concrete/CMU

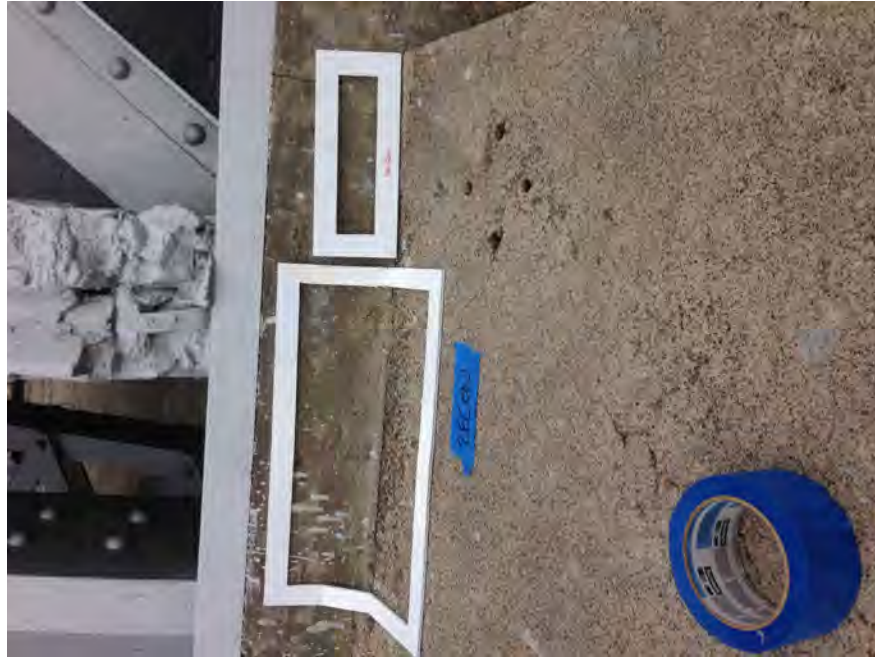
Sample Location: Ground Floor, Column Line 2, East Side
Sample Number: 2ECON - Stem Wall
Sample System / Condition: Concrete/CMU

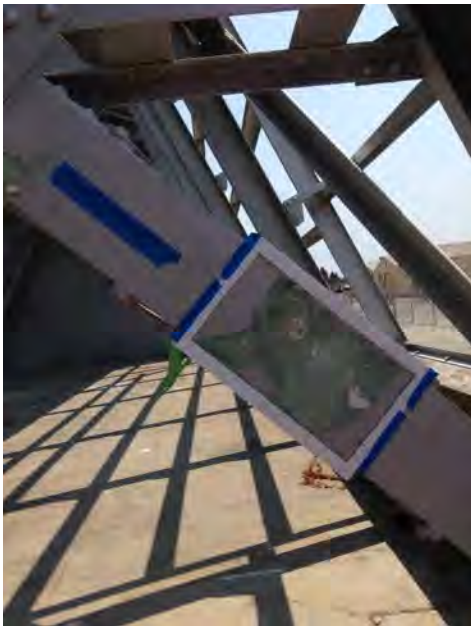
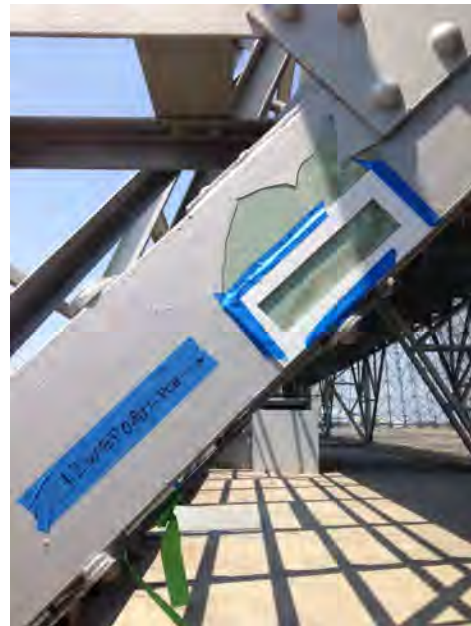
Sample Location: Ground Floor, Column Line 12, West Side
Sample Number: 12WEP0807
Sample System / Condition: Exposed Original Paint

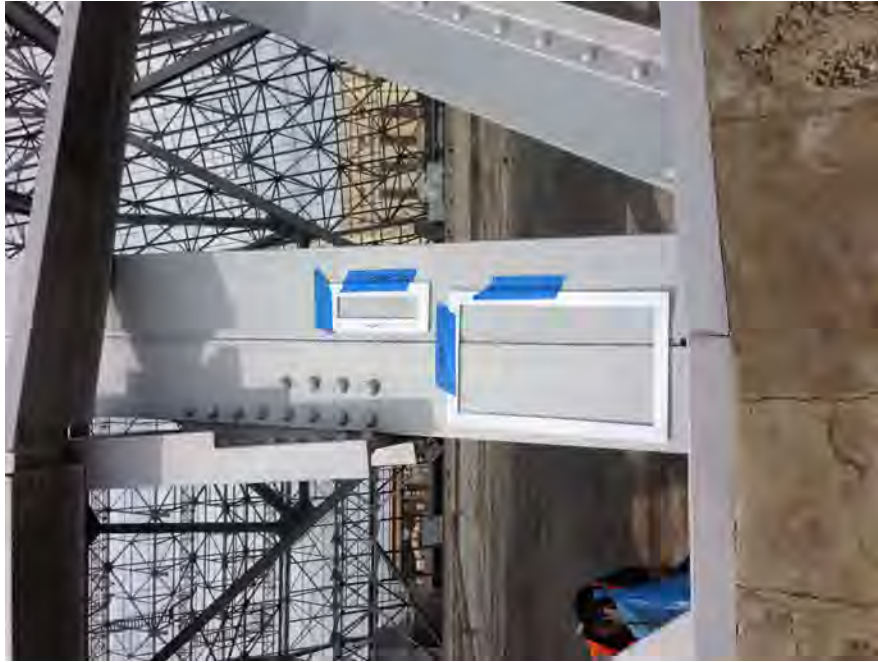
Sample Location: Ground Floor, Column Line 1, East Side
Sample Number: 1EO
Sample System / Condition: Intact Encapsulant/paint over Structural Steel

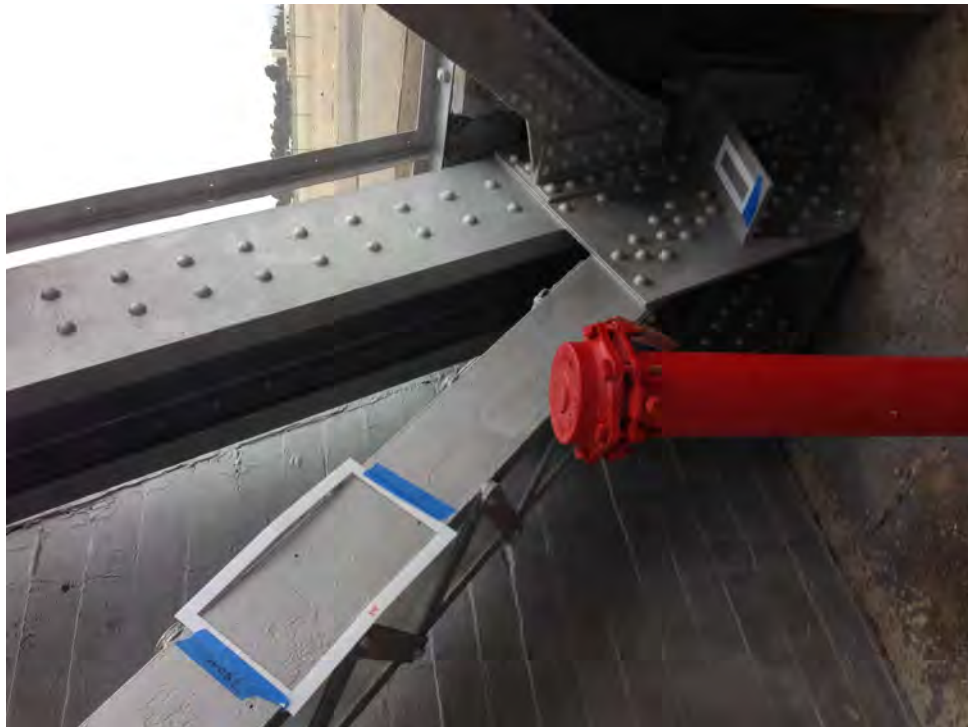
Sample Location: Ground Floor, Column Line 7, East Side
Sample Number: 7EO
Sample System / Condition: Intact Encapsulant/paint over Structural Steel

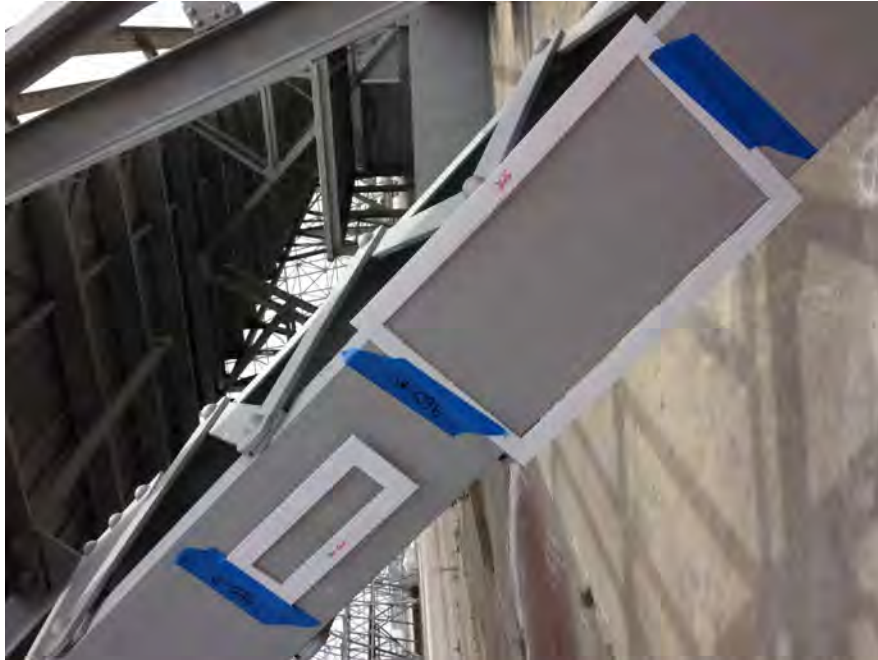
Sample Location: Ground Floor, Column Line 9, East Side
Sample Number: 9EO
Sample System / Condition: Intact Encapsulant/paint over Structural Steel

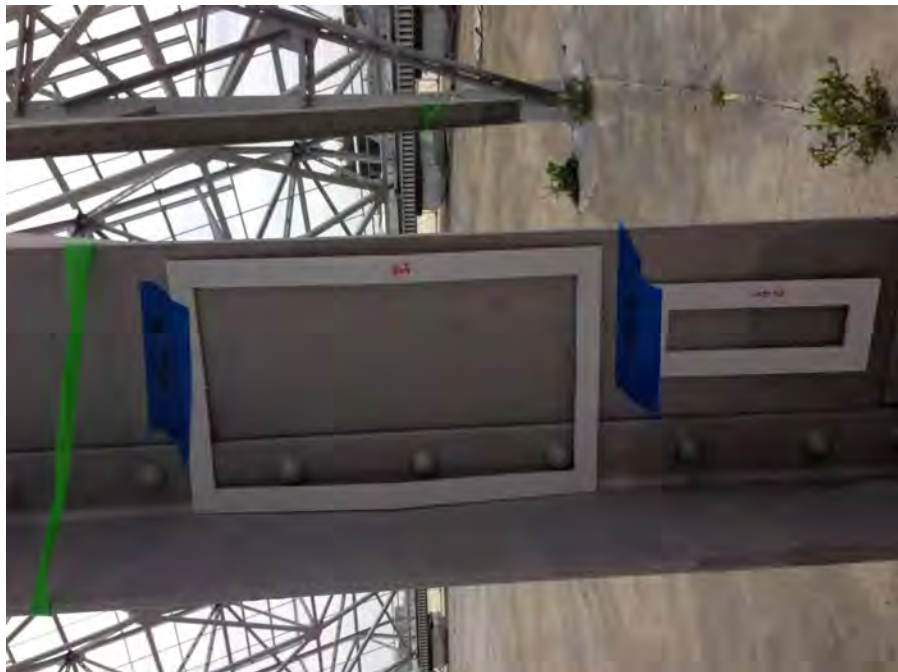
Sample Location: Ground Floor, Column Line 14, West Side
Sample Number: 14WI
Sample System / Condition: Intact Encapsulant/paint over Structural Steel

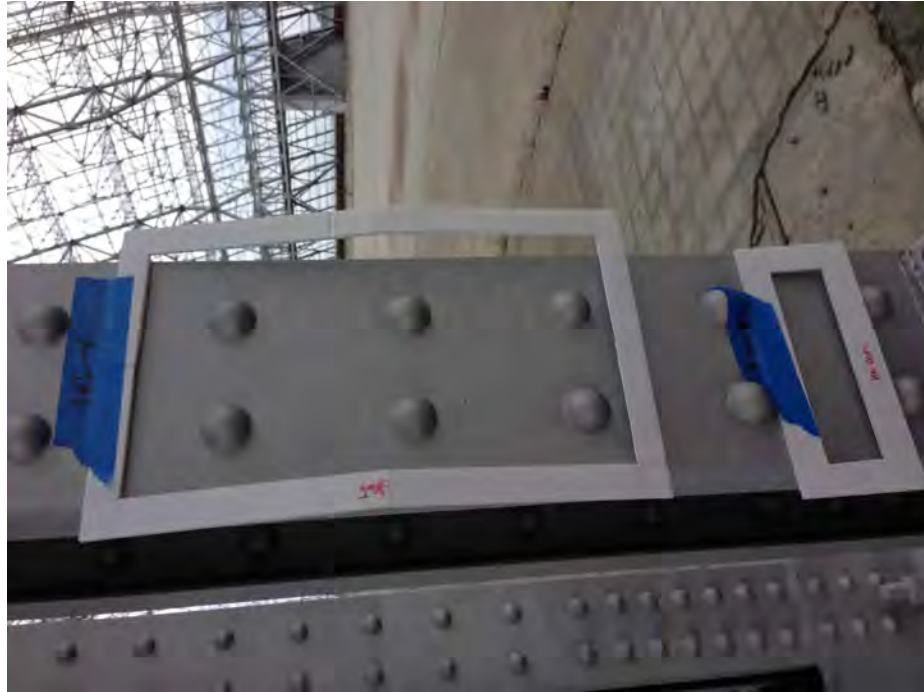
Sample Location: Ground Floor, Column Line 11, West Side
Sample Number: 11WI
Sample System / Condition: Intact Encapsulant/paint over Structural Steel

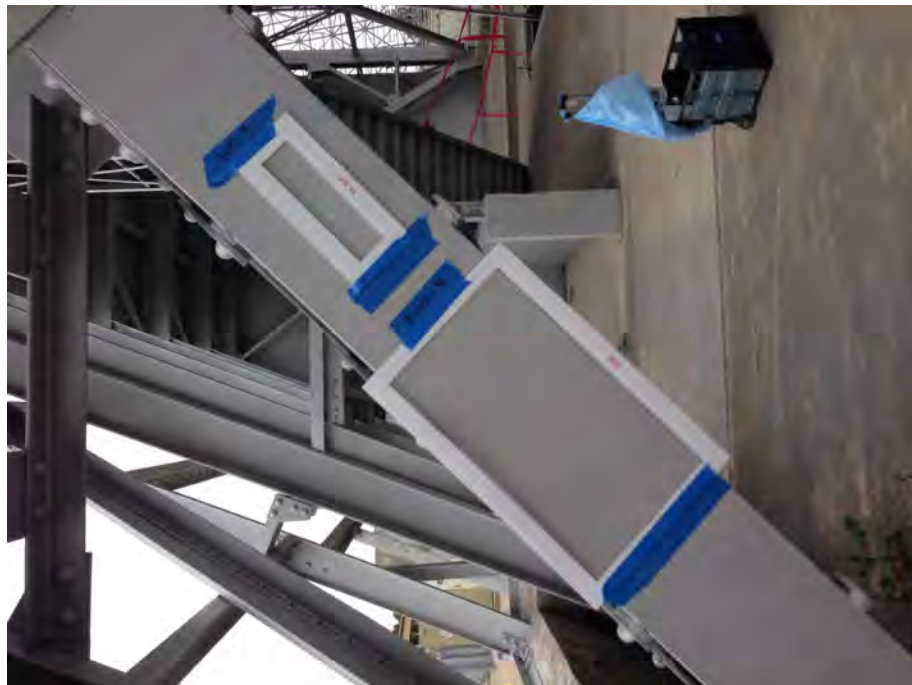
Sample Location: Ground Floor, Column Line 8, West Side
Sample Number: 8WO
Sample System / Condition: Intact Encapsulant/paint over Structural Steel

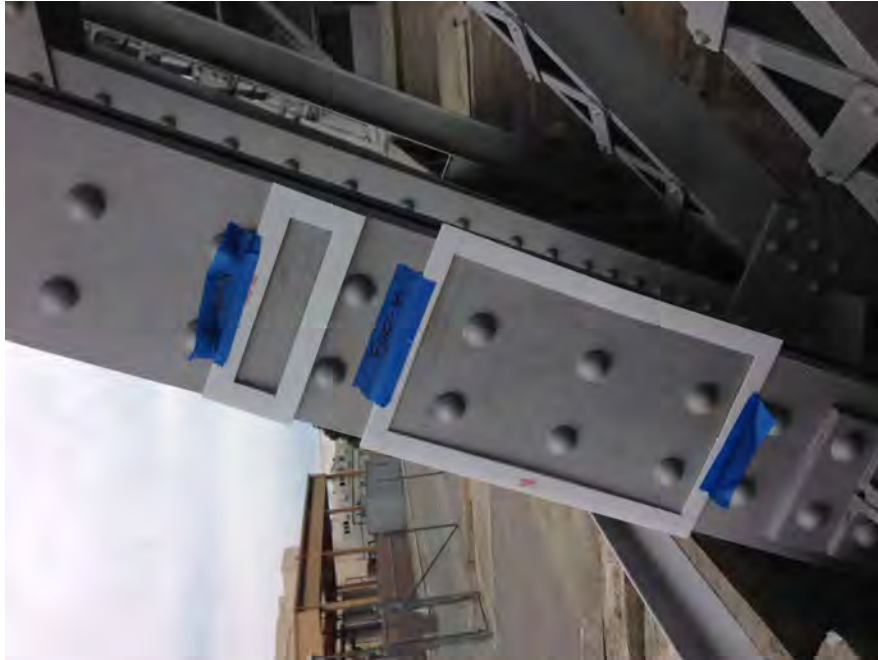
Sample Location: Ground Floor, Column Line 5, West Side
Sample Number: 5WO
Sample System / Condition: Intact Encapsulant/paint over Structural Steel

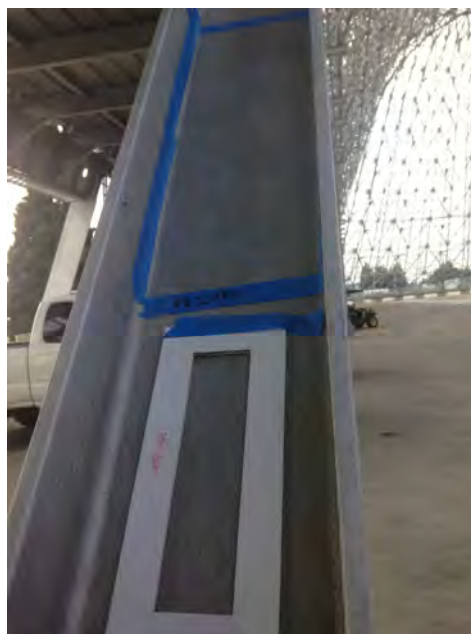
Sample Location: Ground Floor, Column Line 8, West Side
Sample Number: 8EI0811
Sample System / Condition: Intact Encapsulant/paint over Structural Steel

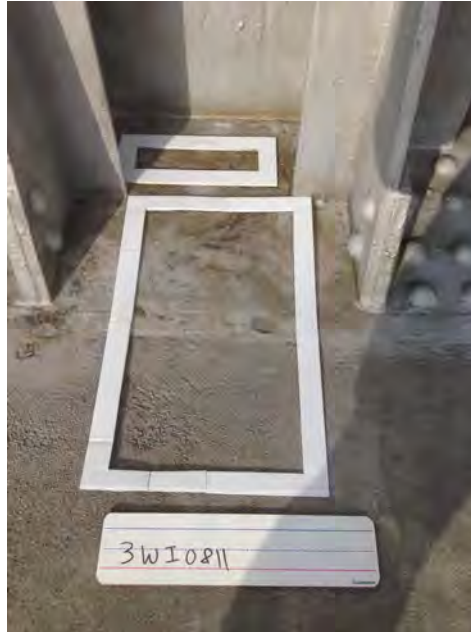
Sample Location: Ground Floor, Column Line 3, West Side
Sample Number: 3WI0811
Sample System / Condition: Intact Encapsulant/paint over Structural Steel

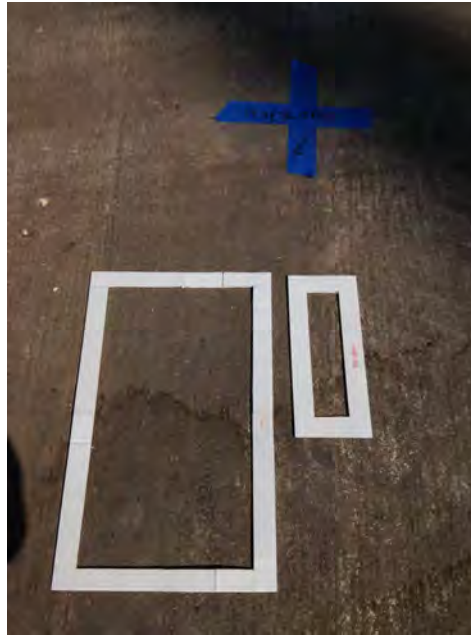
Sample Location: Ground Floor, Column Line 14.5, East Side
Sample Number: 14.5ESC0807
Sample System / Condition: Concrete Floor - Evidence of Pooling/Sediment

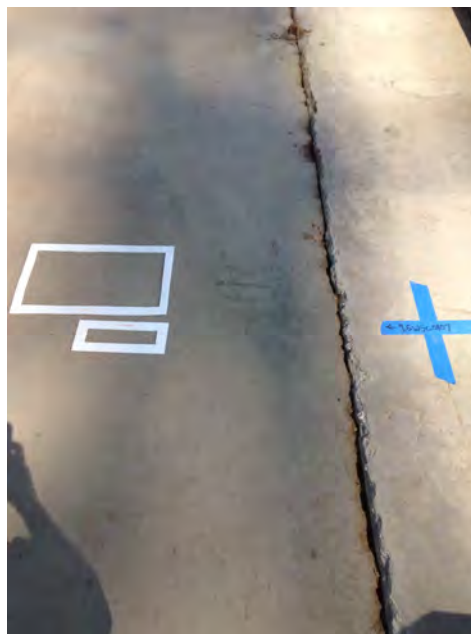
Sample Location: Ground Floor, Column Line 9.5, West Side
Sample Number: 9.5WSC0807
Sample System / Condition: Concrete Floor - Evidence of Pooling/Sediment

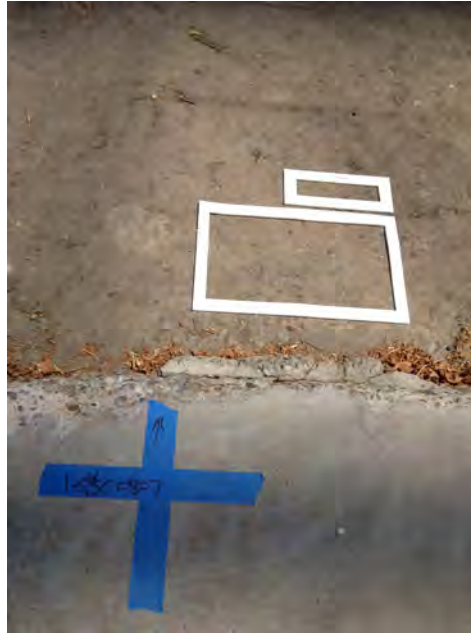
Sample Location: Ground Floor, Column Line 1.5, West Side
Sample Number: 1.5WSC0807
Sample System / Condition: Concrete Floor - Evidence of Pooling/Sediment

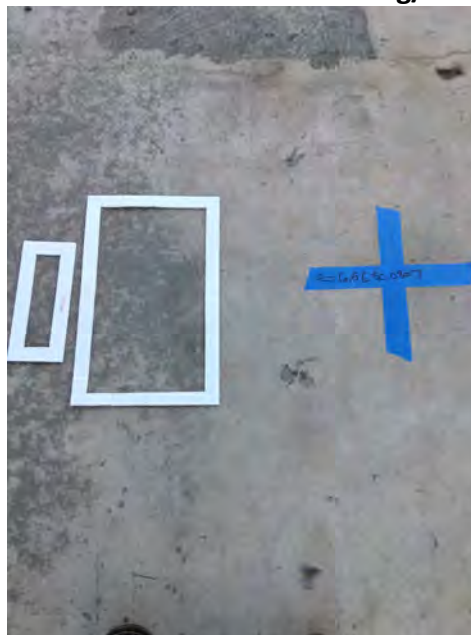
Sample Location: Ground Floor, Column Line 6.5, East Side
Sample Number: 6.5ESC0807
Sample System / Condition: Concrete Floor - Evidence of Pooling/Sediment

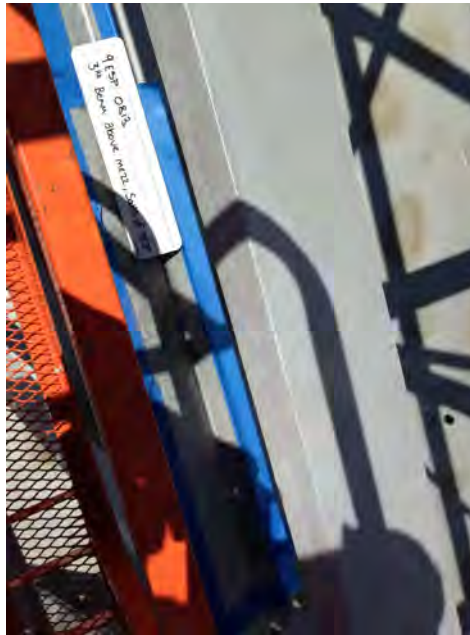
Sample Location: Ground Floor, Column Line 9, East Side
Sample Number: 9ESP0813
Sample System / Condition: Ponding Water Areas - Horizontal Structural Steel

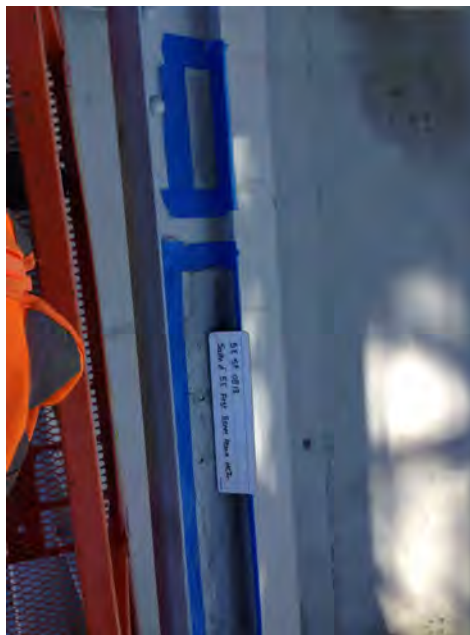
Sample Location: Ground Floor, Column Line 5, East Side
Sample Number: 5ESP0813
Sample System / Condition: Ponding Water Areas - Horizontal Structural Steel

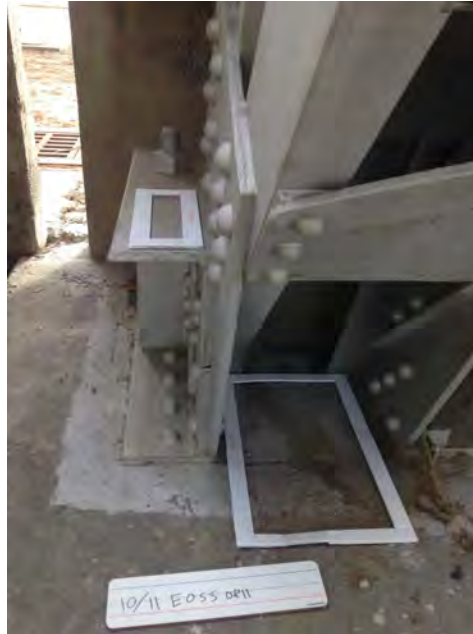
Sample Location: Ground Floor, Column Line 10/11, Outside Column, East Side
Sample Number: 10/11EOSS0811
Sample System / Condition: Base of Steel Column at evidence of Pooling/Sediment

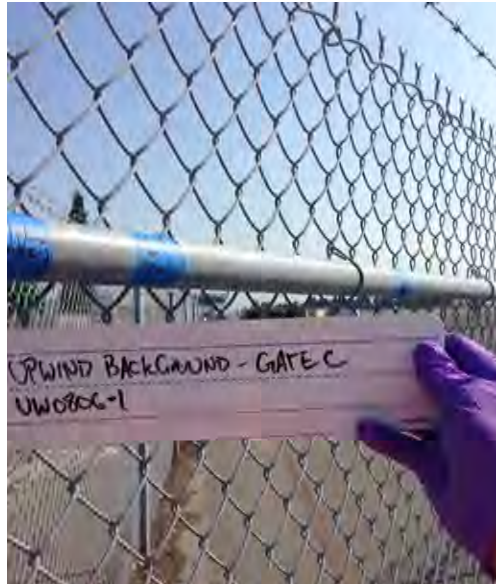
Sample Location: Ground Floor, Upwind
Sample Number: UW0806-01
Sample System / Condition: Upwind Location - Outside H1 Drainage Area

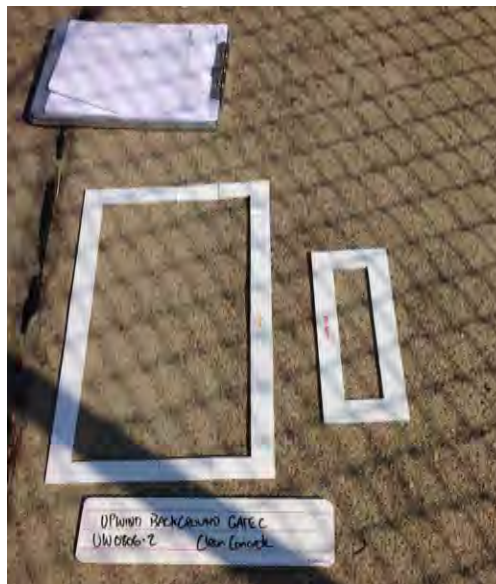
Sample Location: Ground Floor, Upwind
Sample Number: UW0806-02
Sample System / Condition: Upwind Location - Outside H1 Drainage Area

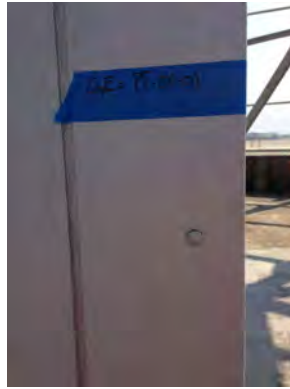
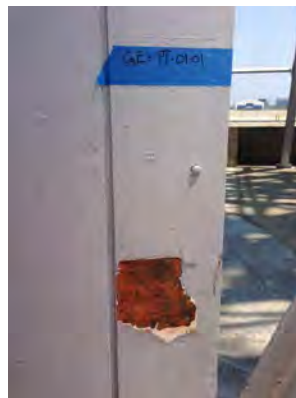
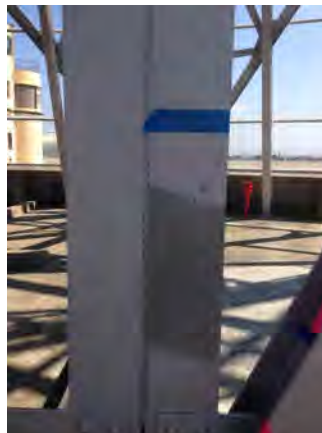
Sample Location: Ground Floor Column Line 14, East Hangar

Material Description: Multi-color paint under CM15 encapsulant over structural steel

After Recoating/Repairs by DPR

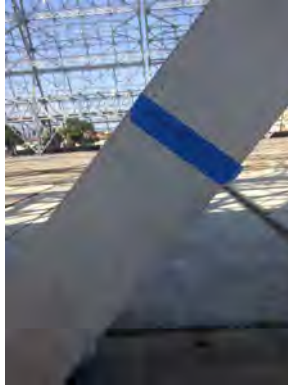
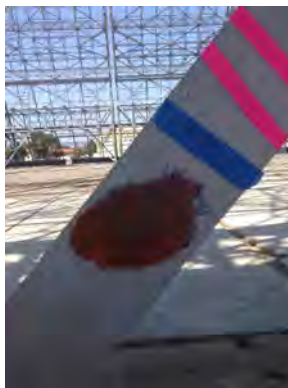
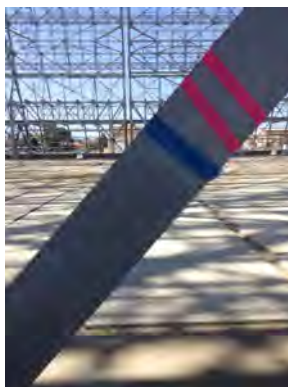
Sample Location: Ground Floor Column Line 4, East Hangar

Material Description: Multi-color paint under CM15 encapsulant over structural steel

After Recoating/Repairs by DPR

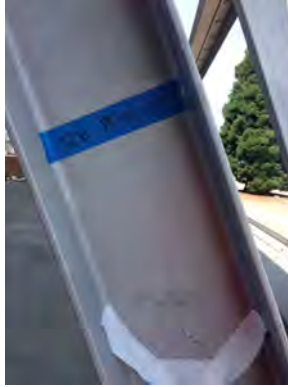
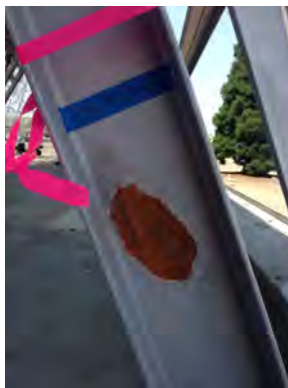
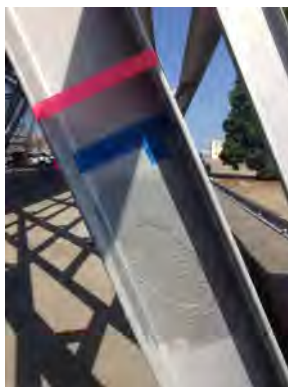
Sample Location: Ground Floor Column Line 12, East Hangar

Material Description: Multi-color paint under CM15 encapsulant over structural steel

After Recoating/Repairs by DPR

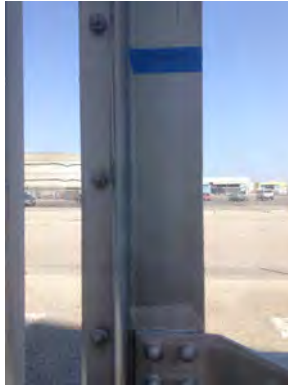
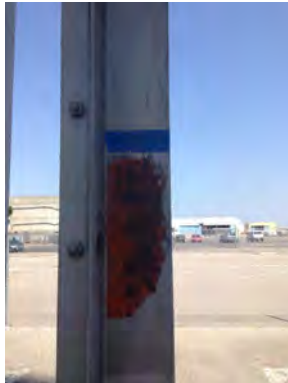
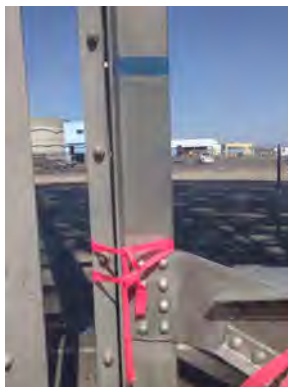
Sample Location: Ground Floor North Column

Material Description: Multi-color paint under CM15 encapsulant over structural steel

After Recoating/Repairs by DPR

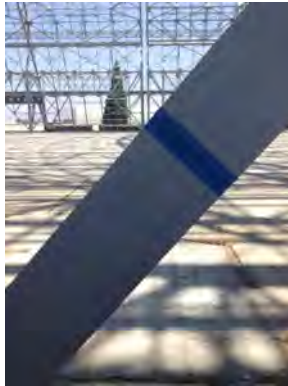
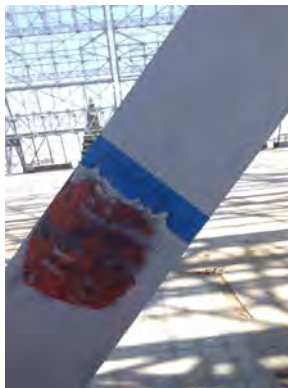
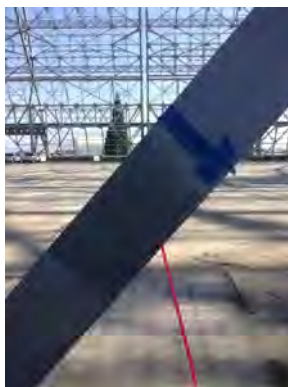
Sample Location: Ground Floor Column Line 11, West Hangar

Material Description: Multi-color paint under CM15 encapsulant over structural steel

After Recoating/Repairs by DPR

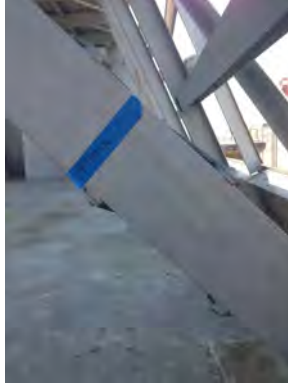
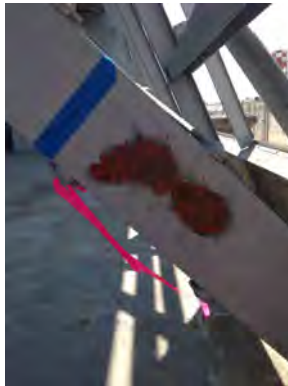
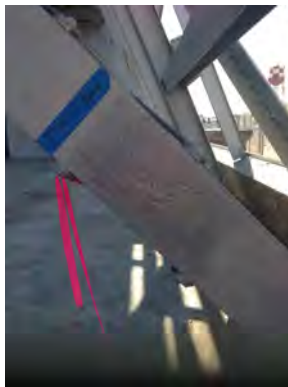
Sample Location: Ground Floor Column Line 1, West Hangar

Material Description: Multi-color paint under CM15 encapsulant over structural steel

After Recoating/Repairs by DPR

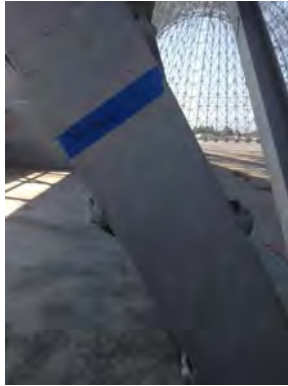
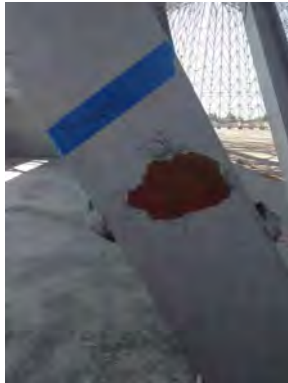
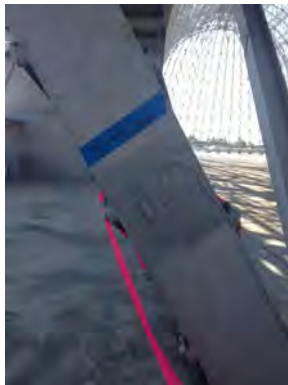
Sample Location: Ground Floor Column Line 6, East Hangar

Material Description: Multi-color paint under CM15 encapsulant over structural steel

After Recoating/Repairs by DPR

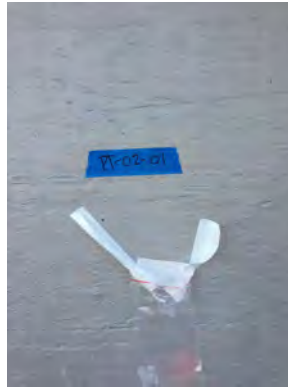
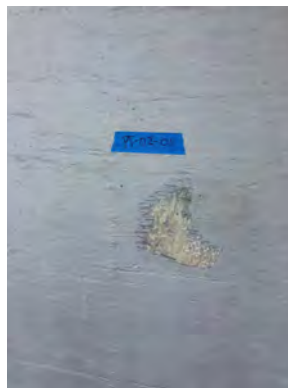
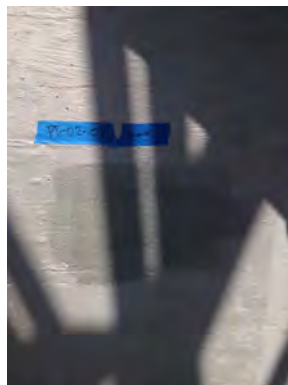
Sample Location: Ground Floor Column Line 12, East Hangar

Material Description: Multi-color paint under CM15 encapsulant over concrete

After Recoating/Repairs by DPR

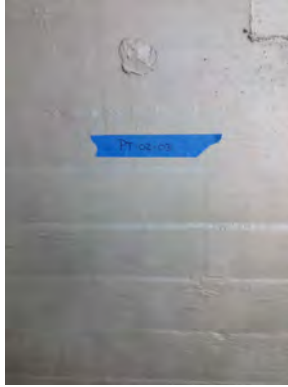
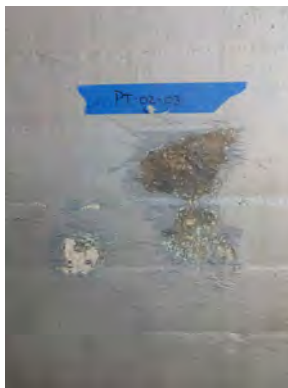
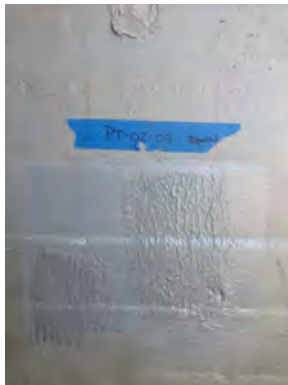
Sample Location: Ground Floor Column Line 14, East Hangar

Material Description: Multi-color paint under CM15 encapsulant over concrete

After Recoating/Repairs by DPR

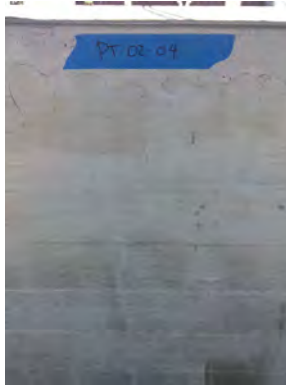
Sample Location: Ground Floor Column Line 10, West Hangar

Material Description: Multi-color paint under CM15 encapsulant over concrete

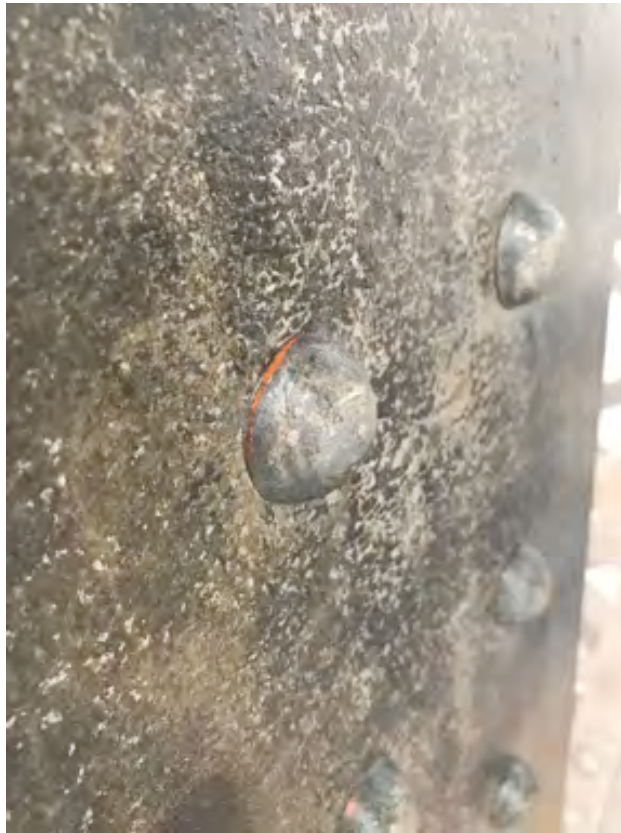
Photograph 3 – Primer evident around rivet head after UHPW removal.

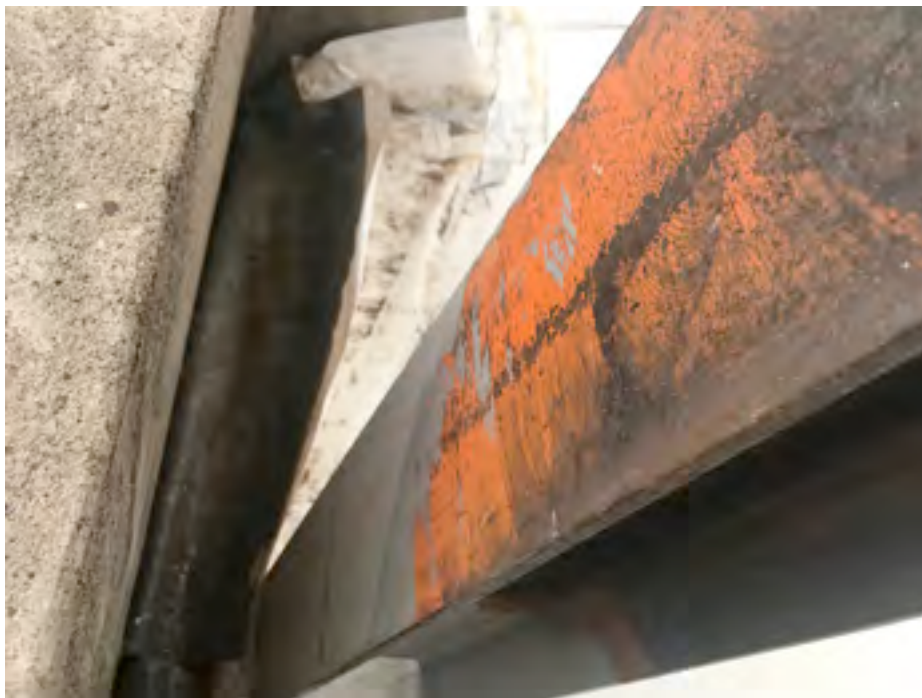
Photograph 4 – Poor removal of paint/coatings where UHPW nozzle was difficult to aim in tight access areas.

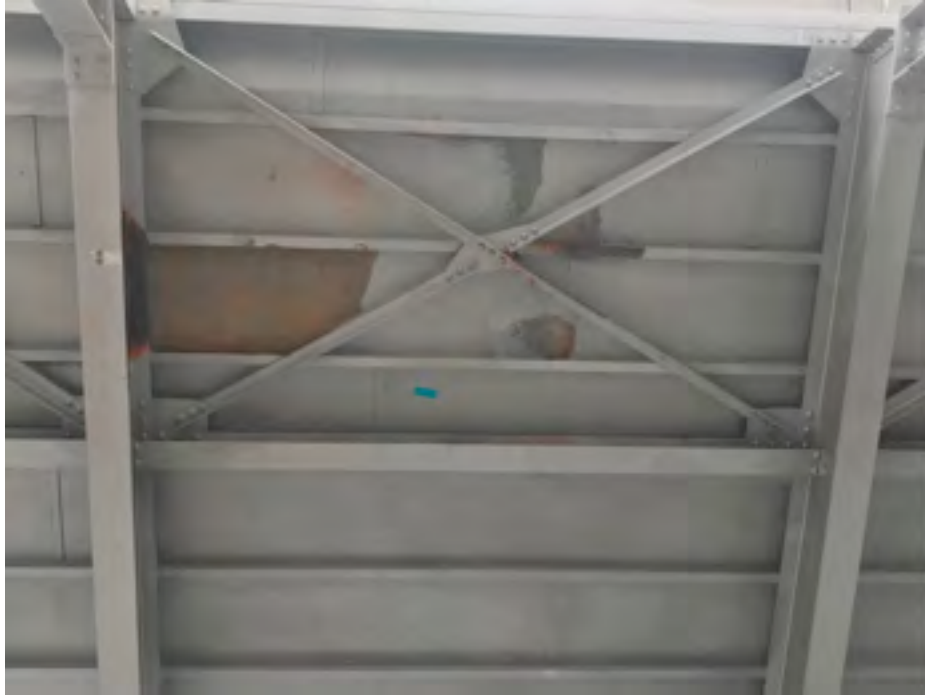
Photograph 5 – Underside of mezzanine after UHPW method was utilized.

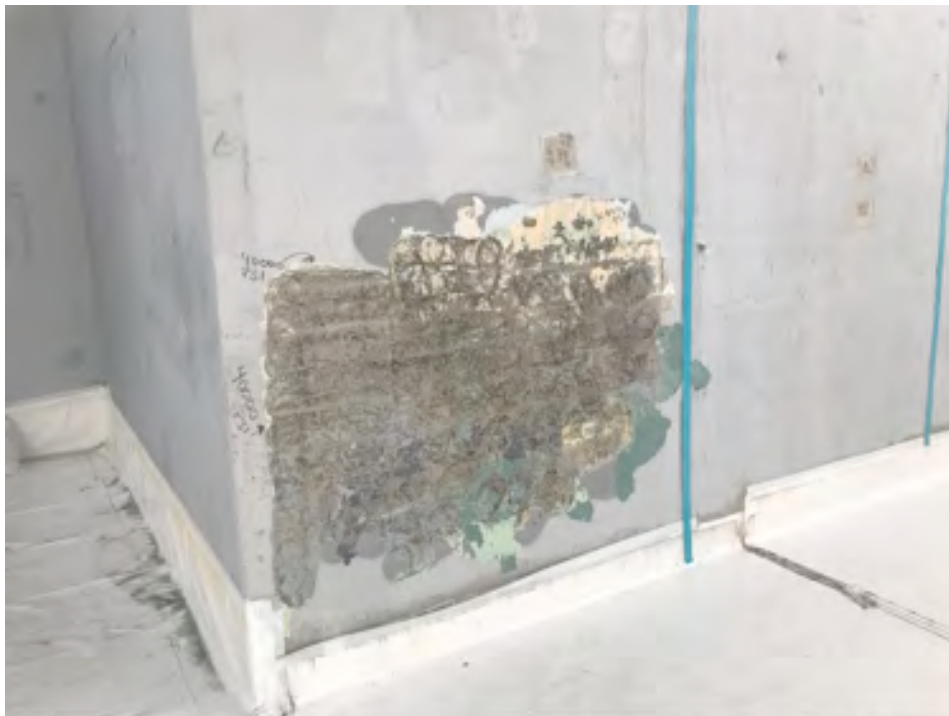
On the concrete wall, the UHPW system was not effective at removing the coatings at pressures under 40,000 PSI. At 40,000 PSI, the concrete wall was damaged by the water, causing the smooth cement surface to be removed exposing the aggregate. Photographs 6 and 7 below illustrate the poor removal of paint/coatings from the CMU wall and the damage caused to the underlying substrate.

Photograph 6 – CMU wall after removal of paint/coatings with UHPW system.

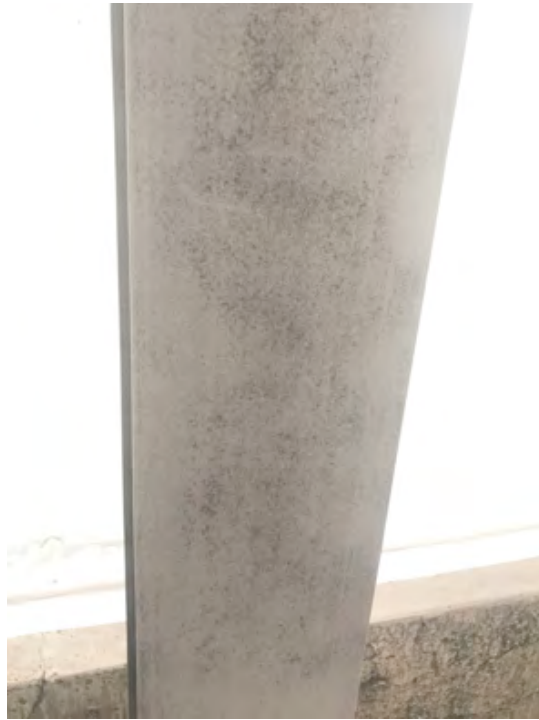
Photograph 8 – Structural steel after removal of paint/coatings with media blast system. Light areas are referred to as ‘white metal.’ Darker areas are residual mill scale.

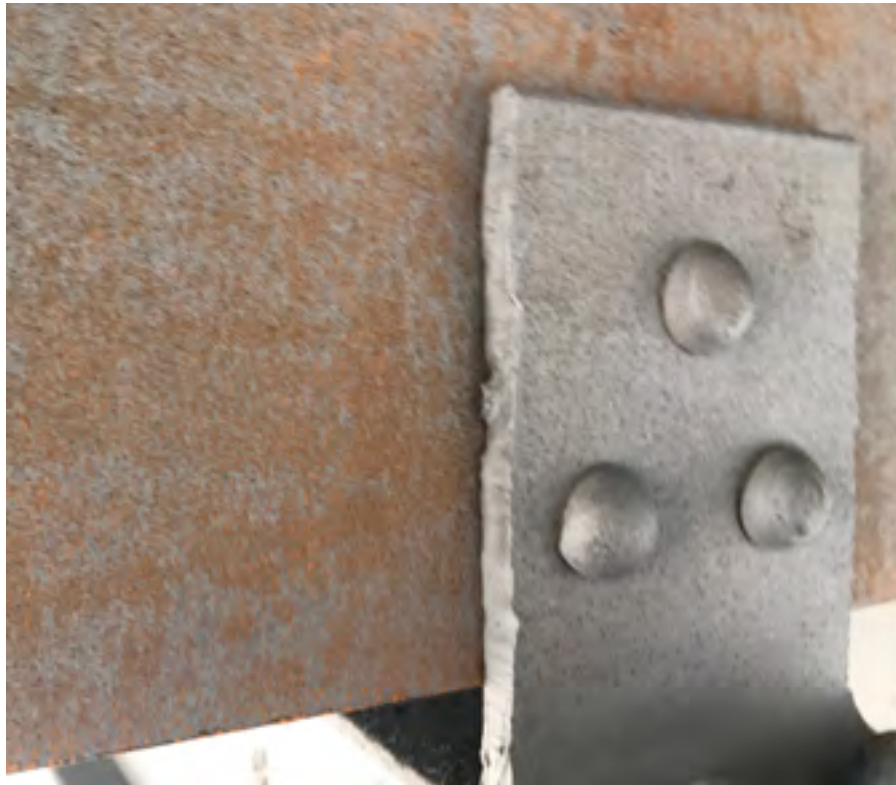
Photograph 9 – Tight-tolerance mated flange/beam connection after removal of paint/coatings with media blasting. (Note: the brown areas in the photo correspond to areas of rust formation due to the wet decontamination of the abated steel)

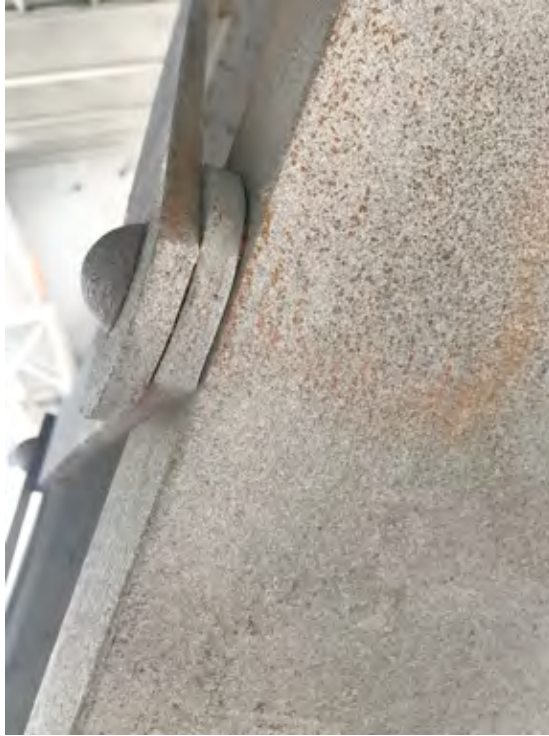
Photograph 10 – Structural steel with tight-tolerance mated brace and rivet head after removal of paint/coatings with media blasting. (Note: the brown areas in the photo correspond to areas of rust formation due to the wet decontamination of the abated steel)

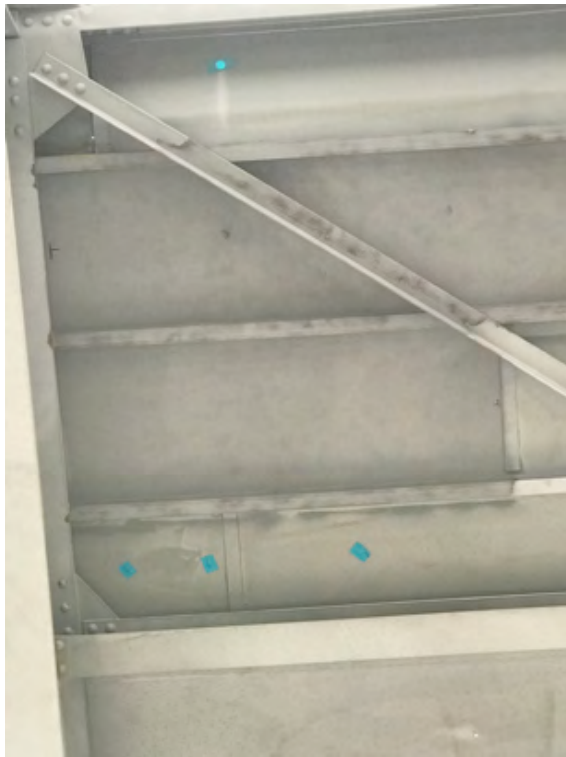
Photograph 11 – Under side of mezzanine after removal of paint/coatings with media blasting.
