DRAFT Final Hangar 1 Engineering Evaluation/Cost Analysis

**Former Naval Air Station Moffett Field,
California**

**13 August 2019
EKI B20019.19**

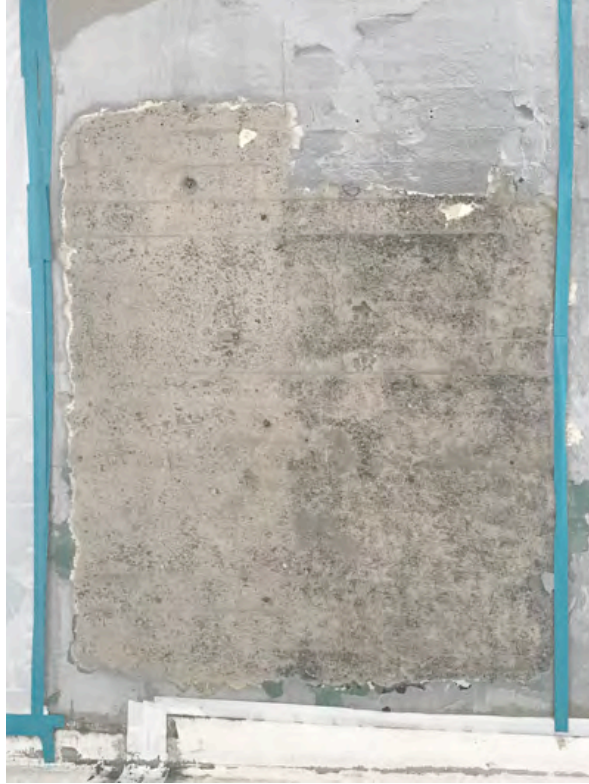
On the concrete wall, the *Kleen Blast* and plastic media both appeared capable of removing the paint/coatings and asbestos-containing skim coat. Although less than the damage observed by the UHPW, both blast medias caused minor damage to the CMU wall finish by removing the "board form" markings. Photographs 12 and 13 below show the CMU wall after removal of paint/coatings by media blasting.

Photograph 12 – CMU wall after removal of paint/coatings with media blasting. Left side (lighter color) was removed with Kleen blast media. Right side (darker color) was removed using plastic media.

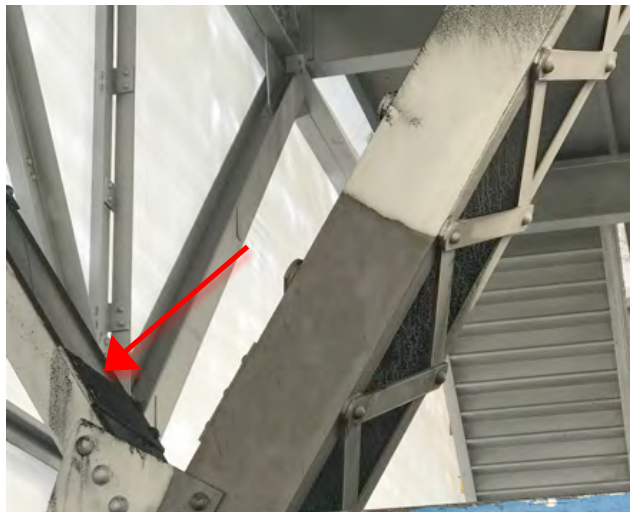
Visually, the surfaces abated by Vapor Media Blasting appeared very similar to the surfaces that were abated by Media Blasting. The steel surfaces abated were noted to be clean white steel; however, due to the use of water vapor as a propellant, surface rust appeared much sooner with this method. Photographs 14-17 below illustrate surfaces after the removal of paints/coatings with the vapor media system.

Photograph 14 – Structural steel after removal of paint/coatings by vapor media system. This photo was taken before cleaning the Pilot Study enclosure and black areas (see the red arrow) are areas where spent abrasive media has accumulated.

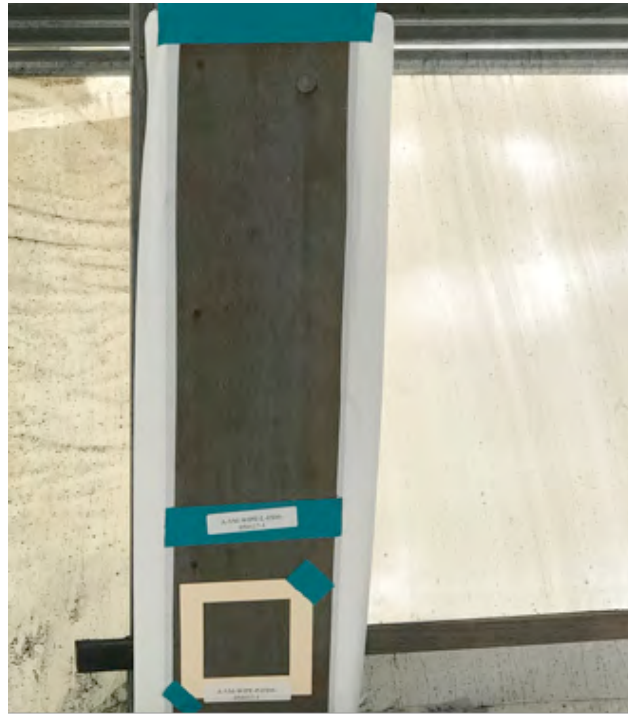
Photograph 15 – Structural steel after removal of paint/coatings at time of verification sampling.

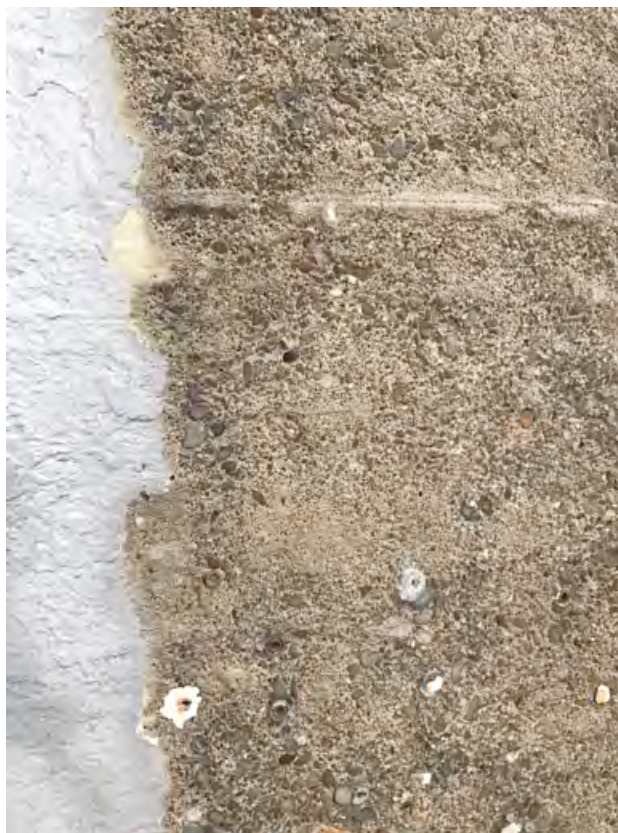
On the concrete wall, the vapor media system appeared capable of removing the paint/coatings and asbestos-containing skim coat. The amount of damage noted was similar to that of Media Blasting. Photograph 18 below shows the CMU wall after removal of paint/coatings with the vapor media system.

Photograph 18 – CMU wall after removal of paint/coatings with vapor media system.
