Building 46 (Hangar 2) and Building 47 (Hangar 3)

Due Diligence Phase 1 Report

**A.22 - Hangar 3
Emergency Truss Repairs**

Hangar 3 Emergency Truss Repairs Narrative

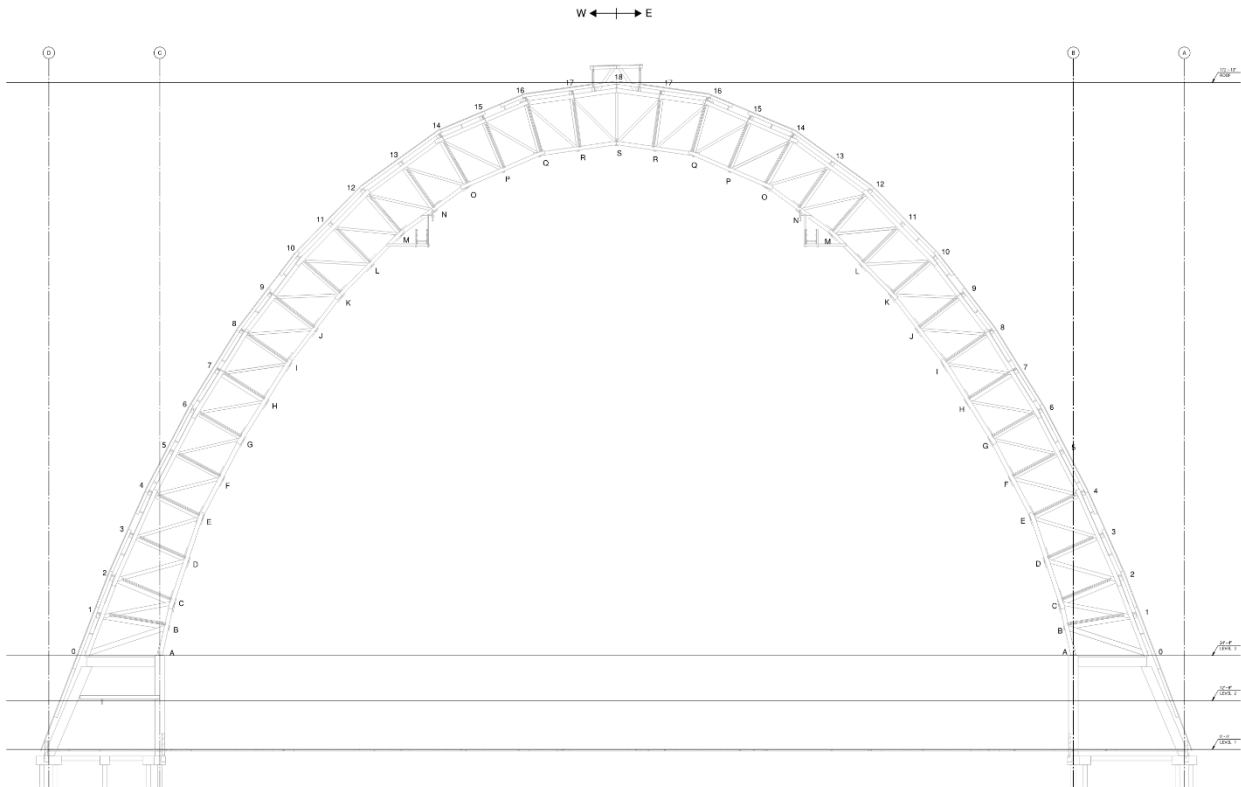
Figure 4. Typical truss elevation with labeled panel points.

On June 24, 2015, KPFF performed a routine site visit to observe field conditions of the shed framing in Hangar 2. During that site visit, KPFF also observed Hangar 3 trusses from the deck slab and upon observation, suspected damage progression in the Hangar 3 arched trusses. On June 30, 2015, KPFF performed a follow-up site visit to Hangar 3 with aerial boom lift access and observed severe damage progression and increased excessive truss deflections. Turner Construction provided photographs of the ridge line indicating substantial increased deflection at the roof monitor. KPFF issued findings in engineer's field report EFR-03 along with recommendations for a zone of immediate emergency shoring due to damage progression. Selected photos from EFR-03 are provided below in Figure 1, Figure 2, and Figure 3. A reference truss elevation with panel points labeled is provided in Figure 4.

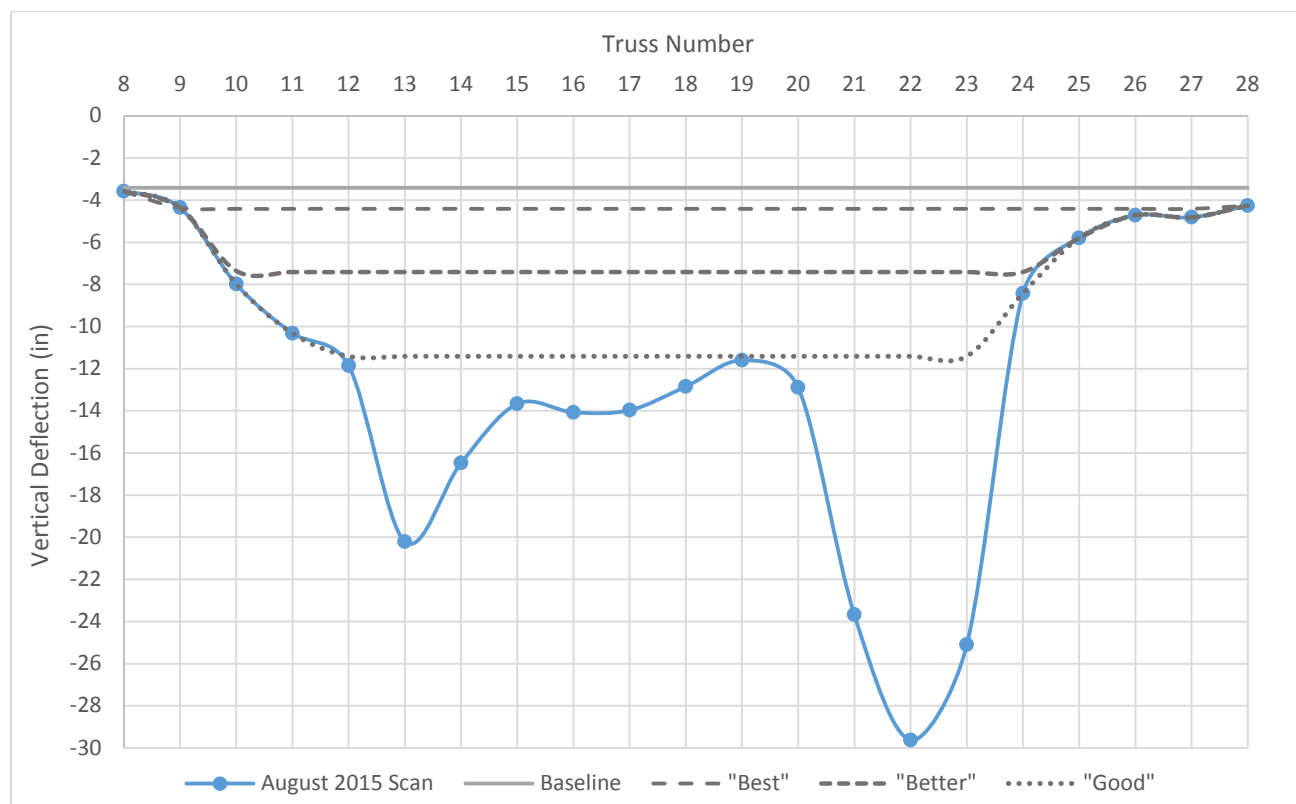
Figure 9. Hangar 3 Panel Point 18 Deflection with Deflection Criteria Options

In addition to selecting a method of installation, the project team also selected a target criteria for roof deflections. The number of exoskeletons and the number of jacks required depends on the amount of deflection to be reversed during the Emergency Repair process. However, full restoration back to the previous undamaged roof geometry may prove to be physically infeasible due to the complexity, risk, and timing involved in these operations due to existing field conditions. KPFF established the target deflection criteria shown in Table 1 and Figure 9 based on “Good”, “Better”, and “Best” scenarios.

Figure 9 was generated to illustrate the roof deflections (in blue) relative to a baseline that represents the average roof deflection at the trusses in the hangar that do not exhibit severe damage. The figure was used to compare the different deflection criteria options.

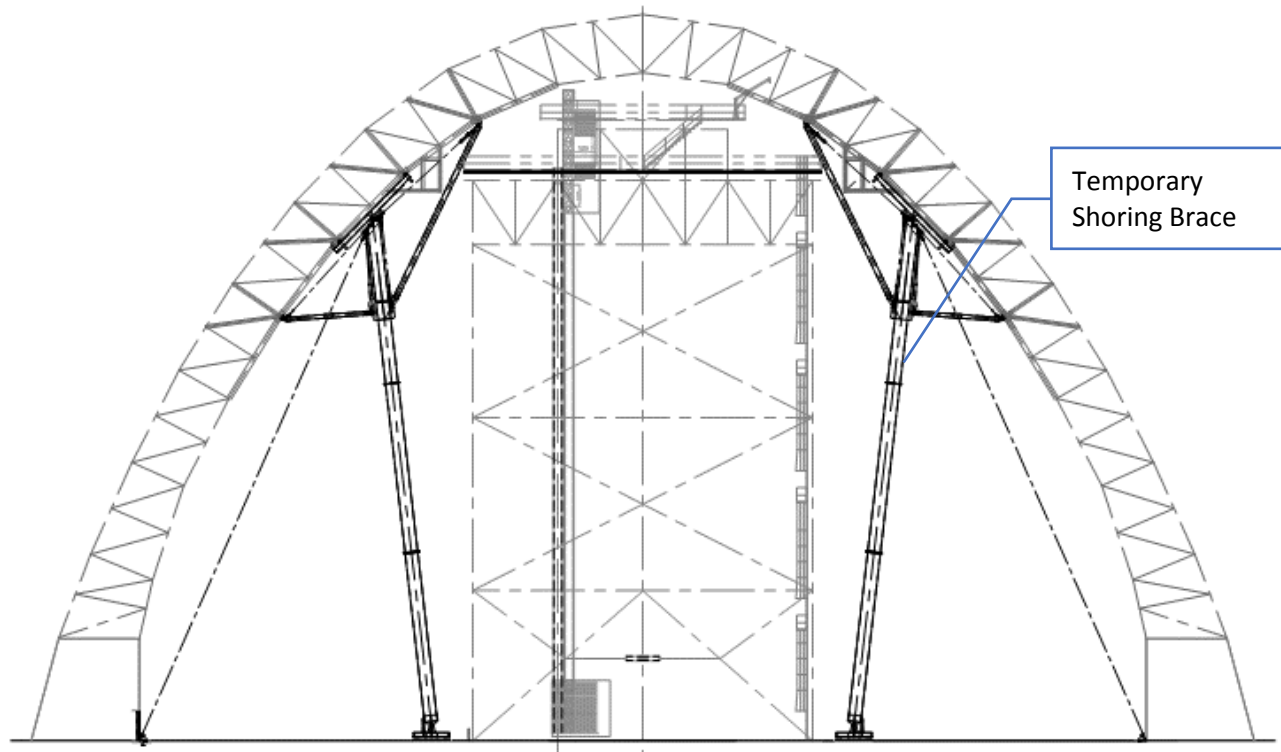
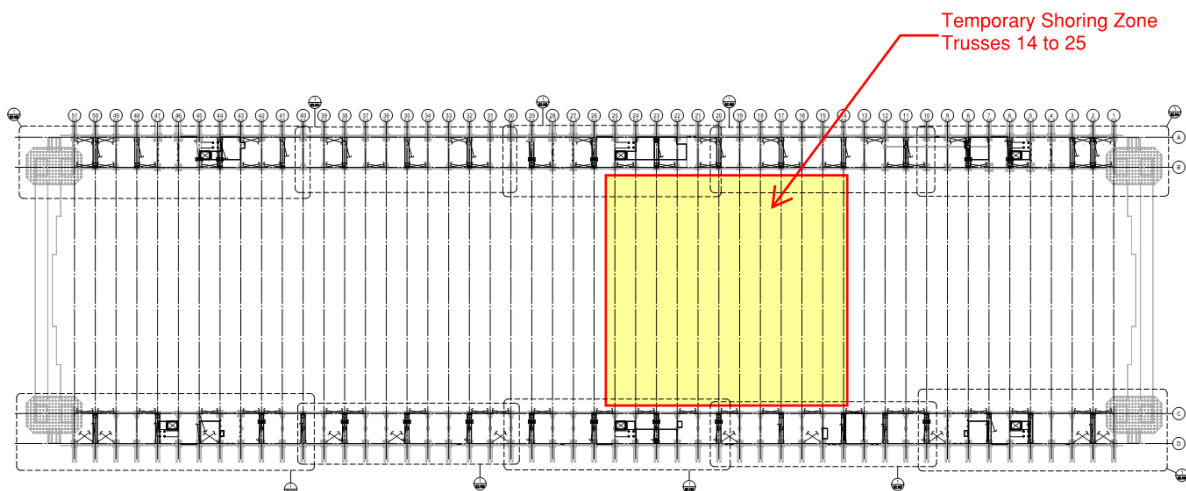
Figure 11. Temporary Shoring + Shoring Tower

Figure 12. Zone of temporary shoring.

Step 1: Install temporary shoring braces to prevent full collapse of hangar (Figure 11 and Figure 12). The upper portion of the hangar remains unsupported and local damage progression and partial collapse of the upper zone is still possible.

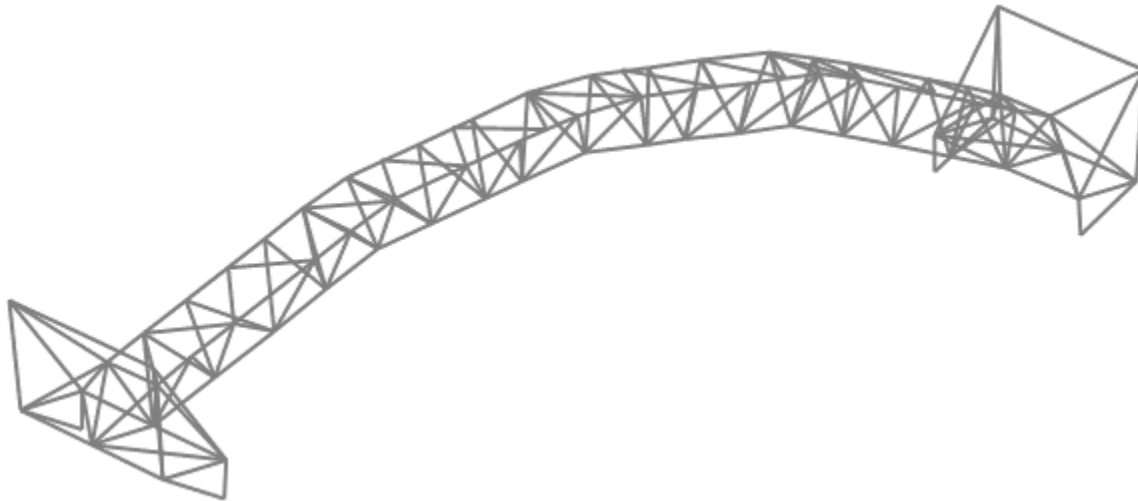
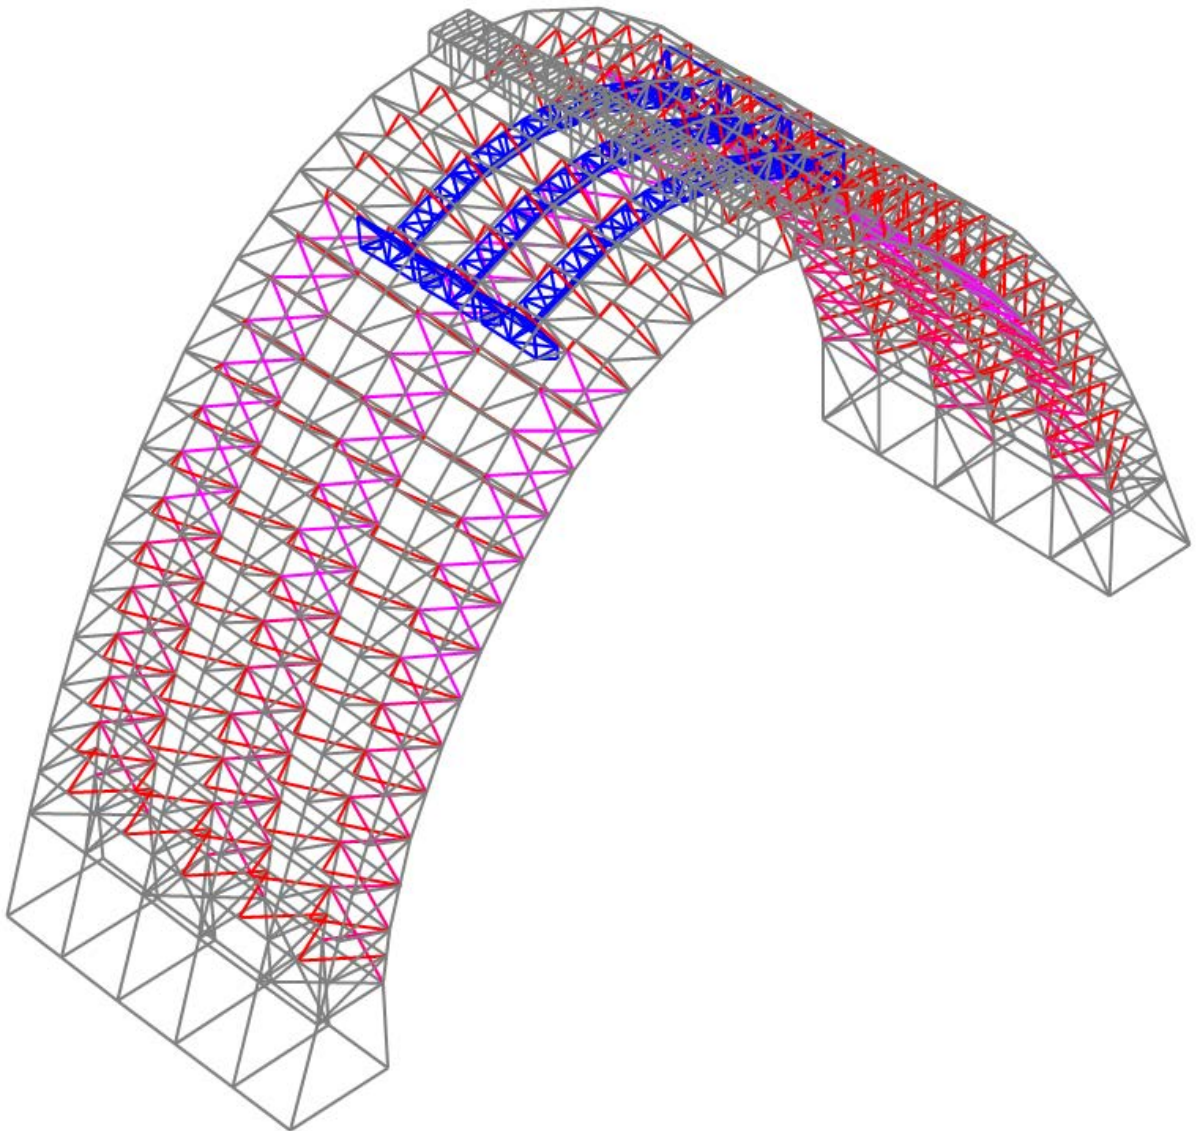
Figure 14. 3D Isometric of Steel Exoskeleton

Figure 15. 3D Isometric of Exoskeletons Installed between Existing Wood Trusses

Step 3: Install steel truss support frames called “Exoskeletons” (Figure 14) in between existing wood trusses that have exhibited significant damage and deflection. The Exoskeletons are shop welded in segments which are field bolted together. The Exoskeletons are to be installed in the space between the existing trusses and will be attached to the existing trusses with bolts and steel plates (Figure 15).

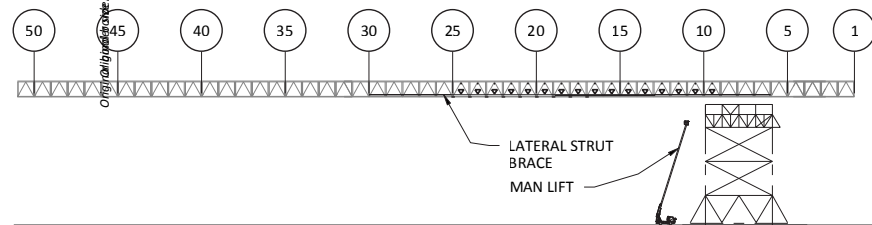
3. INSTALL LATERAL BRACING BEYOND EXOSKELETON LOCATIONS

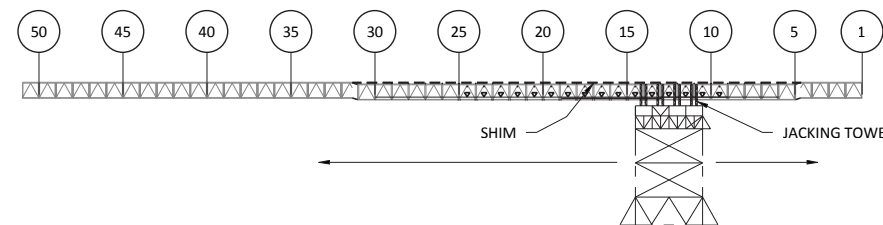
8. ADDITIONAL ROOF ELEVATION ADJUSTMENT BY SHIMMING - AS REQUIRED

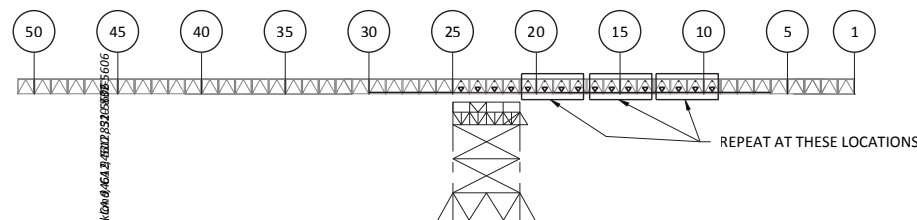
4. REMOVE HANGAR TRUSS DAMAGE AT EXOSKELETONS, AND DISCONNECT HANGAR TRUSSES FROM THE ROOF.

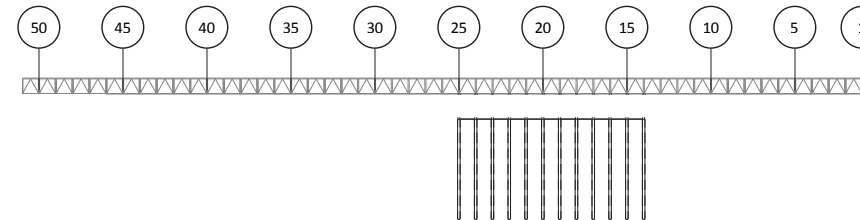
9. REMOVE LATERAL BRACING AND TEMPORARY SHORING

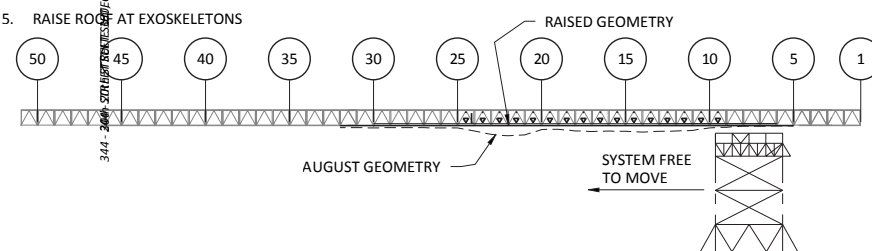
5. RAISE ROOF AT EXOSKELETONS

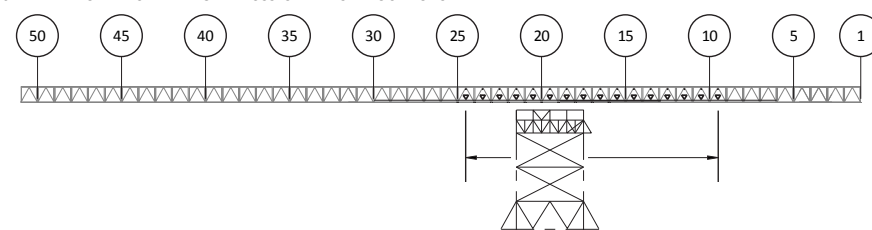
6. REPAIR OR REBUILD HANGAR TRUSSES AT RAISED LOCATIONS

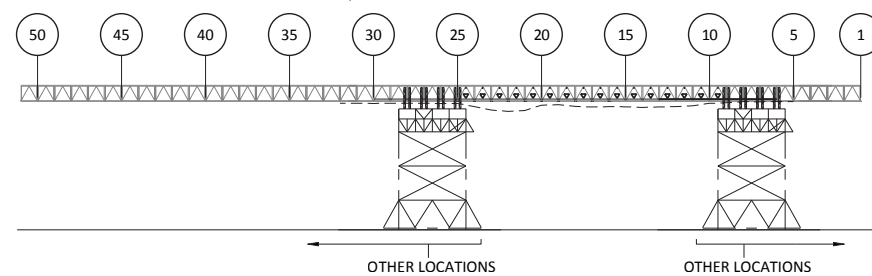
7. RAISE AND REPAIR OTHER LOCATIONS - AS REQUIRED

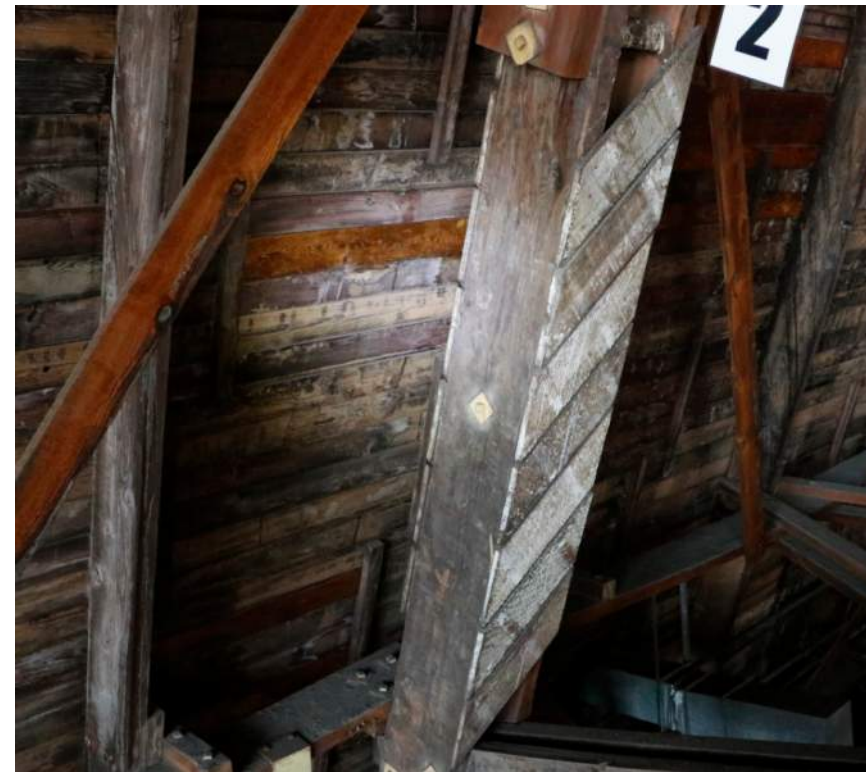
- Battens were added to bottom chords, and some top chords and diagonals to increase stability and help prevent buckling
- Upgrade was intended to increase the longevity of the temporary structure
- Battens added to **2244** members per hangar
- Batten wood was treated with a mixture of borax, white lead, and linseed oil paint.
- "These battens, with a few additional bolts and blocking at the chord splices, are the principle measures taken in strengthening and making permanent these wood buildings."
"Strengthening of LTA Hangars, Naval Air Station, Moffett Field, California", J.S. Marsh, 1946

Typical chord member with battens

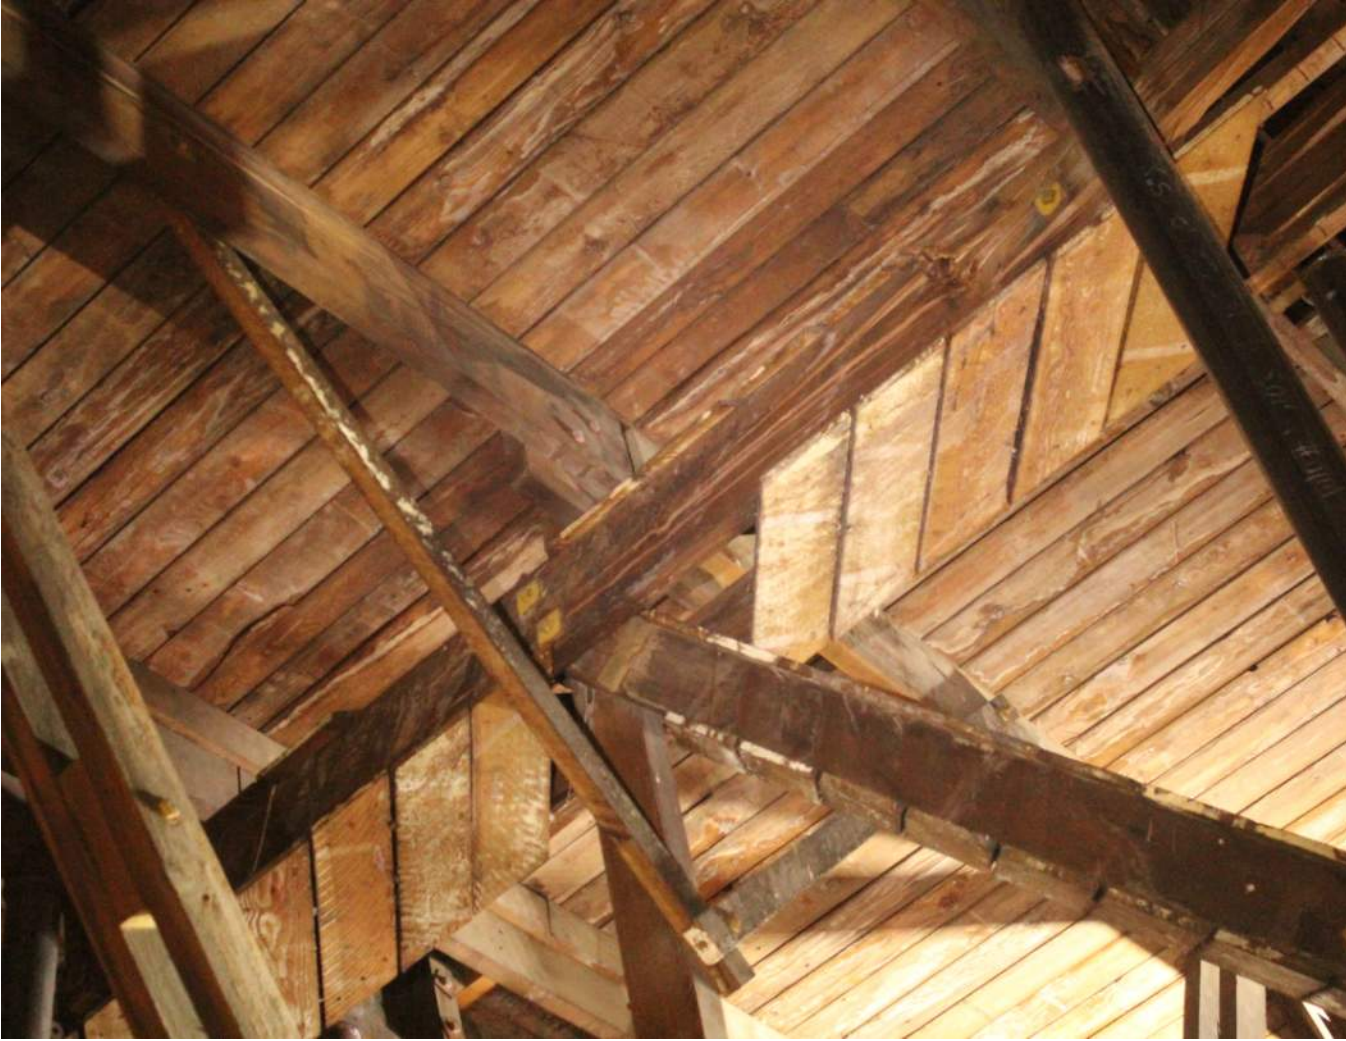
- Knee-braces were added to reduce the unbraced length of certain vertical web members
- These braces were part of the 1946 strengthening measures described by J.S. Marsh.
- Knee braces added to **700** vertical web members

Typical vertical web member with added knee-braces

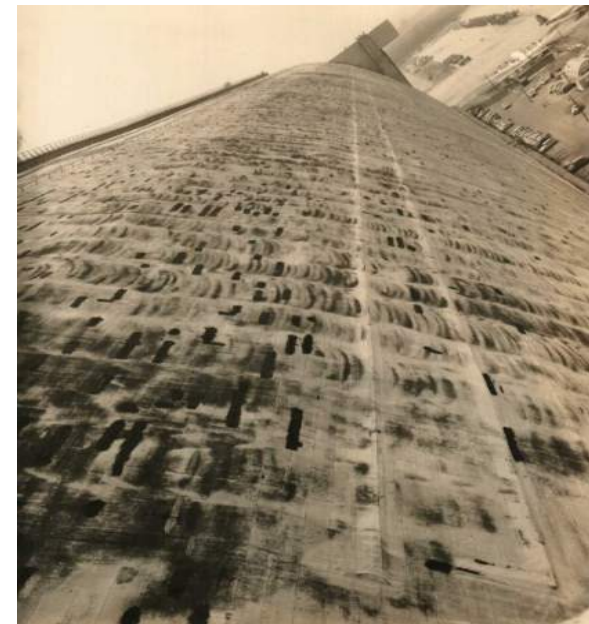
- Original roofing system was roll-roofing over panelized wood sheathing
- Roof was upgraded to corrugated aluminum panels over roofing felt in 1956
- Approximately **466,000** ft² of roofing per hangar

Original roofing system
-Seabees Historic Photos

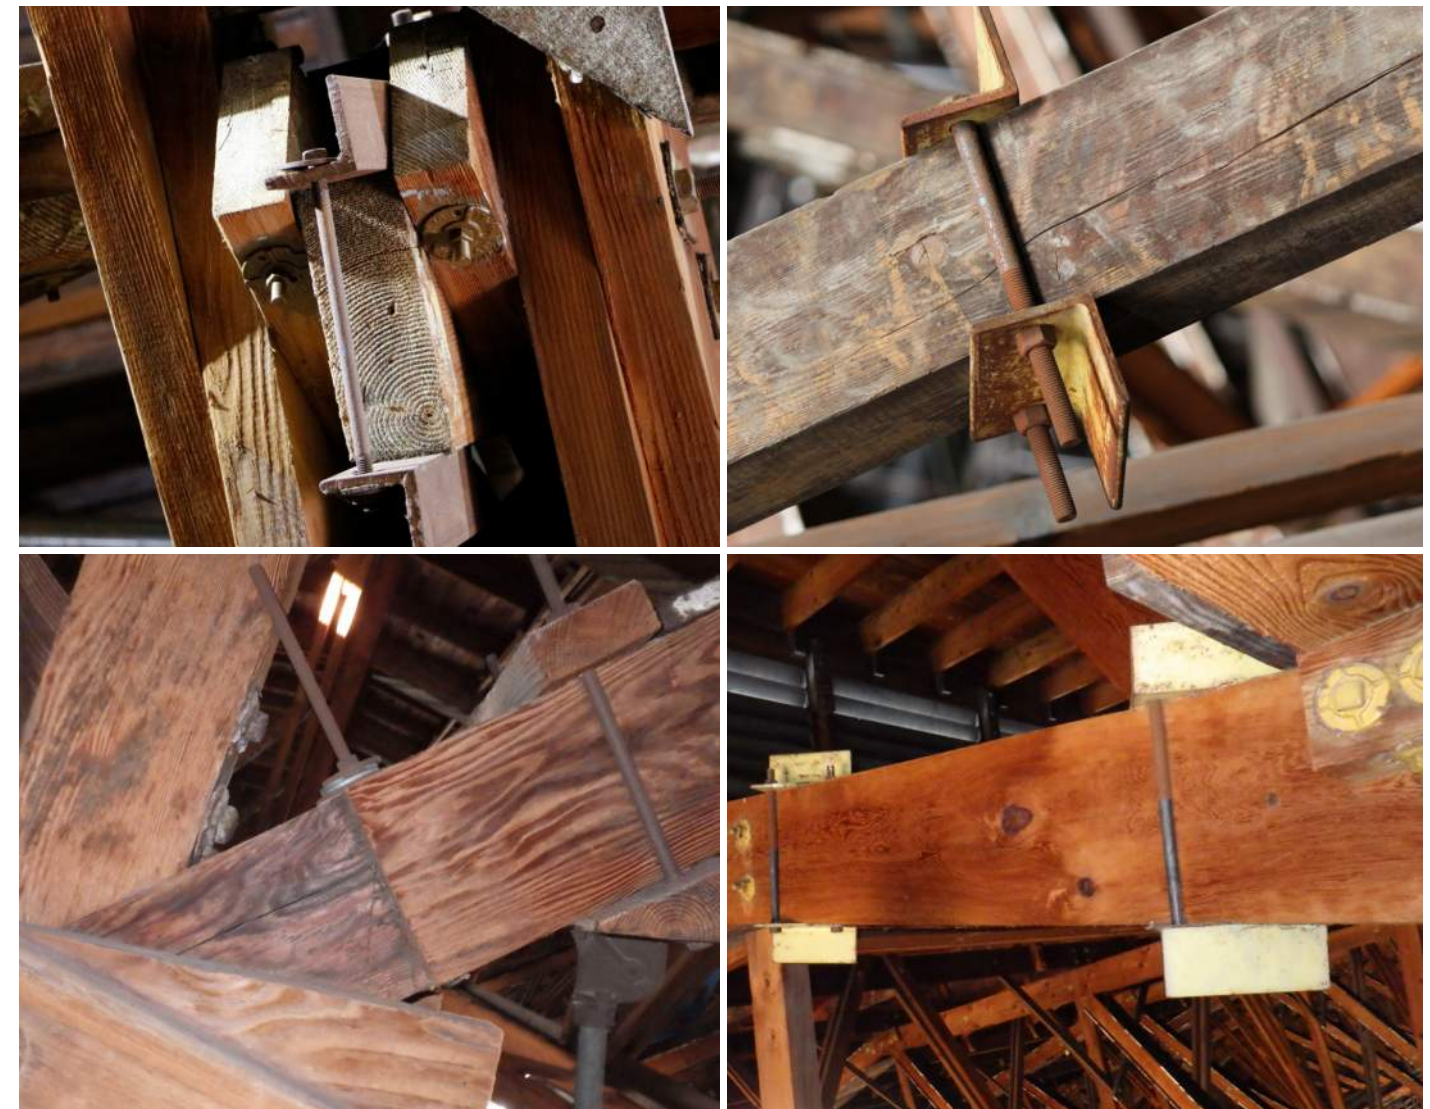
- Standard repairs for Navy maintenance included steel clamps and stitch bolts to fix minor splits "Maintenance Procedure for Timber Trussed Structures" Department of Navy Bureau of Yards and Docks, 1944
- Repairs occurred periodically throughout the service life of the hangars
- Navy records indicate that Timber Structures performed an inspection of the hangars in 1954
- The extent of these repairs is not fully documented
- Minor repairs have been documented at **541** members in H3 (many still undocumented)

Minor repairs made during Hangar 3 service life

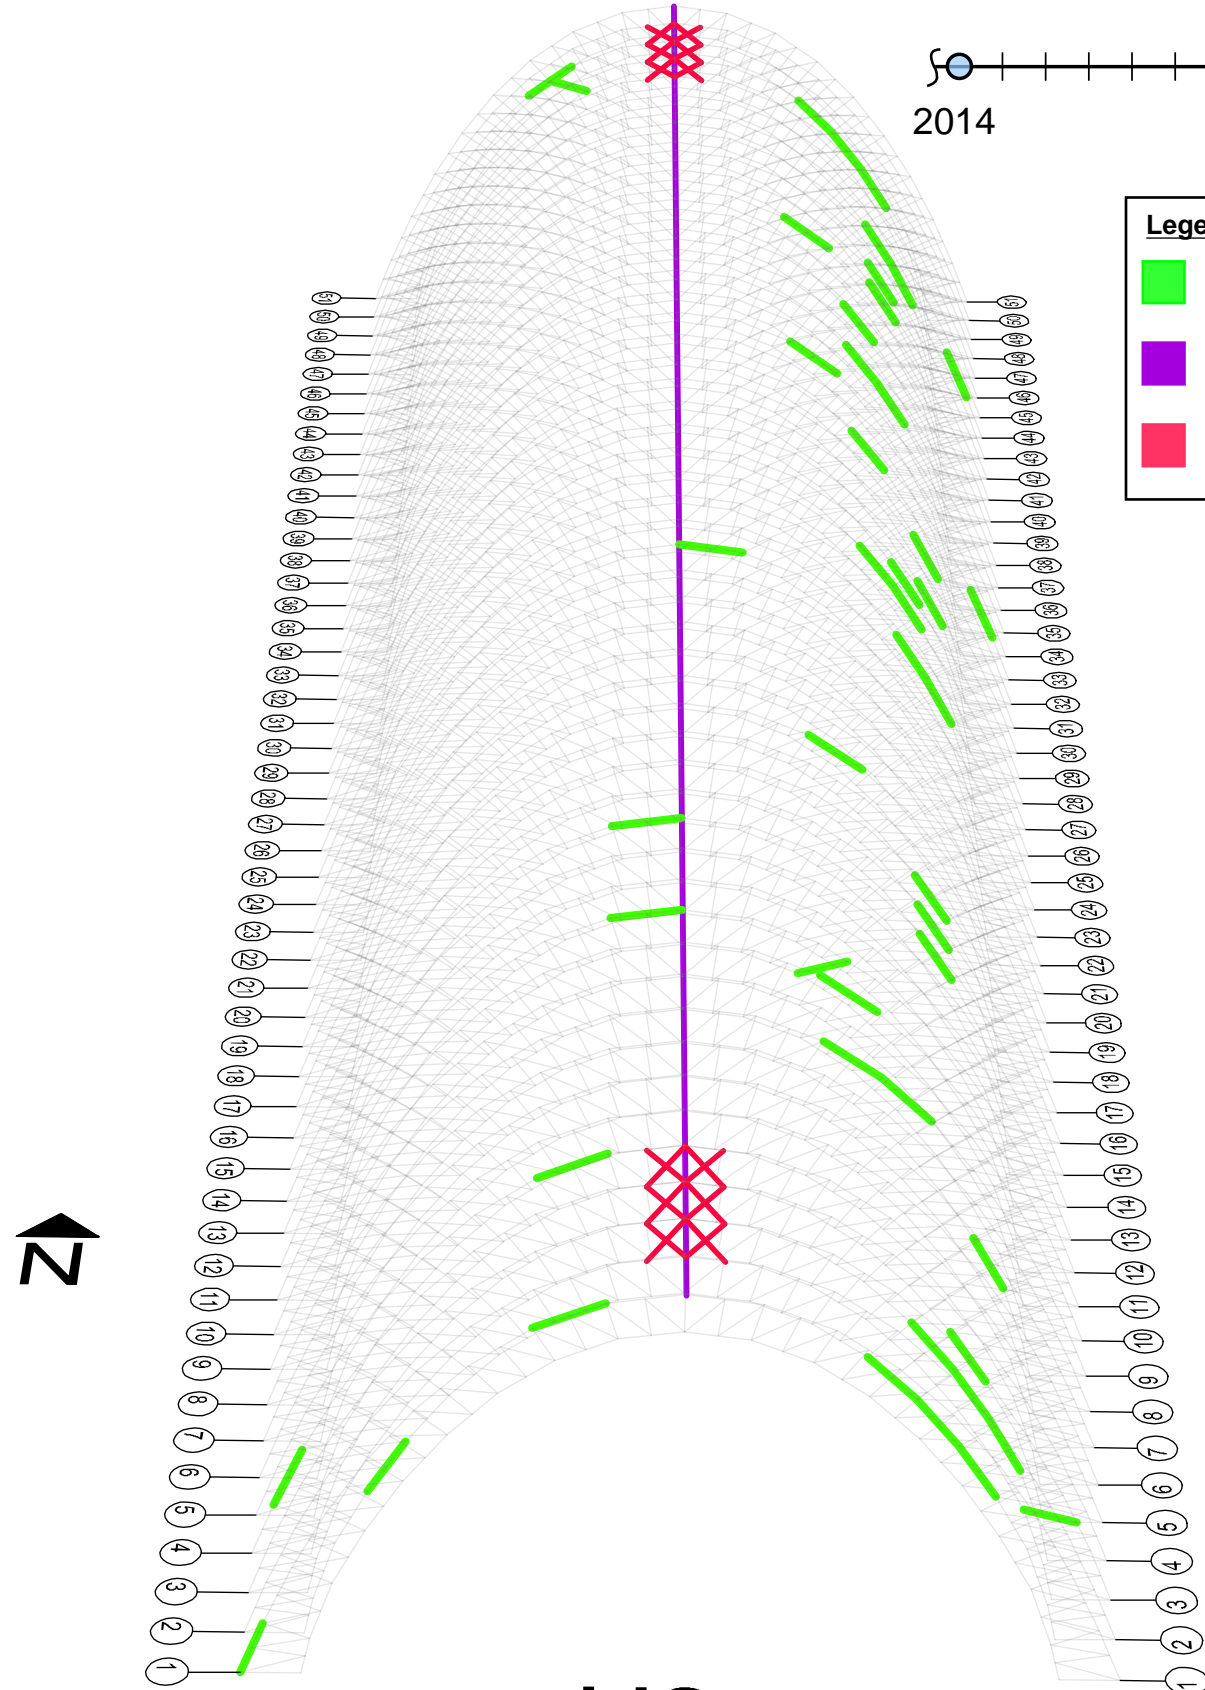
- Major glulam repairs were made in 1981 to correct buckling observed in truss chords
- Glulam strongback members were installed to re-align chords, but load path remained in the original members
- Major repairs made to **49** members
- Struts added at each arch at node 18 to brace top of truss, with rod cross-bracing added at the north and south ends of the hangar
- Minor repairs were also made with clamps and stitch bolts. Many 1x6 purlin ties were replaced with steel rod ties

Buckled chords (left) and glulam strongback repairs (right)
- "Restoration of Navy LTA (Lighter than air) Hangars", Donal Neal, 1986

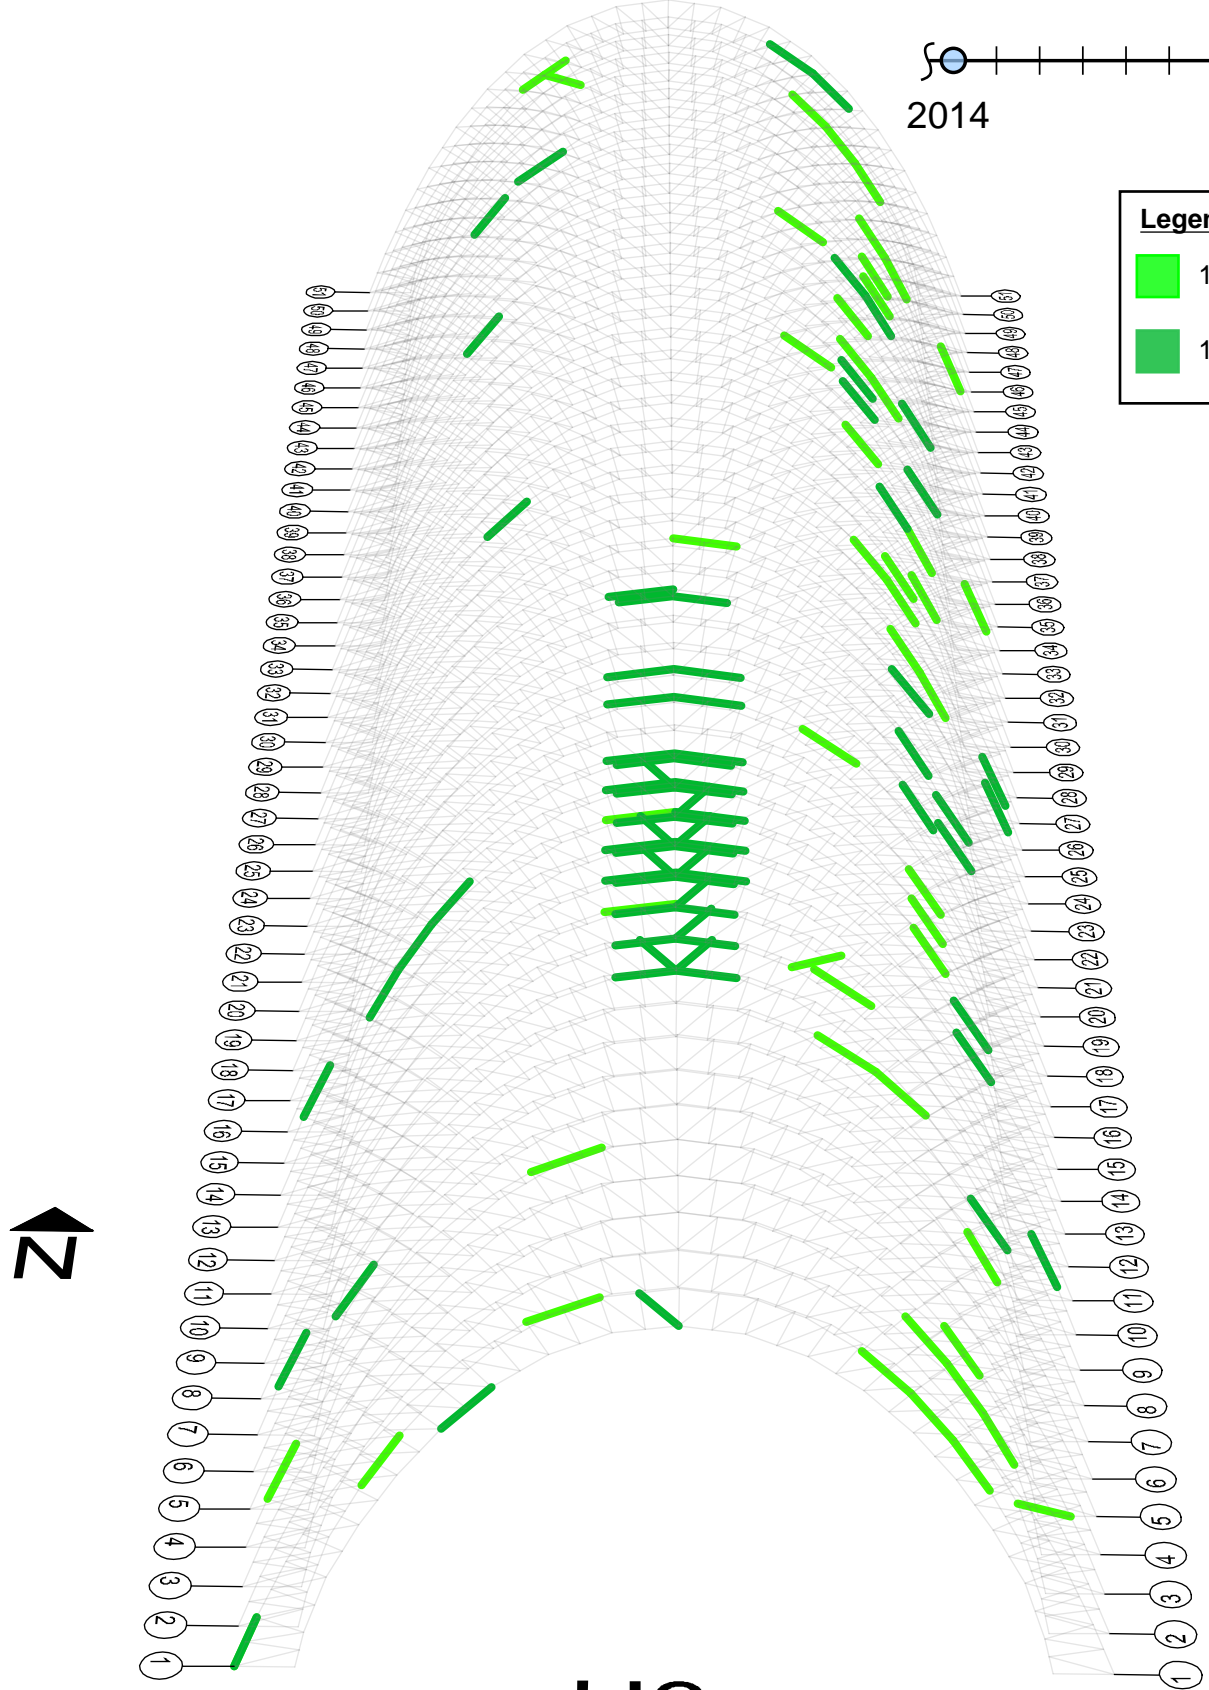
- Continued deterioration of Hangar 3 necessitated further glulam repairs in 1993
- Repairs consisted of glulam strongbacks for buckling, and multi-chord glulam sistered members
- Many of these repairs were made in the critical zone where the most severe deflections and damage were later found
- Major repairs made to **75** members
- Sistering repairs also made to roof support purlins and minor clamp repairs were again performed on arch trusses

1993 glulam sister repairs to chord members in critical zone

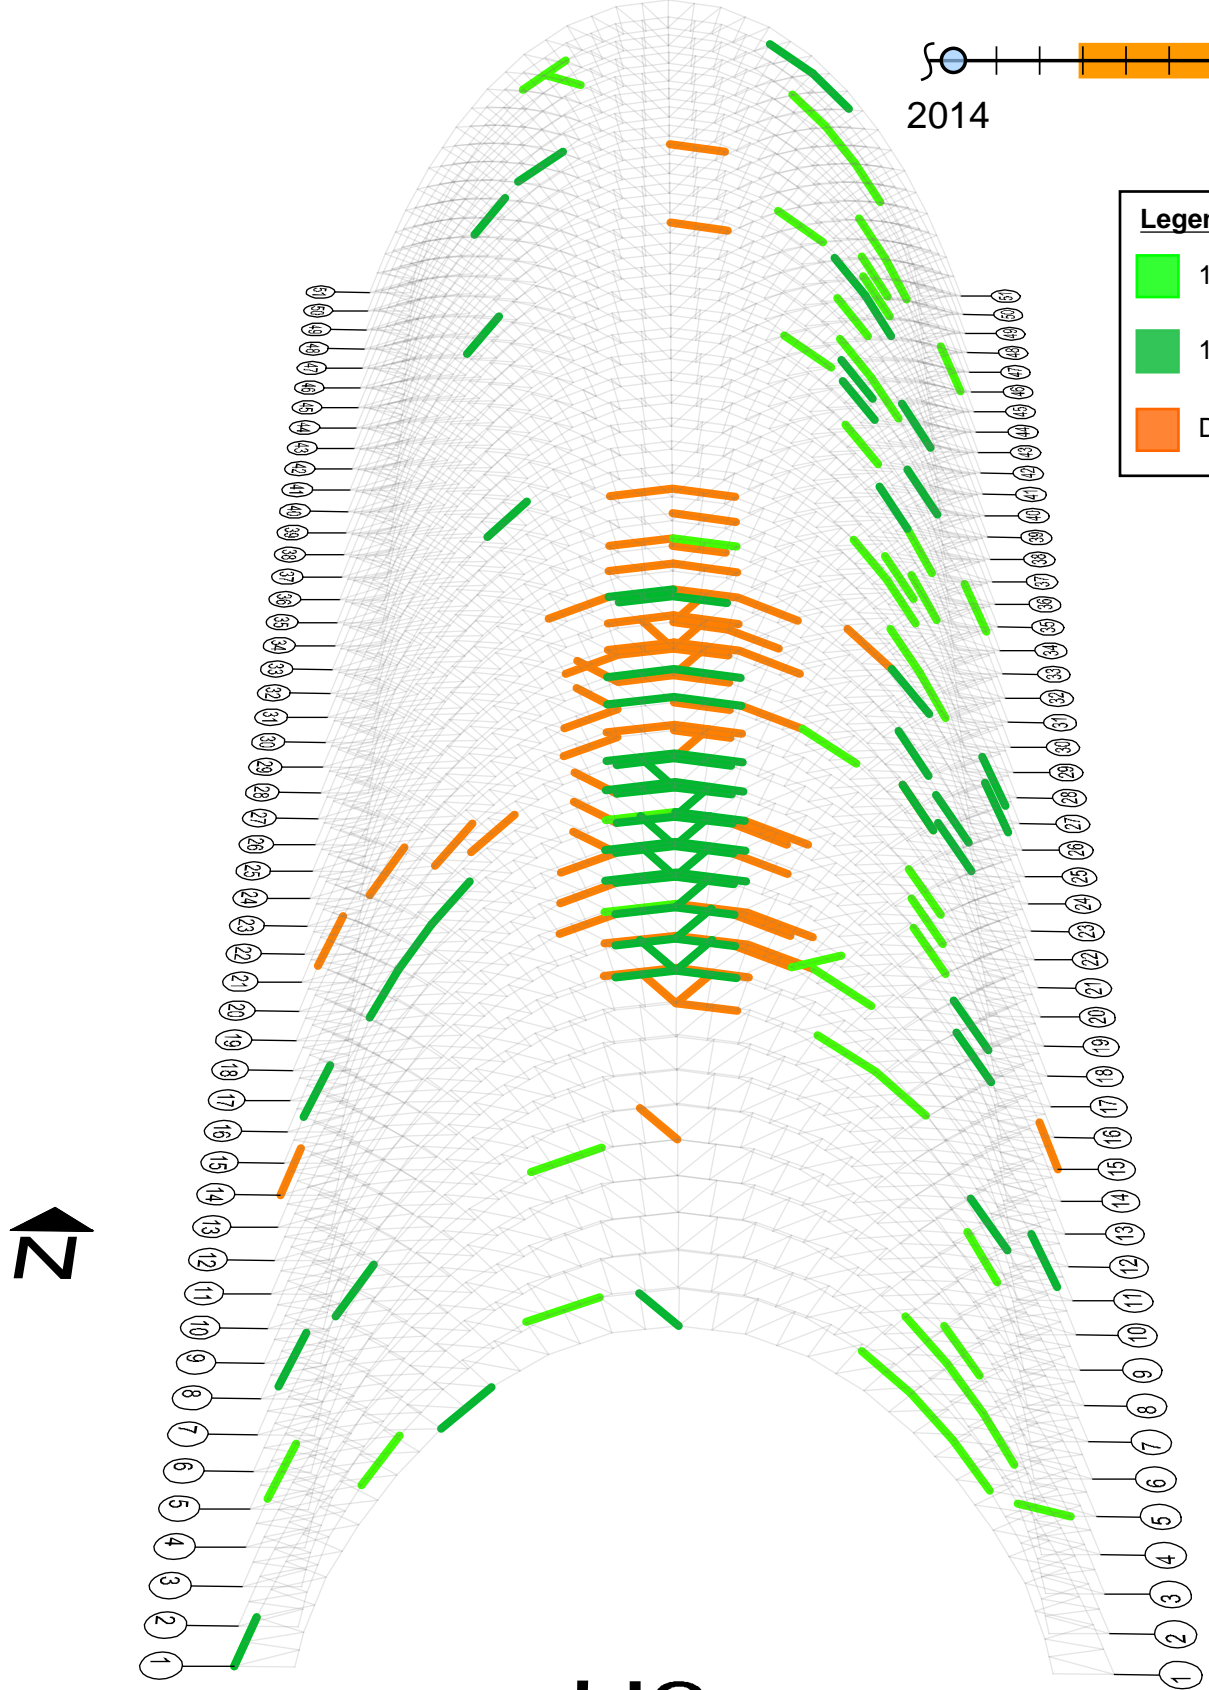
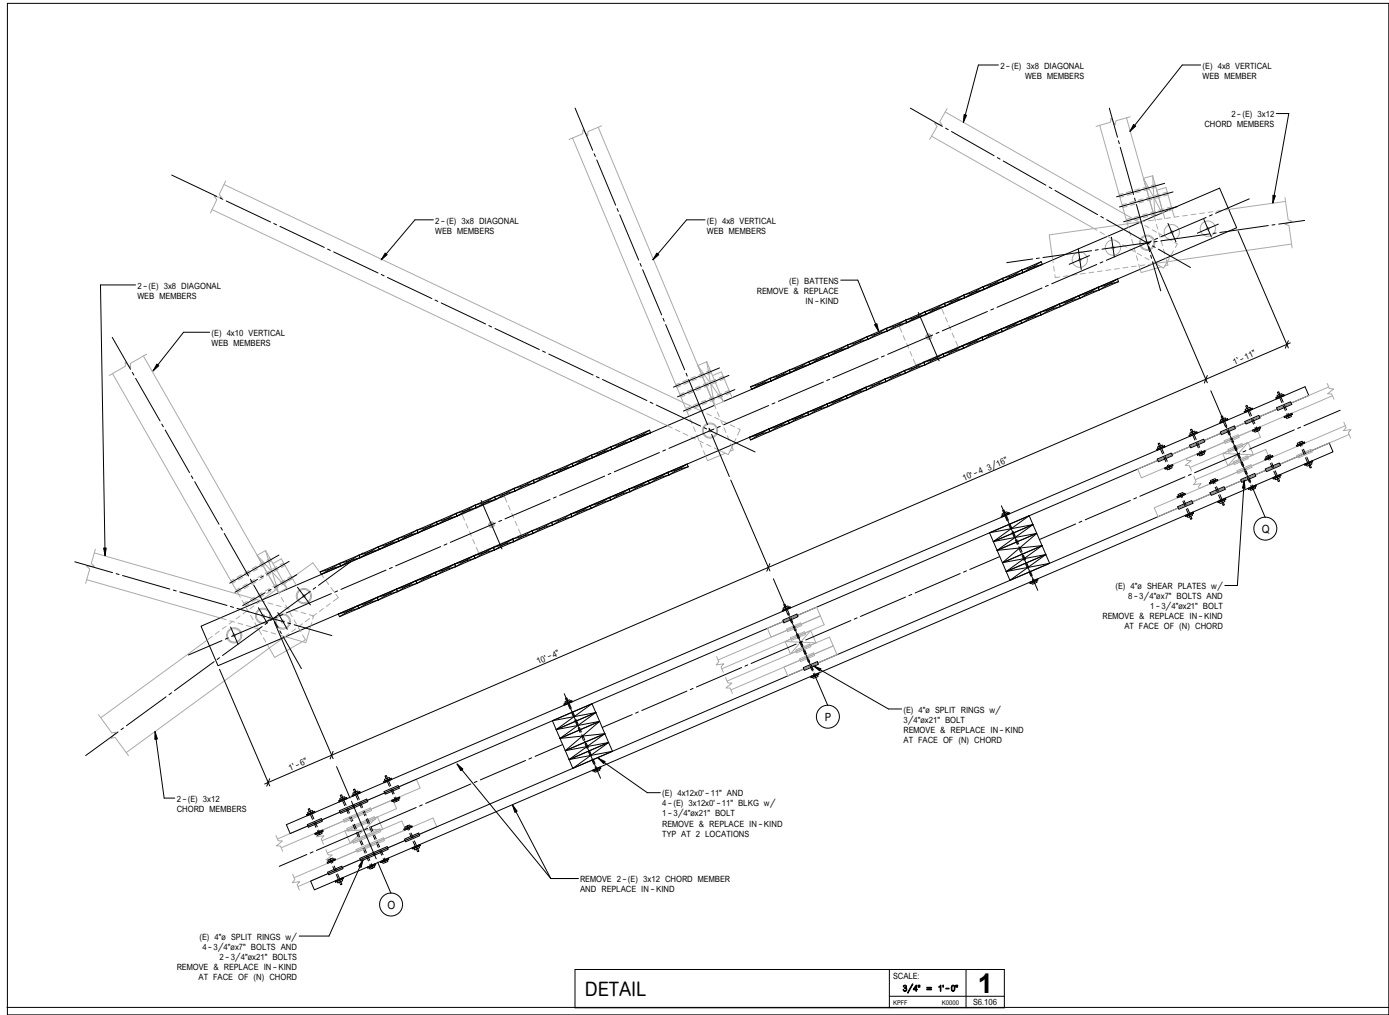
- TPAS® data was reviewed and damaged members were identified for repair
- **68** members were found to be damaged and in need of major repairs

Example detail for removal and replacement of damaged chords found in TPAS®

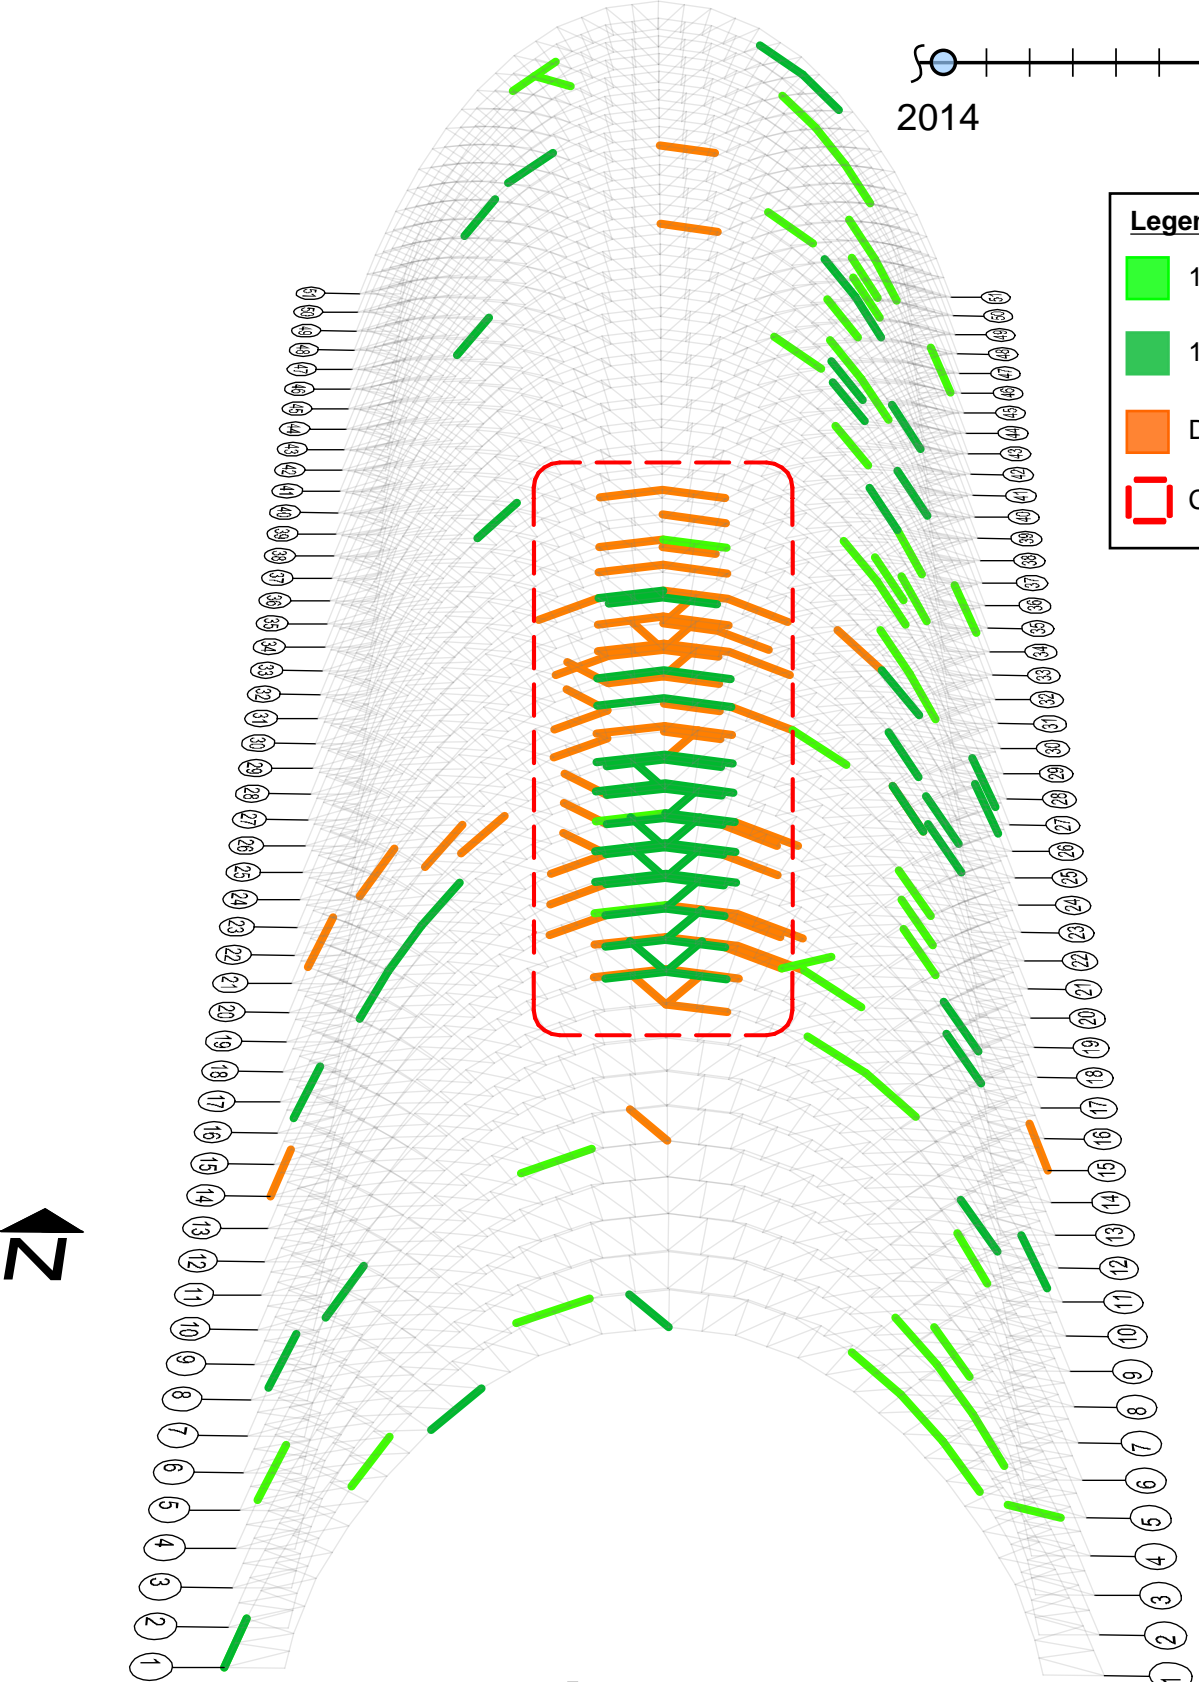
- During a site visit on June 24, 2015 KPFF observed damage progression in arch trusses
- On July 2, 2015 KPFF issued an Emergency Truss Repairs permit drawing set
- KPFF, Power Engineering Construction, Turner, and Page & Turnbull coordinated work to implement shoring and emergency truss repairs
- Permit for emergency repairs was received from NASA on August 19, 2015.
