Building 46 (Hangar 2) and Building 47 (Hangar 3)

Due Diligence Phase 1 Report

**A.22 - Hangar 3
Emergency Truss Repairs**

Hangar 3 Emergency Truss Repairs Narrative

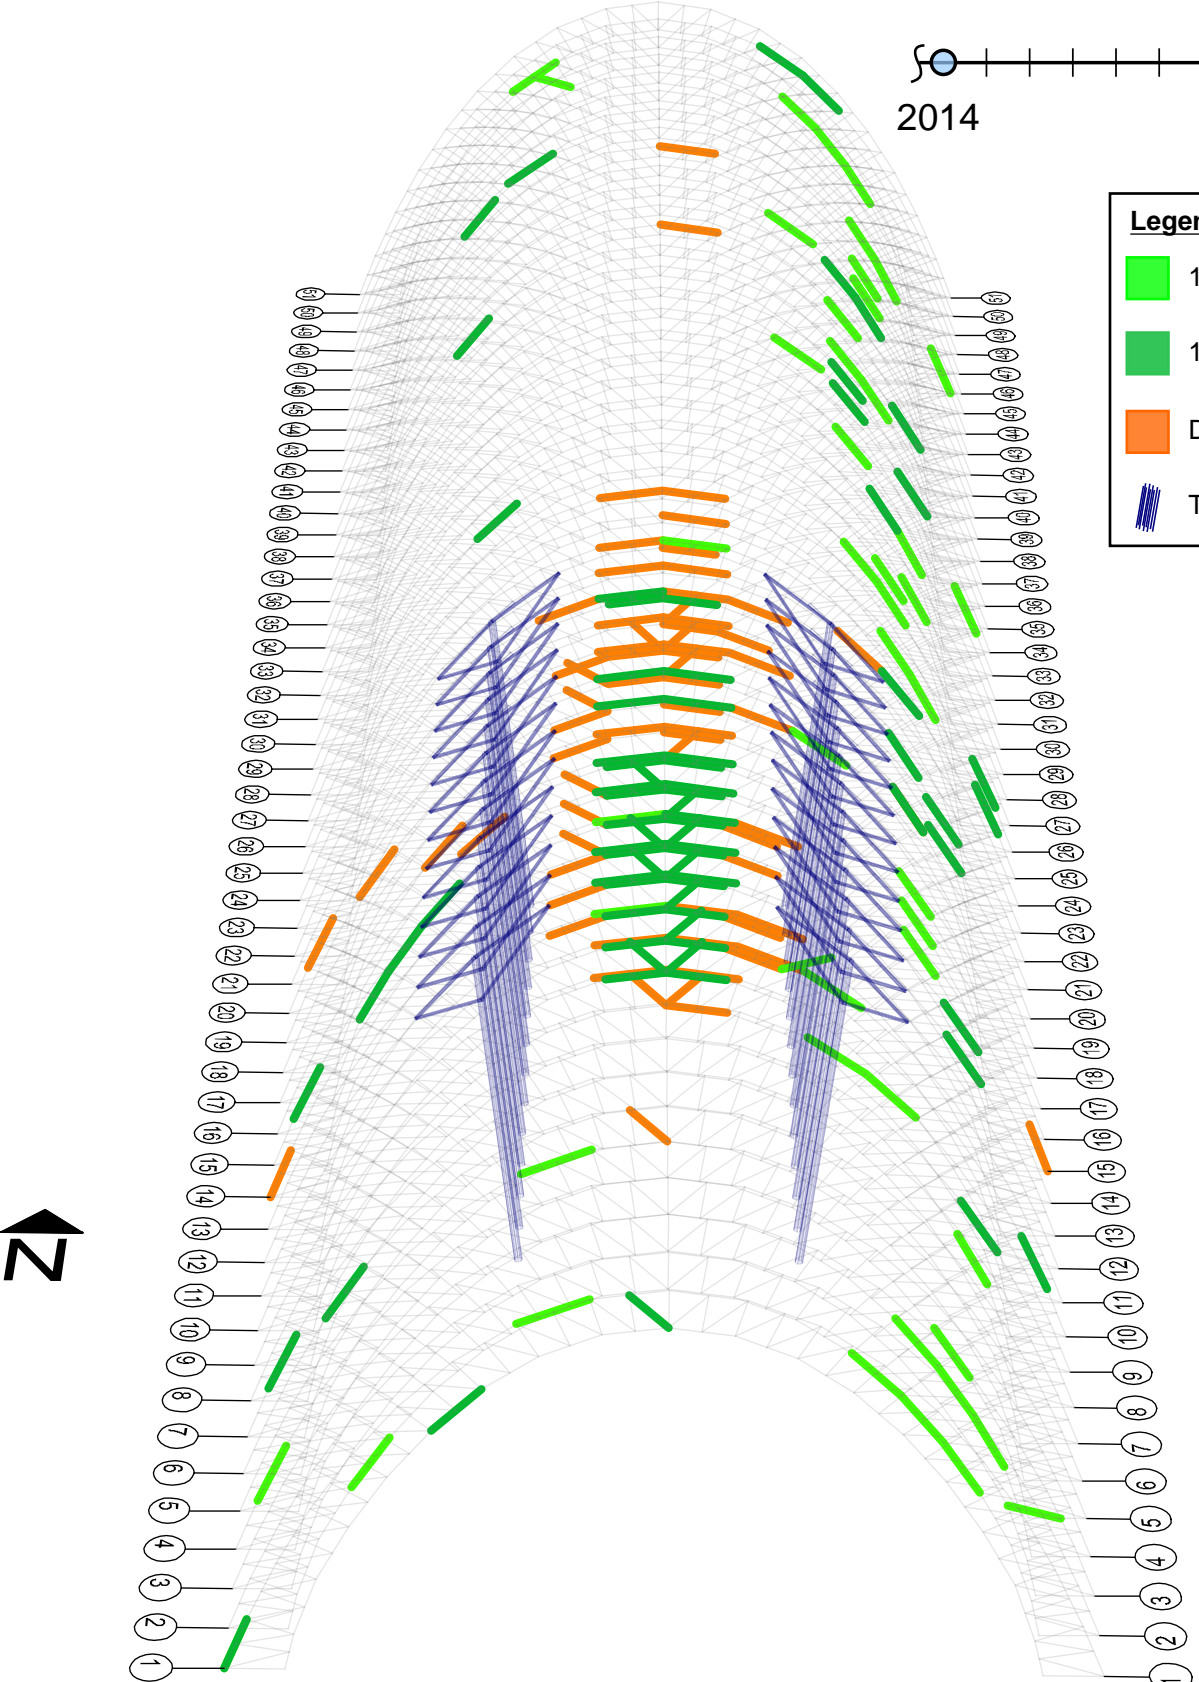
- Evidence of severe damage and progressive collapse of Hangar 3 necessitated a shoring and emergency repair program
- As part of the contractor's means and methods of performing repairs, 36"Ø steel pipe shores were placed between trusses 9-26
- Pipe shores were designed to provide secondary stability in the event of progressive roof collapse during repair procedures
- Steel exoskeletons with jacks would then be placed at top to jack the roof and rebuild the critical zone

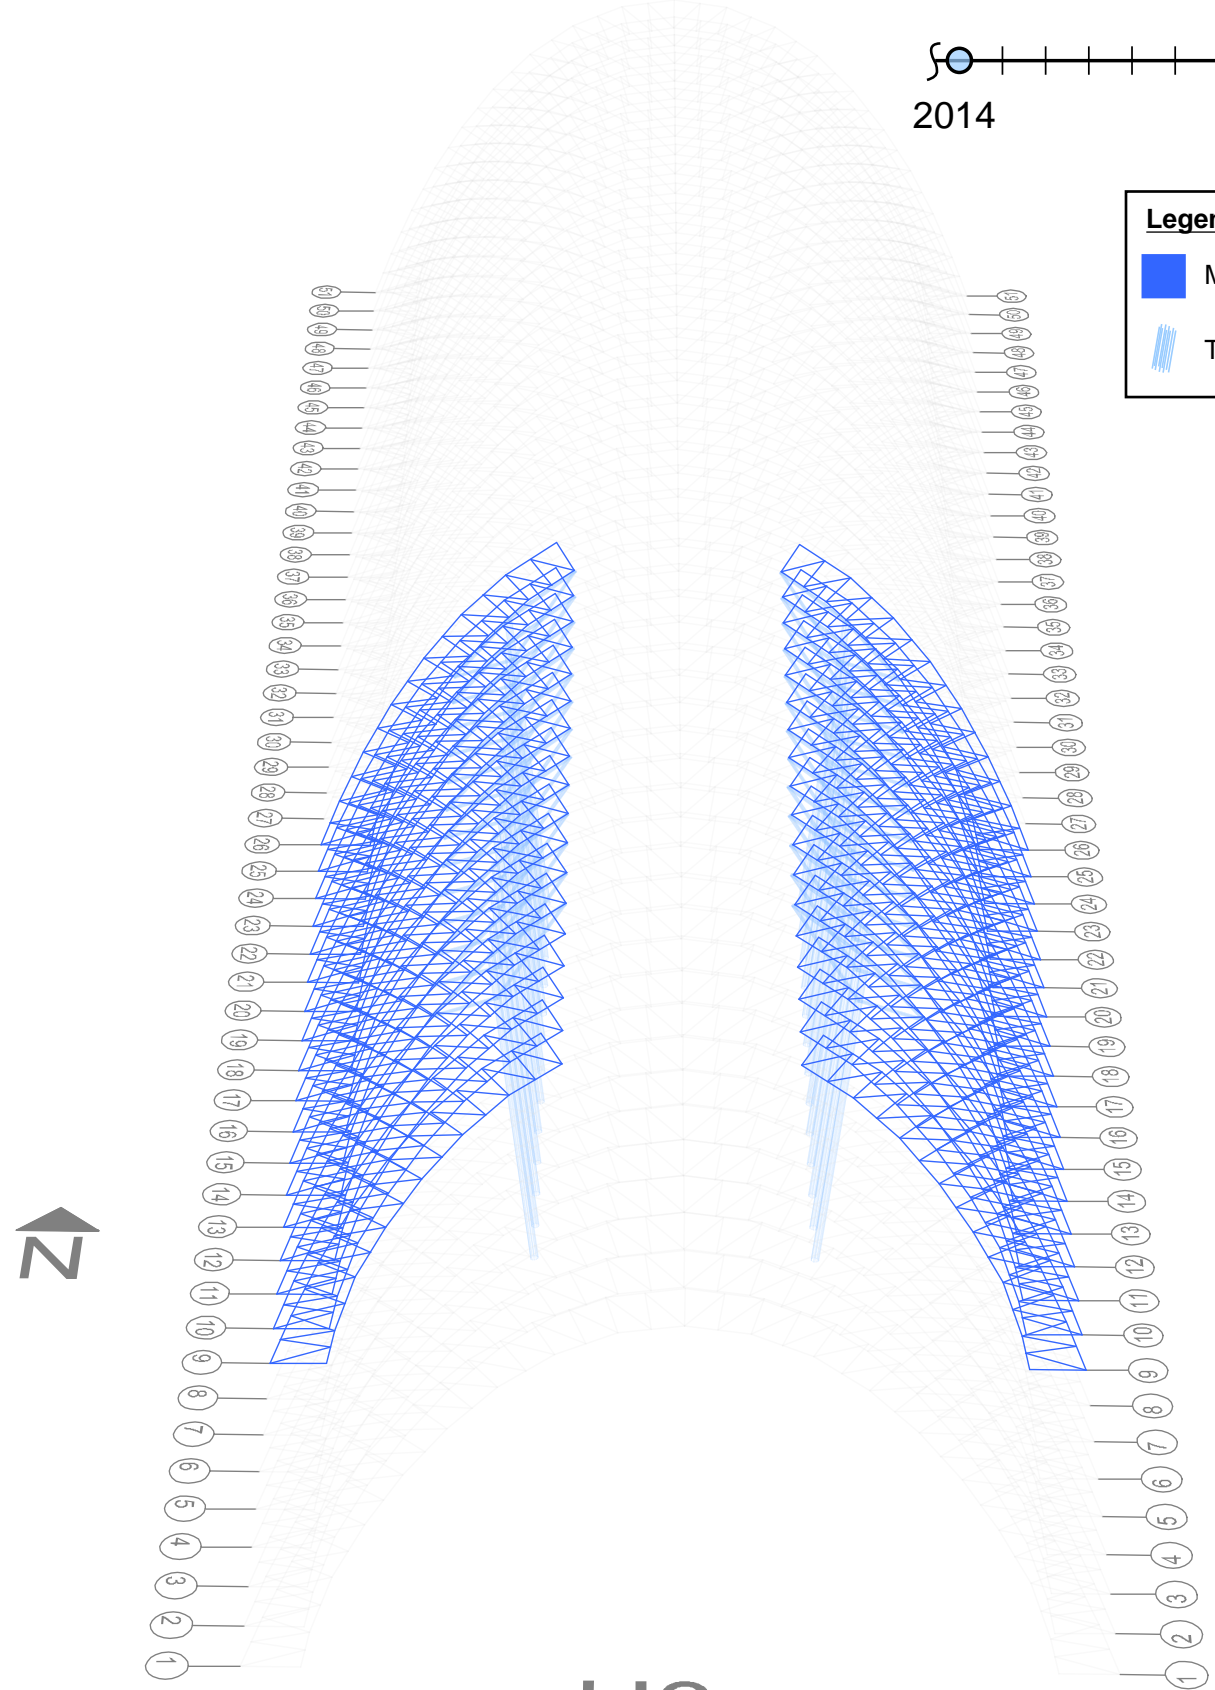
- Before the exoskeletons could be placed, the condition of the trusses below had to be verified to ensure they could take the additional weight
- Any damage of main arch members needed to be repaired prior to exoskeleton installation
- KPFF conducted a survey of main arch members between Trusses 9-26 below panel point O and 14
- **1548** main arch chords and webs were surveyed for damage

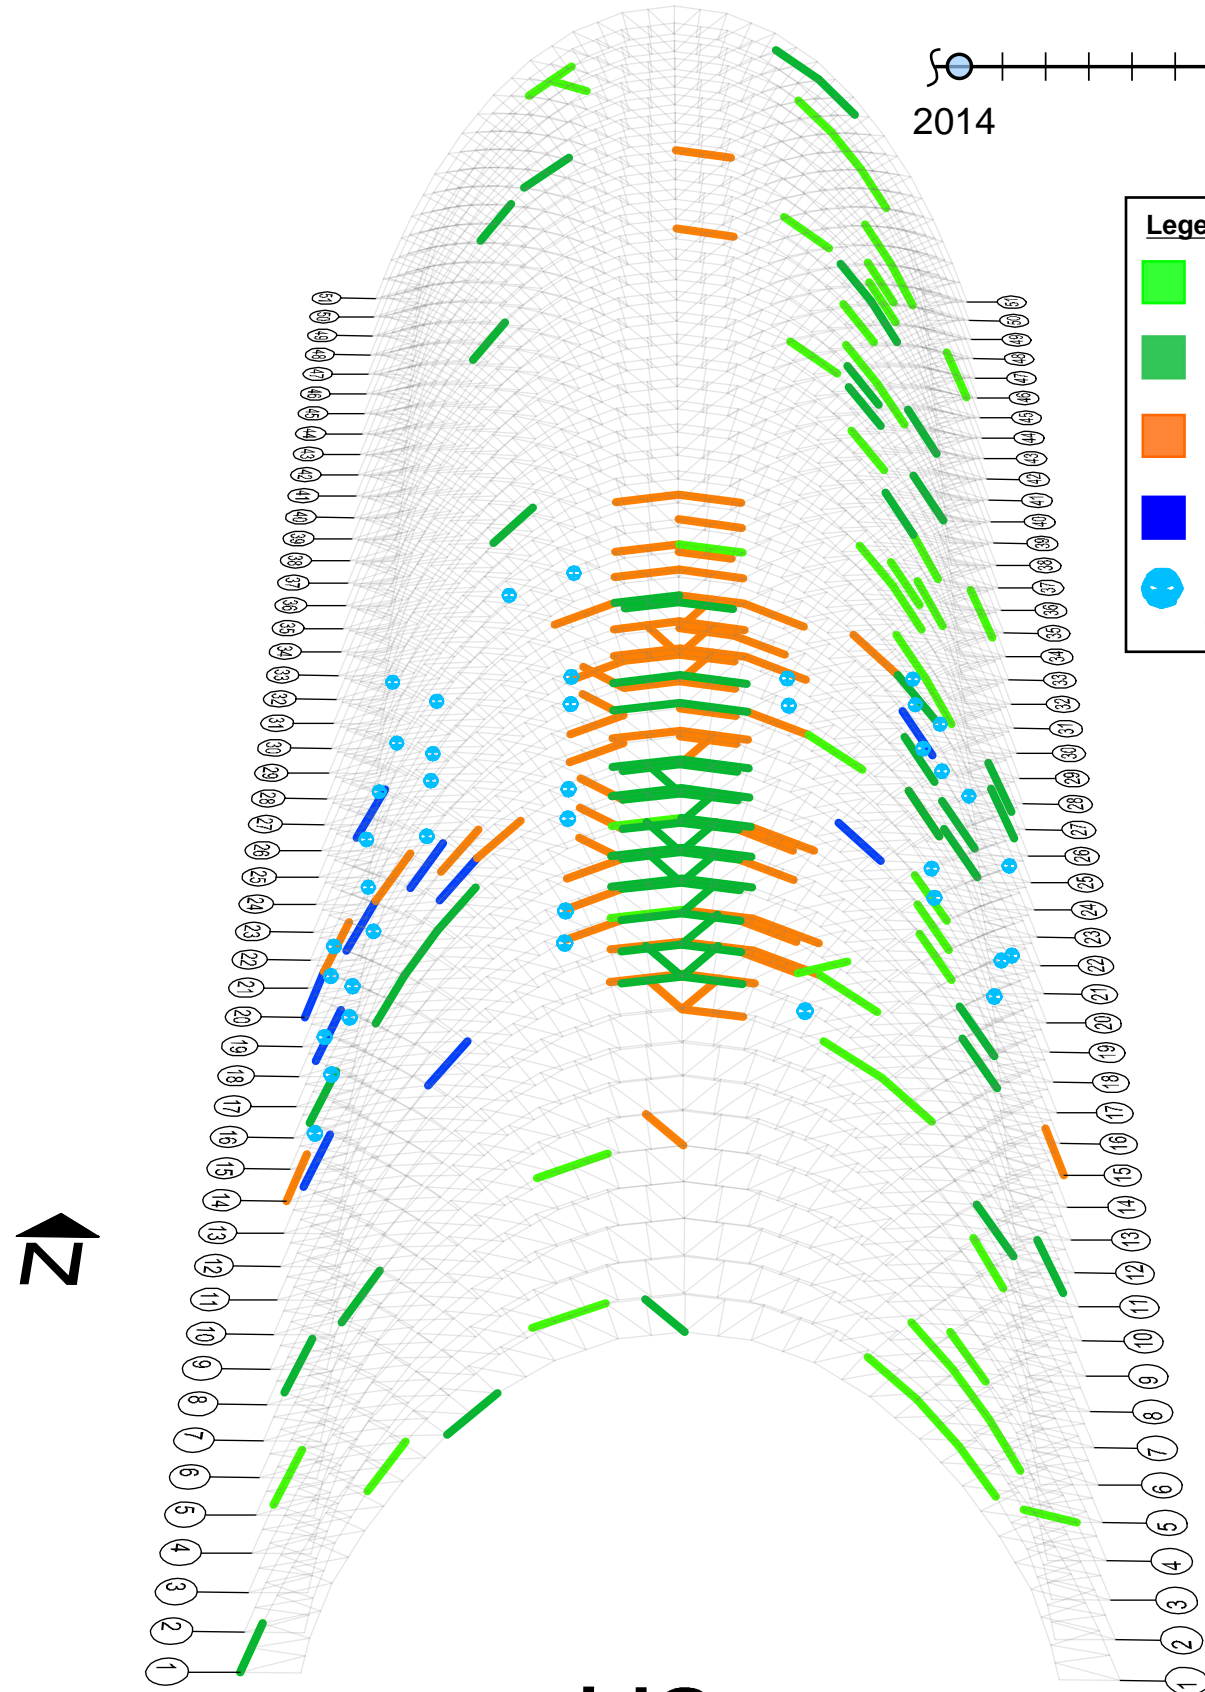
- The KPFF survey discovered chord damage which was either not observed or not present during the due diligence investigations
- The survey uncovered extensive deficiencies within the web member connections, including many plug pullout failures
- **10** additional arch members received glulam sistering repairs
- **39** chord connections received connection strengthening brackets

Chord sister repair installed prior to exoskeletons

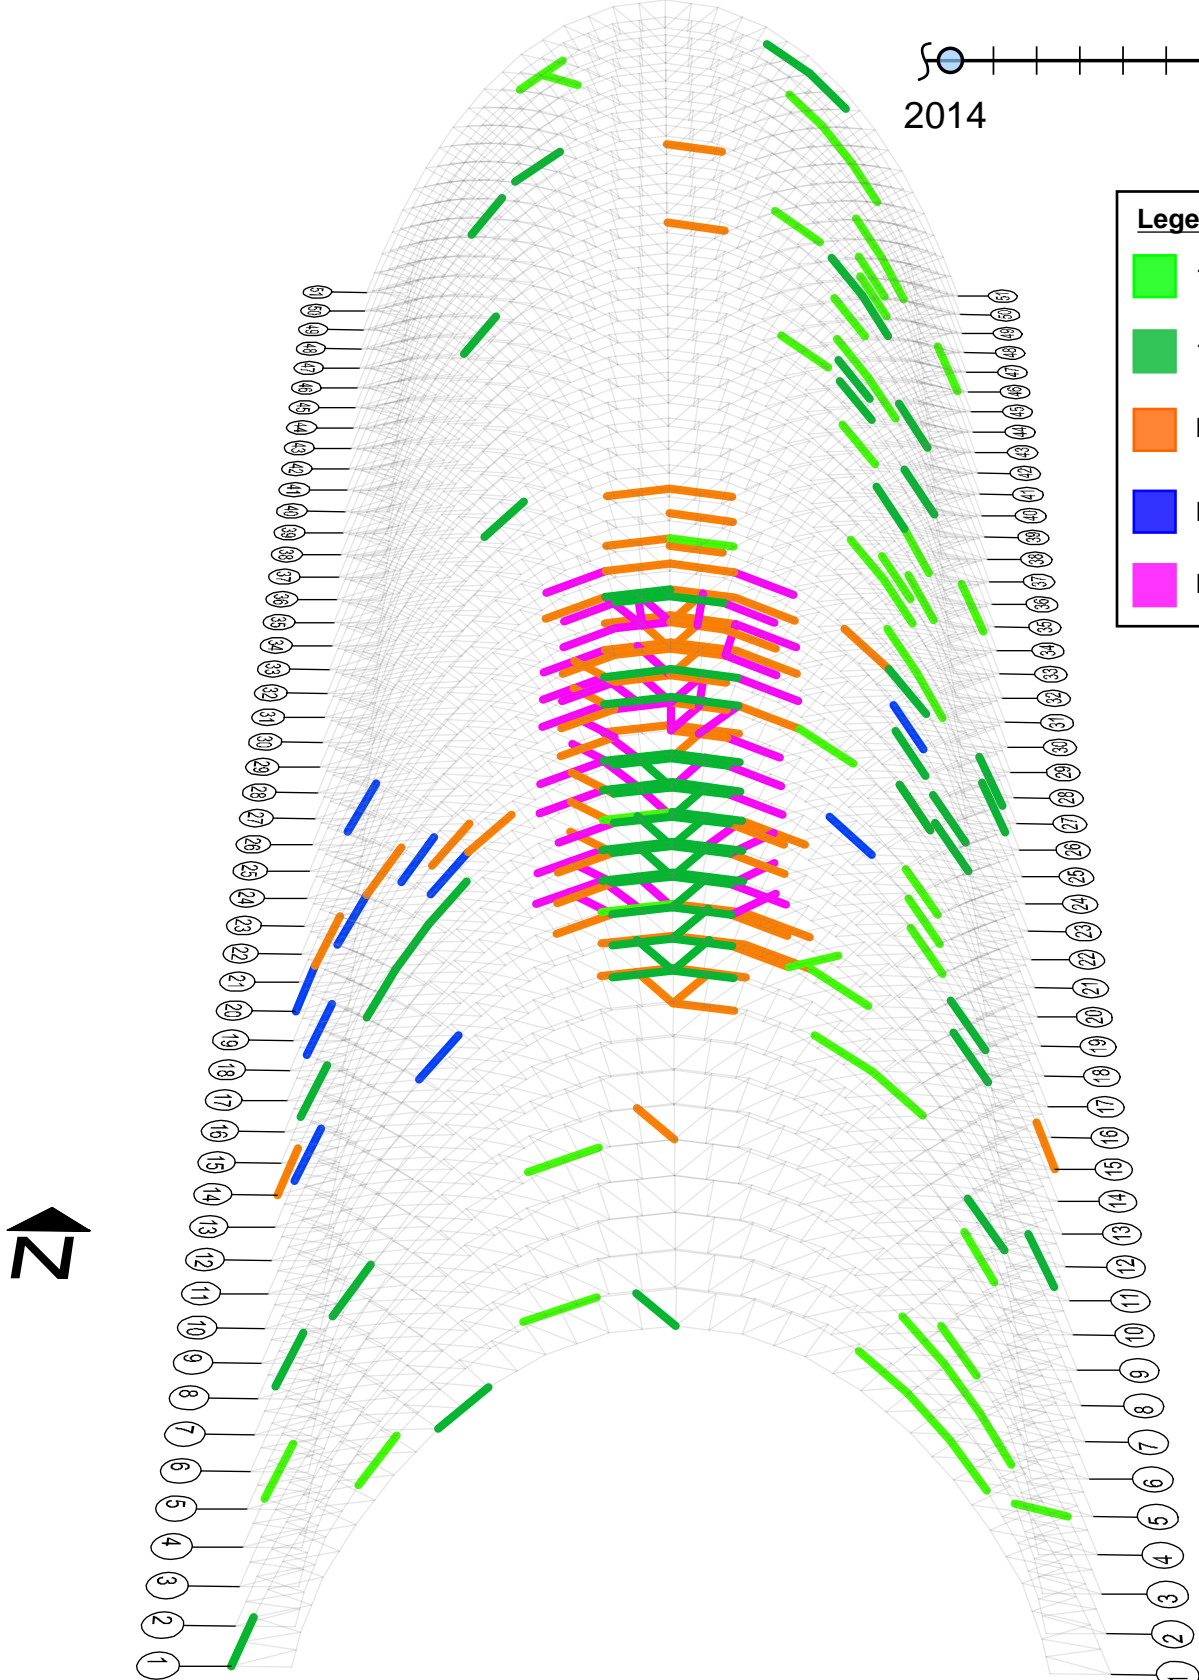
- **50** additional members were identified as severely damaged and scheduled to be removed and replaced after roof jacking
- Before jacking and repairs were made, decision was made to defer further construction activities

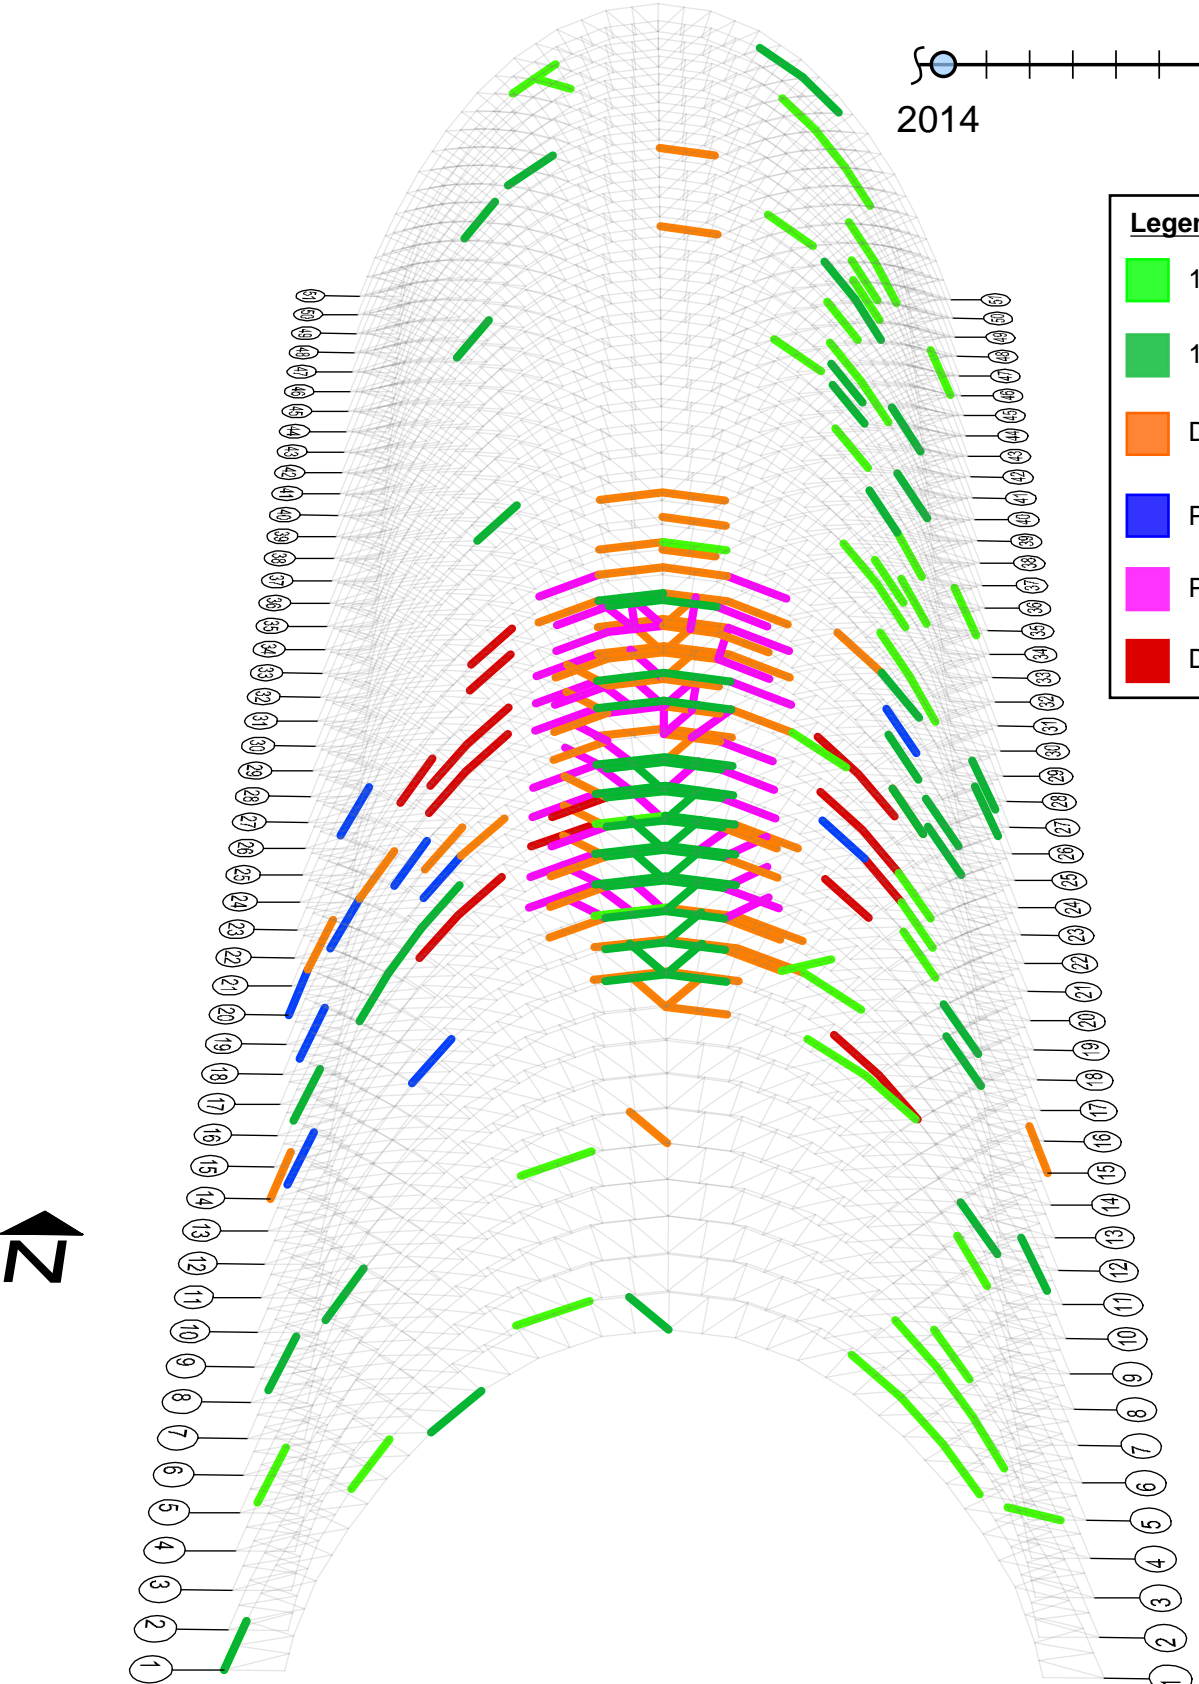
- Months after installation of exoskeletons, major splits were observed in chord members which had previously been observed and cleared.
- Major damage was observed on **19** chords, most between panel points I to M.
- Sistering repairs installed on most severe cases
- Due to the concentration of new damage at the lower chord members at panel points I to M, preemptive measures were taken to help reduce the progression of damage.
- Preemptive measures included fully-threaded screws at connections, and steel clamps.
